ANNUAL SUMMARY REPORT

Project Title: P8 Evaluate the performance of the Transport Network
Reconstruction Program (TNRP)
(Year 2 – 2015/16)

Authors: Dr. Jeffrey Lee and Lory Noya

Client: Queensland Department of Transport and Main Roads

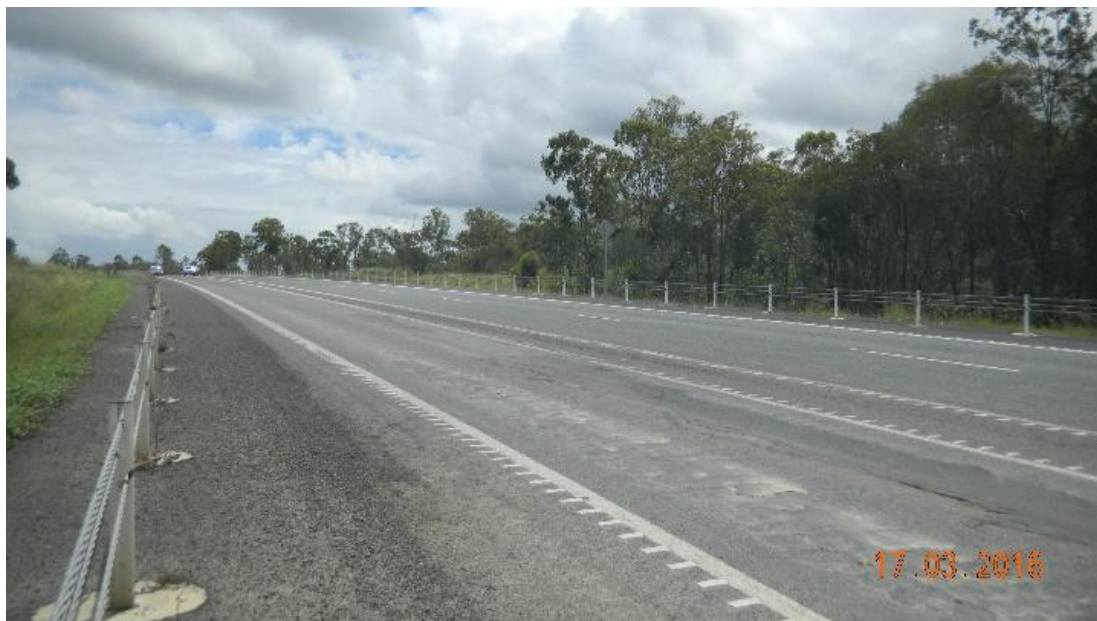
Figure 3.2: Pavement defects observed along Bruce Highway (10D)

Of particular interest are some sections along the Bruce Highway where premature crocodile cracking was found on cement modified or stabilised pavements. Some photographs taken at these sites are shown in Figure 3.2 and Figure 3.3. Without detailed field coring and material information on the stabilised pavements, a preliminary conclusion is that over-dosage of stabilising agent can be one of the most likely reasons for the premature distress.

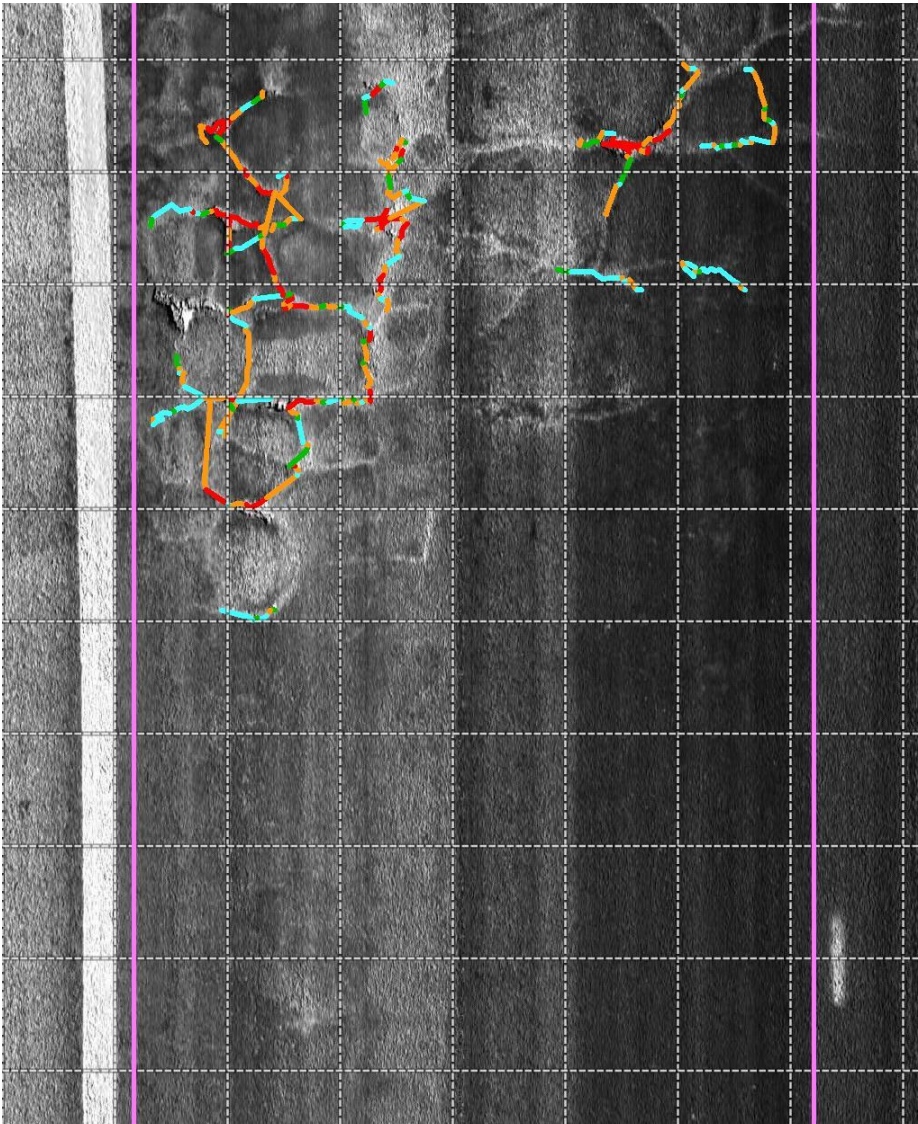
Figure 3.4: Automatic crack detection image collected along the Capricorn Highway (16A)

In Year 1 of the study, a few pavement sections had a low PCI value. One of the sections flagged was located near Rockhampton along the Capricorn Highway (Rockhampton – Duaringa), 16A, between chainage 16.6 km and 18.8 km. This condition was confirmed by the TSD automatic crack detection survey collected on 12 June 2015. An example of the surface condition is shown in Figure 3.4.

The original plan was to visit this section to gain a better understanding of the causes of the pavement distress. However, the section has since been repaired, therefore further investigation of the original work cannot be conducted.

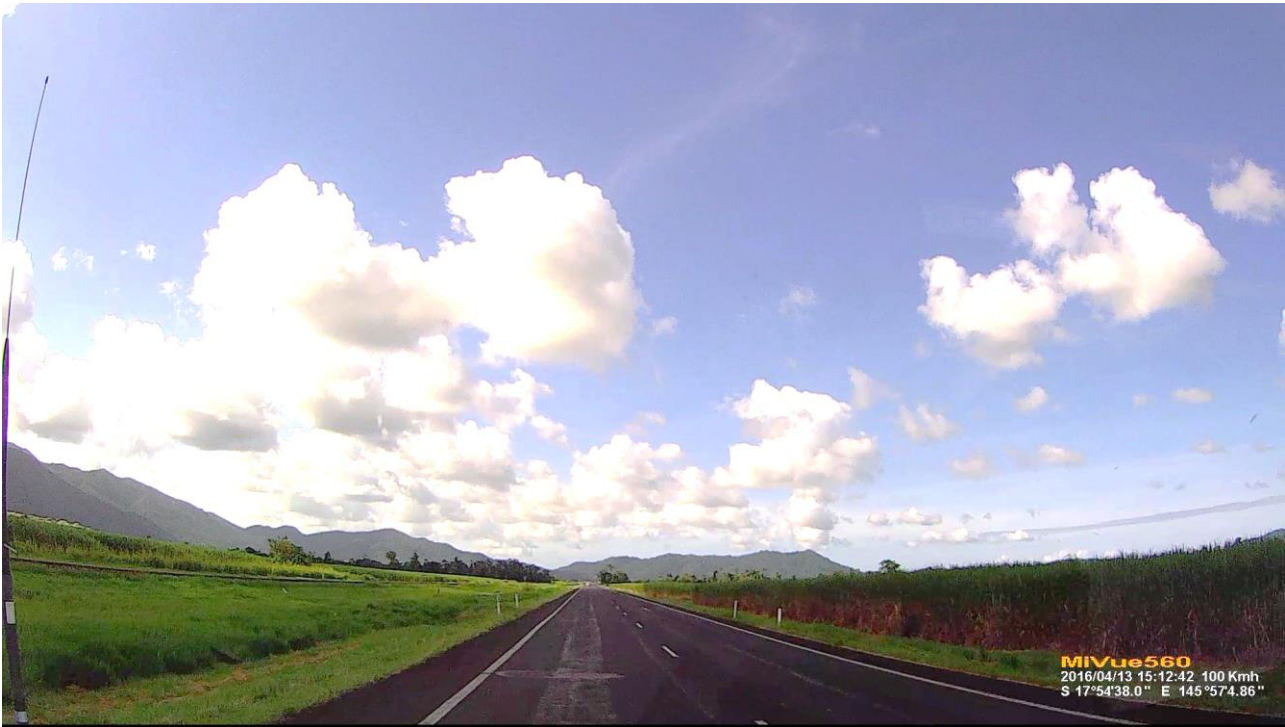
Figure 4.2: Pavement defects along Bruce Highway (Ingham – Innisfail), 10N, Ch. 96.6–105.517 km

It was noted that the section of Bruce Highway (Ingham – Cairns) 10N near El Arish Range, was one of the monitoring sites identified in Year 1 of the project. Flushing along the wheel paths has been reported within the foamed bitumen stabilised section. Figure 4.2 and Figure 4.3 are photographs taken along the Bruce Highway section (10N) at the time of the site visit. Defects along the wheel paths are visible. Field cores will be taken to visually assess the reason for the flushed seal along the wheel paths. Where needed, further laboratory testing on the sampled material will be conducted.

Coring and pavement material sampling is being organised and is expected to commence in Year 3 of the project.

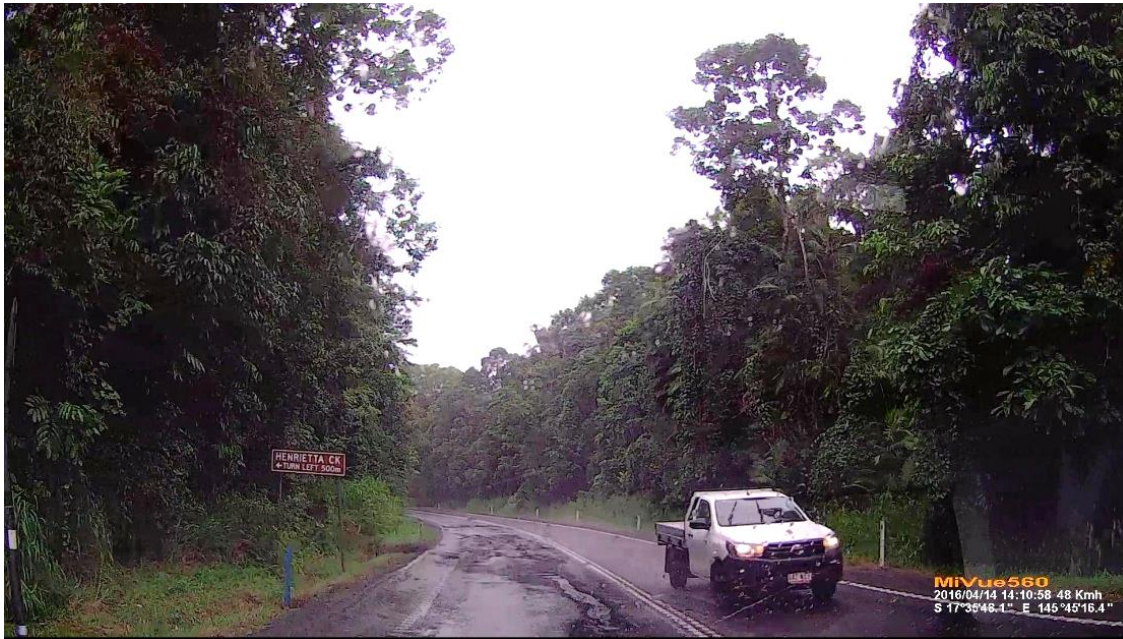
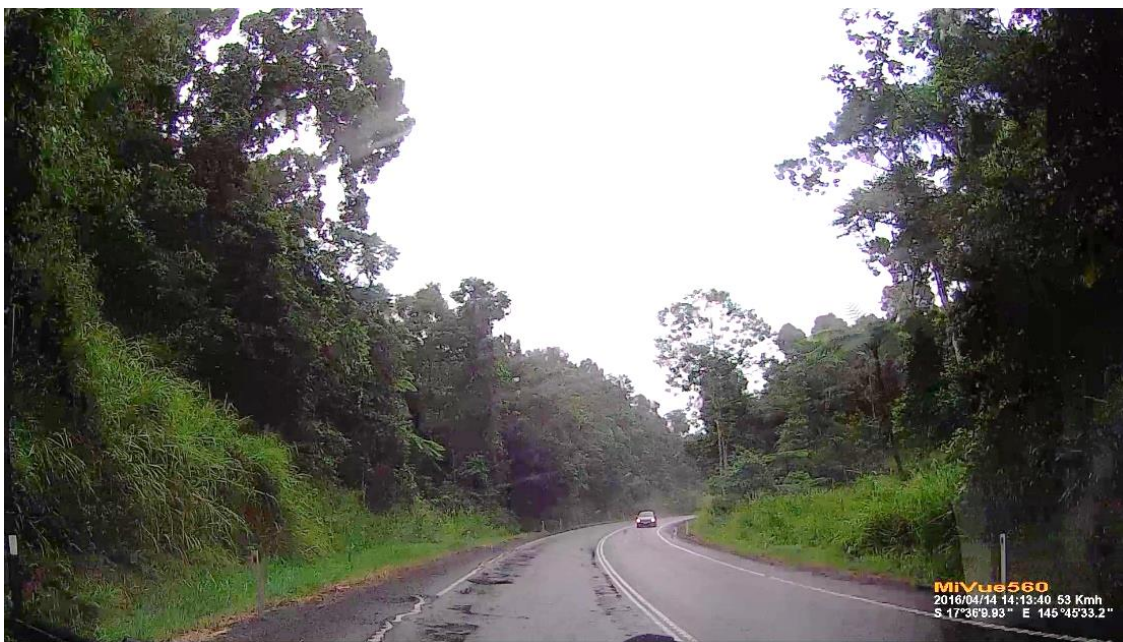
Figure 4.4: Pavement defects observed along Palmerston Highway, 21A, Ch. 29.98–33.92 km

The section along the Palmerston Highway (21A) is located in a hilly region of the district. The road is located on steep gradient, and a significant volume of heavy vehicles utilises this section of the road. Some of the major pavement distress along the section is shown in Figure 4.4 and Figure 4.5, including potholes and severe rutting on the pavement surface. It is noted that some surface maintenance and patching work has been undertaken.

District staff suggested that the cause of premature failure may be caused by water seepage from the cutting areas. From the inspection, it appears that the plant-mixed cement modified base (CMB) treatment varies in width with some patches extending the full width of the traffic lane, while some are part-width treatments. Trenching and cores are planned in the Year 3 investigation to better understand the reasons for the premature failure observed.
