# FINAL REPORT

Project Title: Long-term performance of FRP replacement components and structures (Year 3 - 2017/18)

ARRB Project No: PRG17033

Client: Queensland Department of Transport and Main Roads

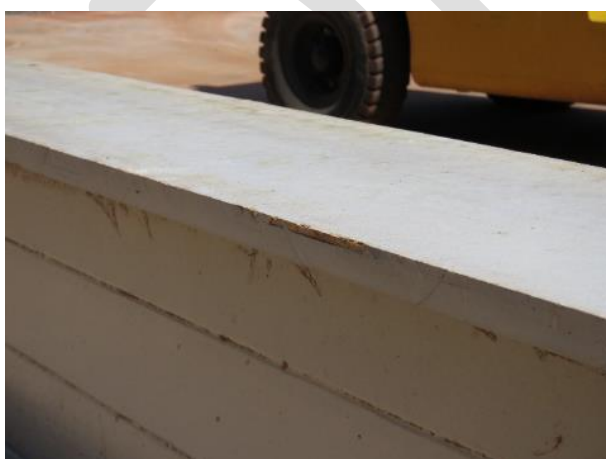
**Figure 3.2: Chipping noted at top flange of Girder 1-15**

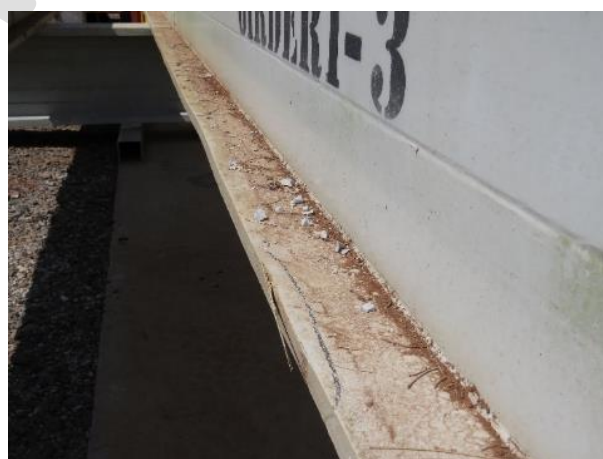
**Figure 3.3: Typical chipping noted at bottom flange of Girder 1-3**

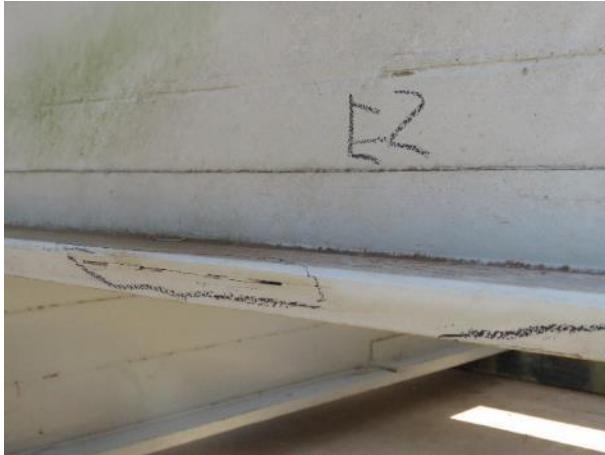
Figure 3.4: Typical delamination noted at bottom flange of Girder 1-6

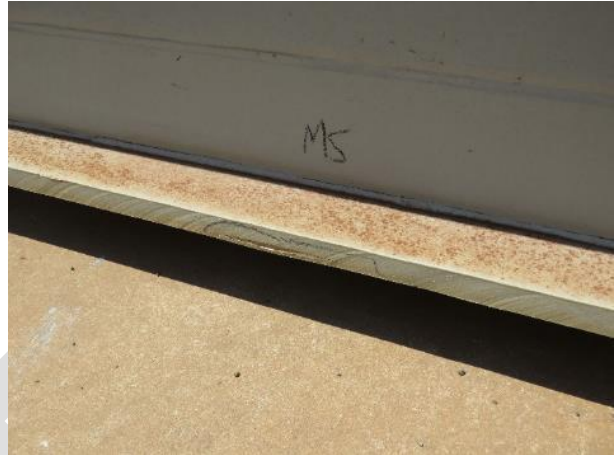
Figure 3.5: Delamination noted at bottom flange of Girder 1-17

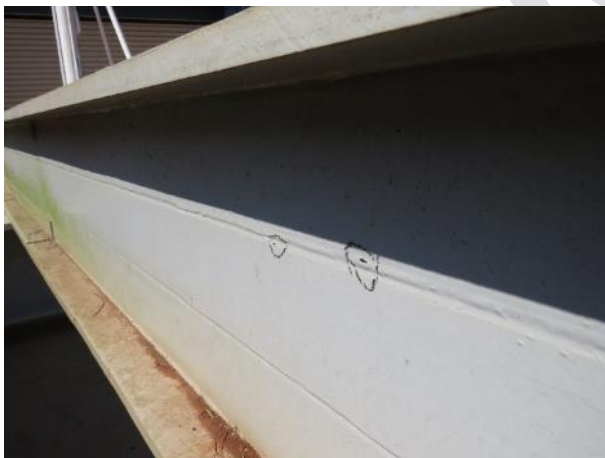
Figure 3.6: Coating defect, holes noted due to air bubbles on painting, Girder 1-6

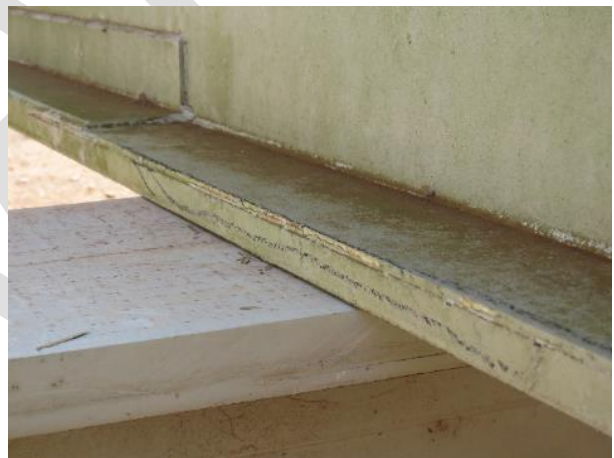
Figure 3.7: Coating deterioration at edge of flange, Girder 1-3

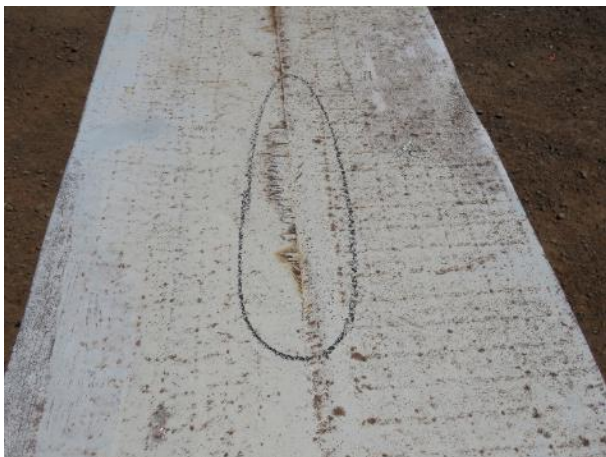
Figure 3.8: Fabrication defect with fibre exposed noted at top and bottom of Girder 1-3

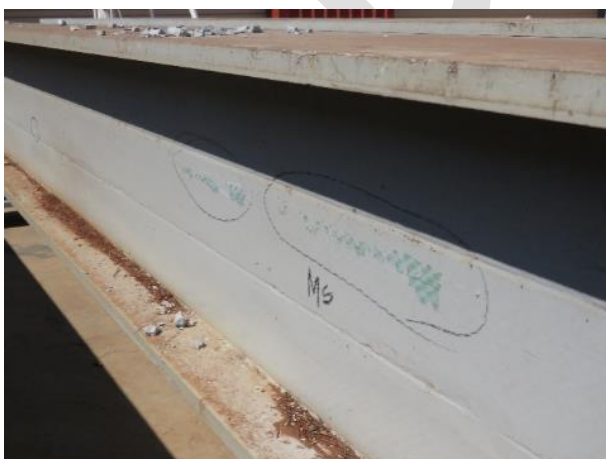
For FRP girders type S2 the most common defect was related to the failure of the coating due to exposure to direct sunlight or where there is water ponding and debris accumulation. Paint blistering and/or peeling were observed at these areas (Figure 3.9 and Figure 3.10). Most of the blistering was found on Girders 2–1. Other Type S2 girders had minor blistering and loss of paint coating. Exposure of the fibres was observed on Girders 2–3 and Girders 2–6 (Figure 3.11), possibly due to physical impact during handling and storage.

Figure 3.9: Typical blistering and peeling of coating

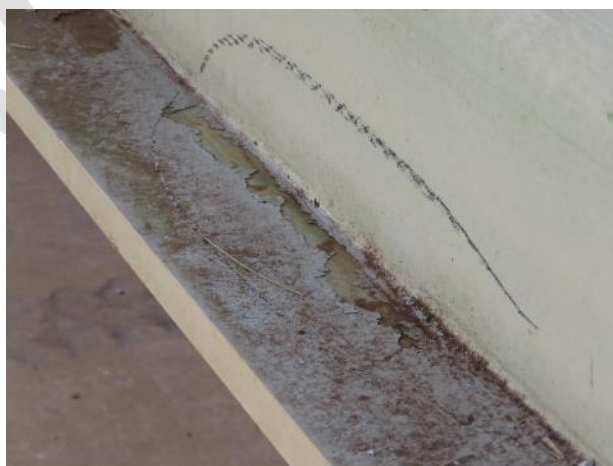
Figure 3.10: Typical peeling of coating noted at the edge of flange

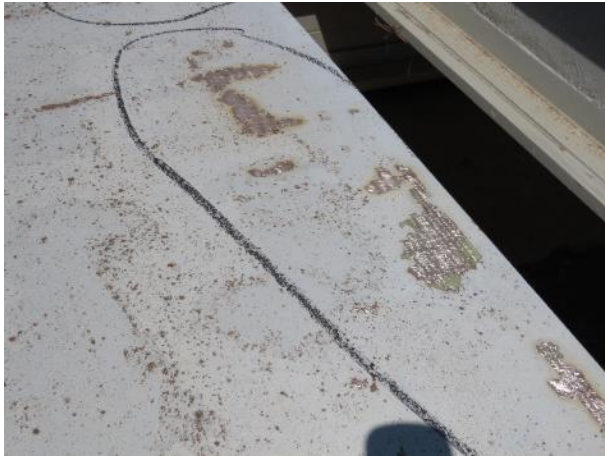
Figure 3.11: Typical peeling of coating at the top of girder G2-6 with fibre exposure

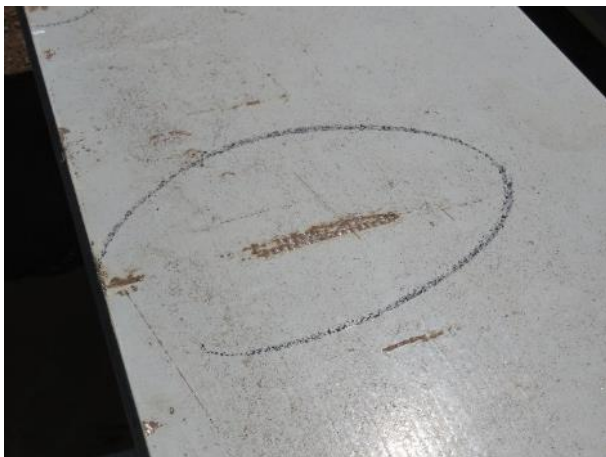
Similar to girder Types S1 and S2, the most common damage observed on the Type S3 girders was coating damage with fibre exposed, and coating blistering (Figure 3.12 and Figure 3.13). It is worth noting that the finished surfaces on the web between the strengthened angles of these girders were very coarse and uneven (Figure 3.14).

Figure 3.12: Coating and peeling with fibre exposed noted at top of girder

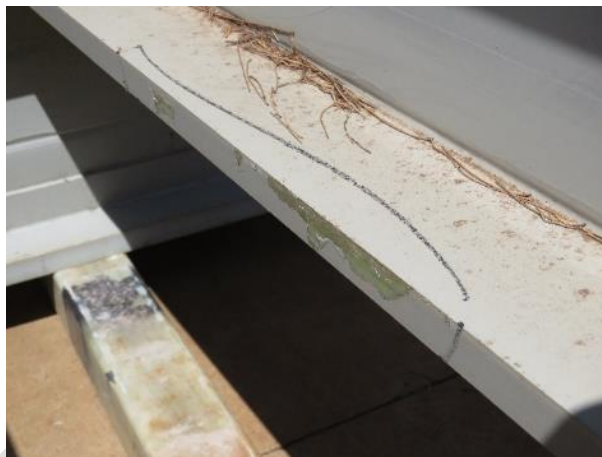
Figure 3.13: Blistering noted at edge of flanges

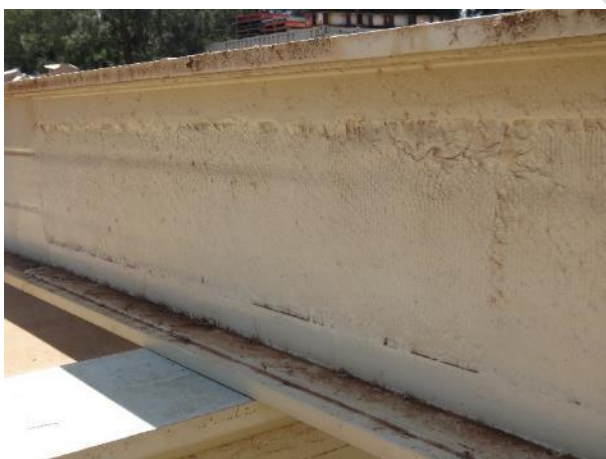
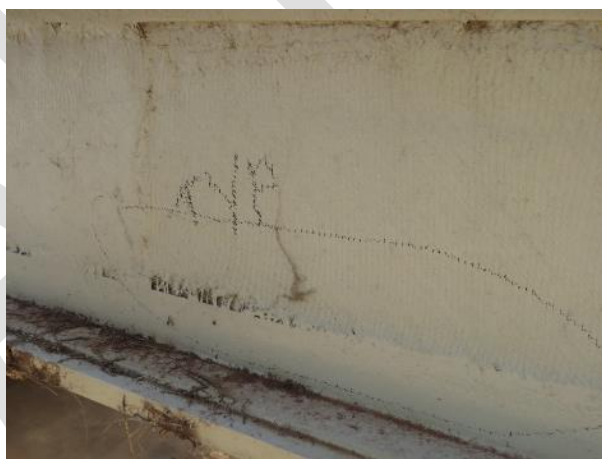
Figure 3.14: Typical defective finishing surfaces noted at the end of girder type S3

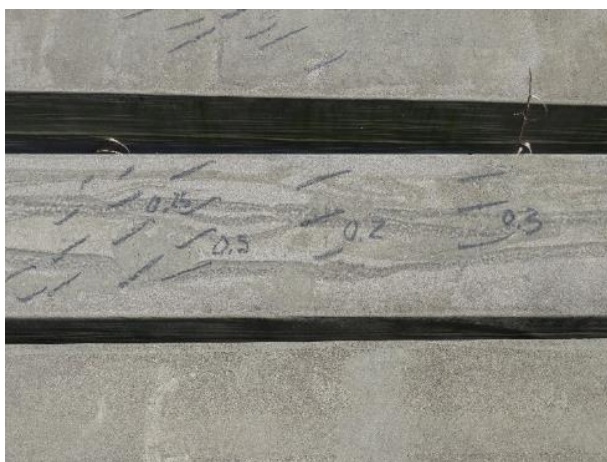
Figure 3.21: Cracking on top of girder 11 at mid-span

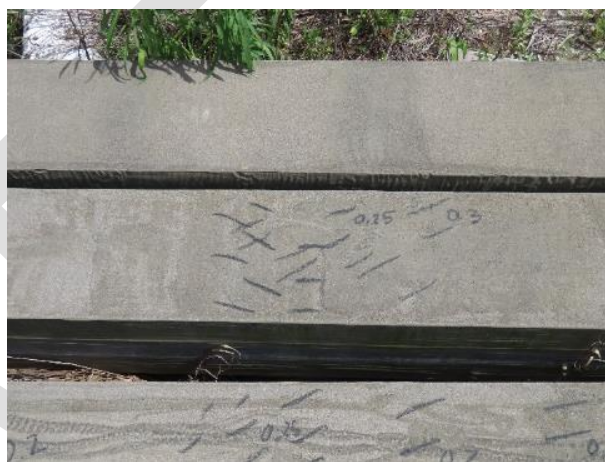
Figure 3.22: Cracking on top of girder 9 at mid-span

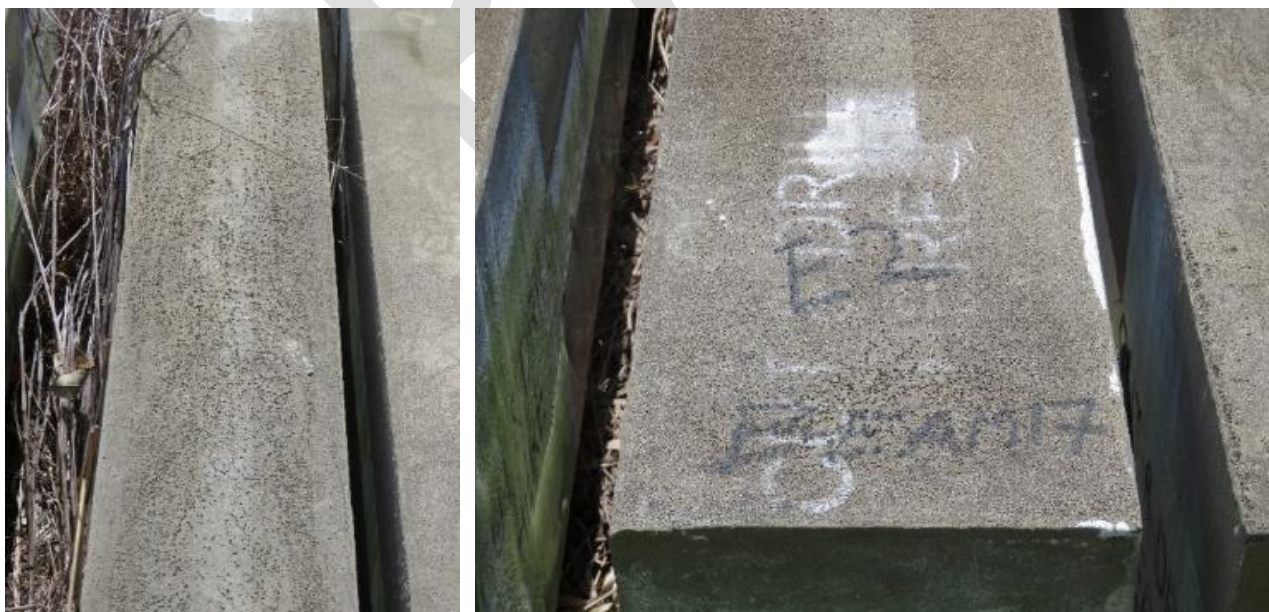
Figure 3.23: Pitting defects on the top surface of girder 17

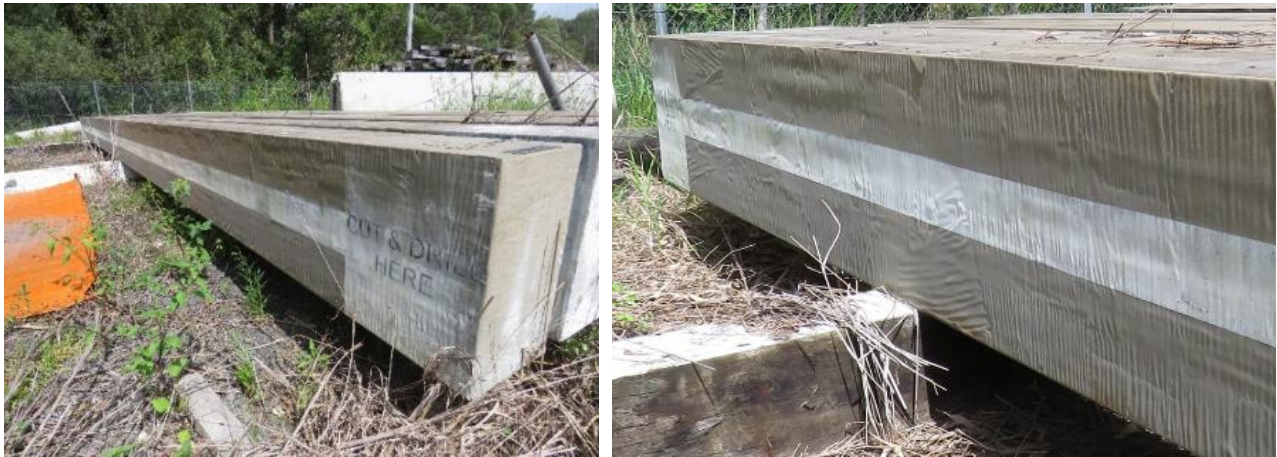
Figure 3.24: Typical deformation of the coating of resin

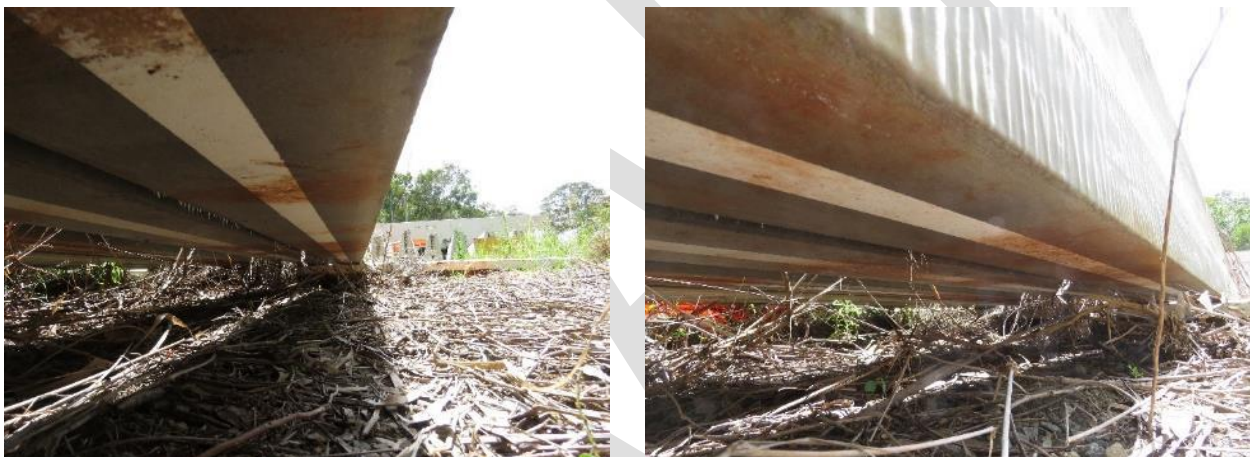
Figure 3.25: Typical rust-type stains at the underside of the girders

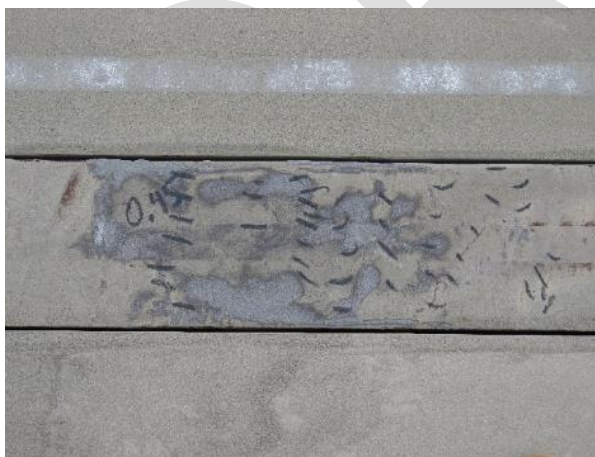
Figure 3.27: Cracking on top of girder 6 at mid-span

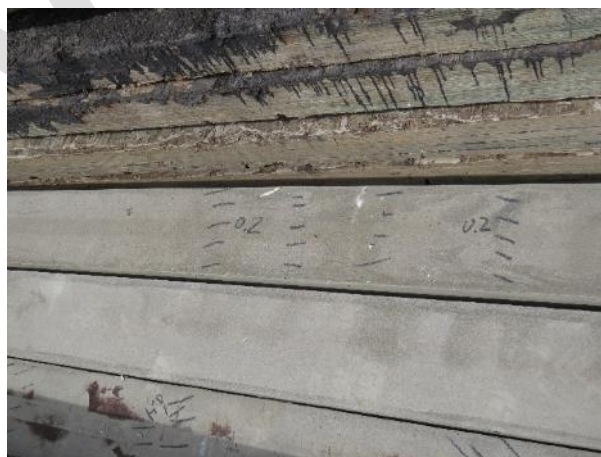
Figure 3.28: Cracking on top of girder 8 at mid-span

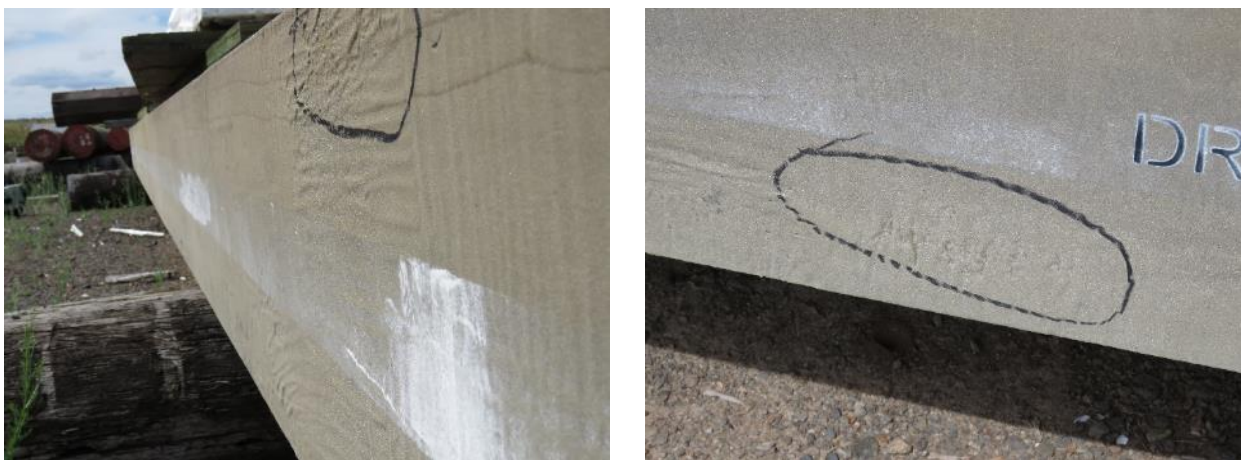
Figure 3.29: Deformation of coating at various locations

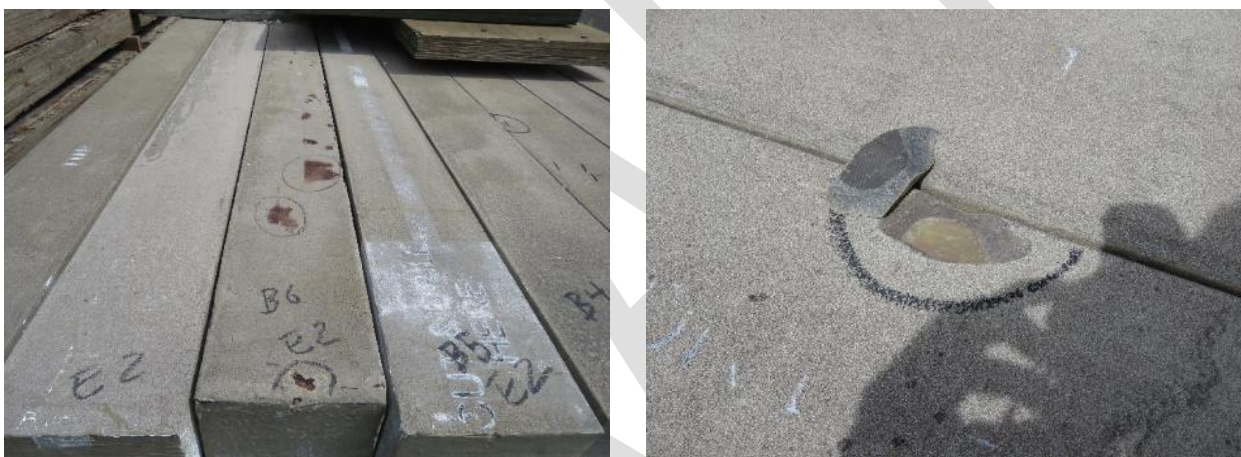
Figure 3.30: Minor damage on coating

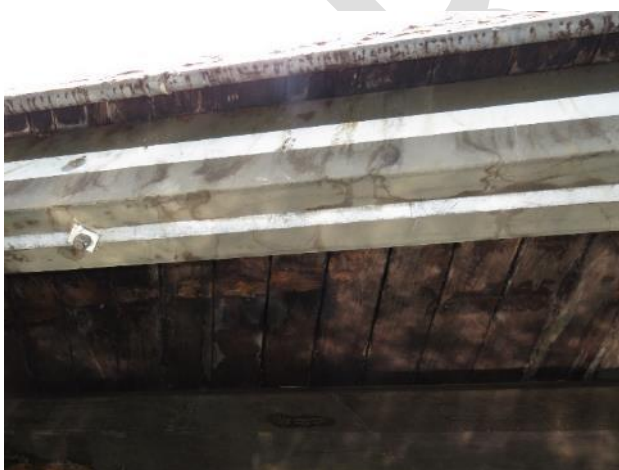
**Figure 5.2: Typical water stain along FRP girder**

In general, the FRP girder had minor defects (a 2D rating) except for the discoloration on the surface of the girder due to water ingress. Without a more intrusive test, there was no other evidence of material degradation or distress of the composite materials at the interfaces with other bridge components. The FRP girder showed no sign of excessive deformation or differential displacement. This indicates that the load-sharing mechanism is in place, and the replacement girder is performing as expected.

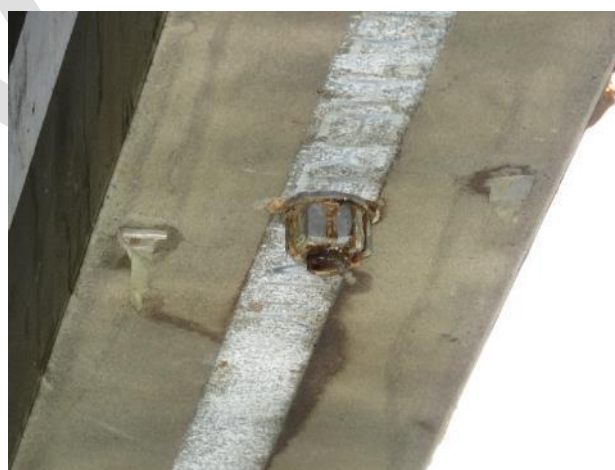
**Figure 5.3: Bolt corrosion under FRP girder**

It should be noted that Thioflex 600 or an approved equivalent sealant is required (in SD 2280) to apply around the bolts' washer to prevent water ingress; however, it was not the case on this bridge, causing the corrosion of the bolts.

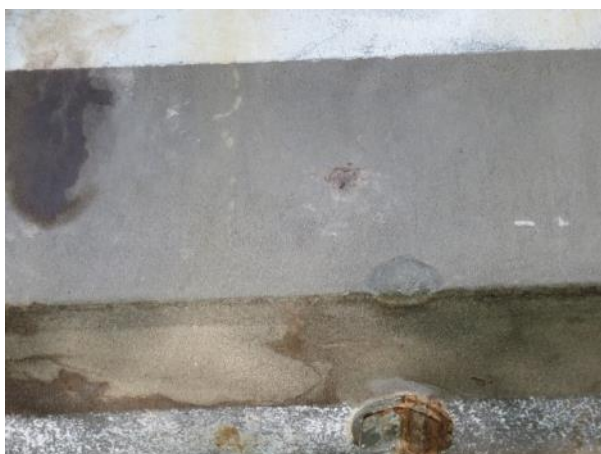
**Figure 5.4: View of minor surface deformation due to impact at the RHS end of FRP girder**

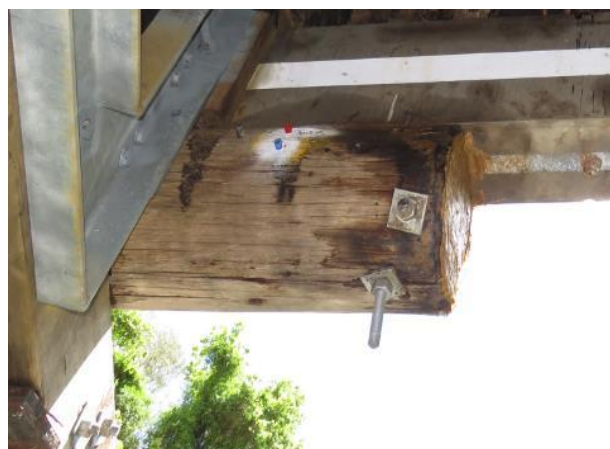
**Figure 5.5: Split noted at corbel under end of FRP girder**

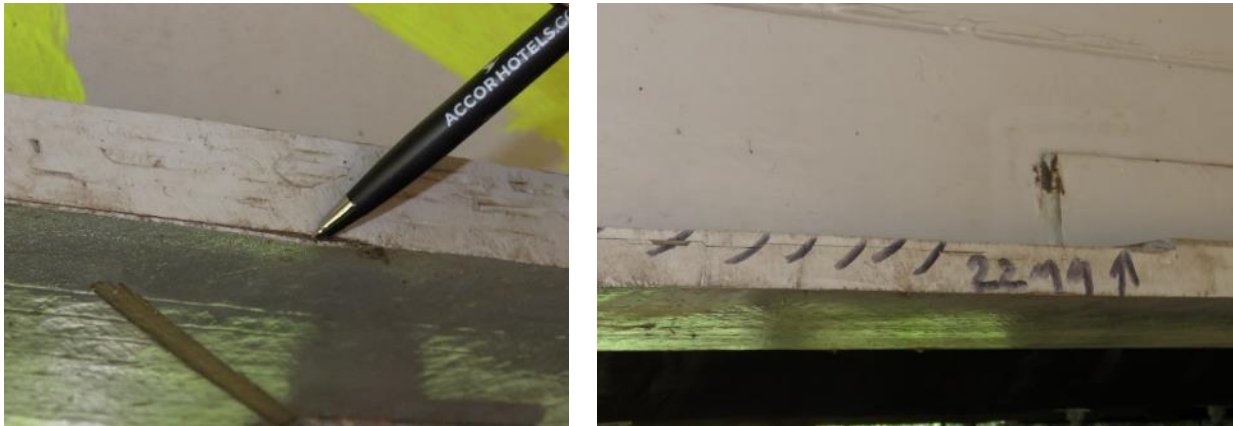
Figure 5.7: Delamination of flange plate at several locations on S1-G1

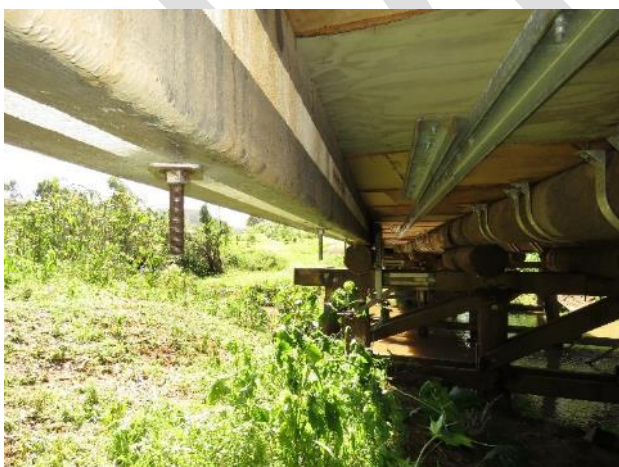
- minor corrosion at the bolts holding down the deck (Figure 5.14)
- minor scratches on the surface at end 1 of girder S2-G1 due to impact, likely during the re-decking process (Figure 5.15)
- water stains along the FRP girders on both inside and outside faces (Figure 5.16)
- minor corrosion of the steel packer plates under the girder supports on the corbels (Figure 5.17).

Figure 5.14: Corrosion of bolts at S2-G1

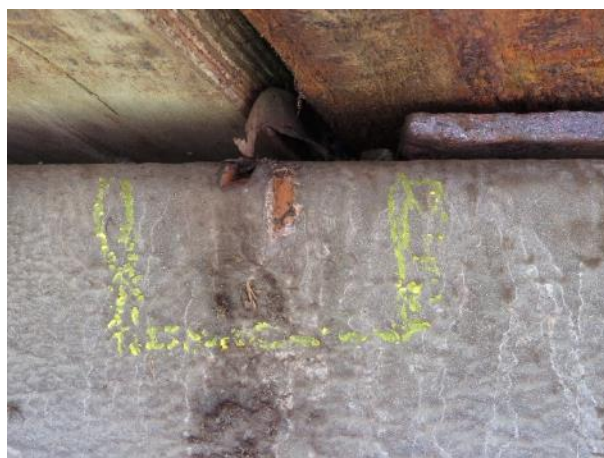
Figure 5.15: Minor deformation at S2-G1

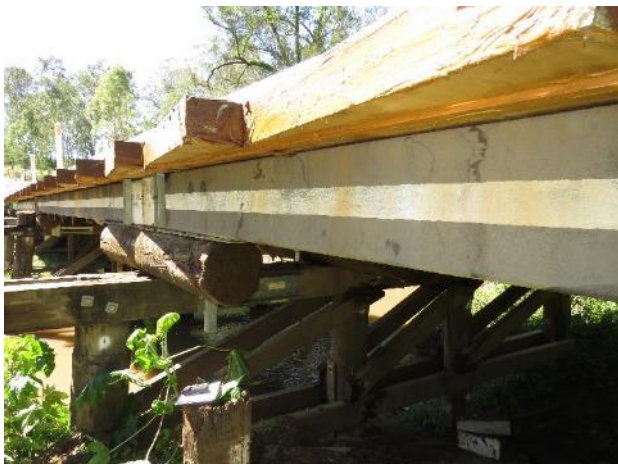
Figure 5.16: Typical water stains on FRP girder

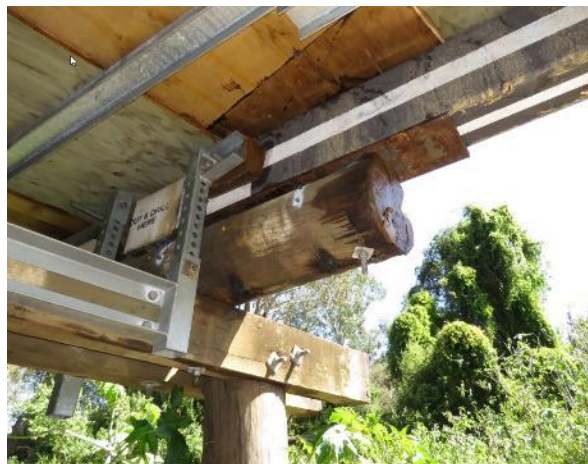
Figure 5.17: Corroded steel plate between FRP girder (S3-G1) and corbel (P2-COR1)

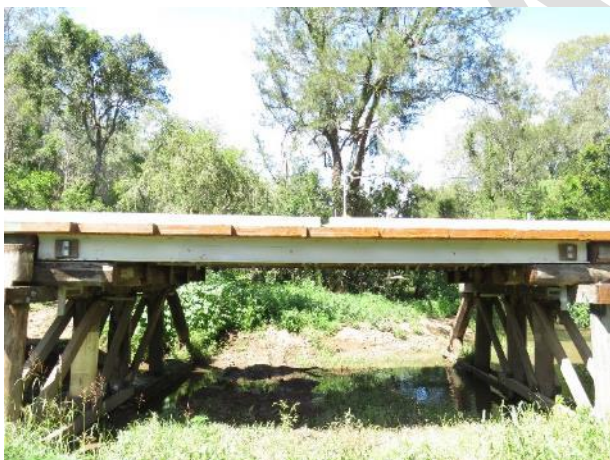
The WCFT type S3 girder (S5-G1) generally had a minor defect (Figure 5.18), with minor peeling off of the coating at the soffit of the girder.

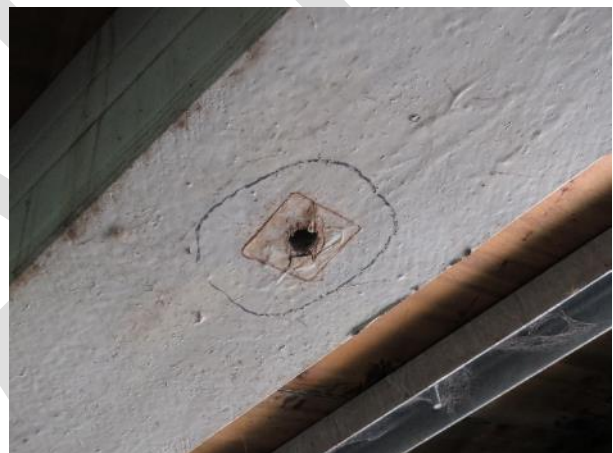
(a) View of a unused hole on the side face of the girder

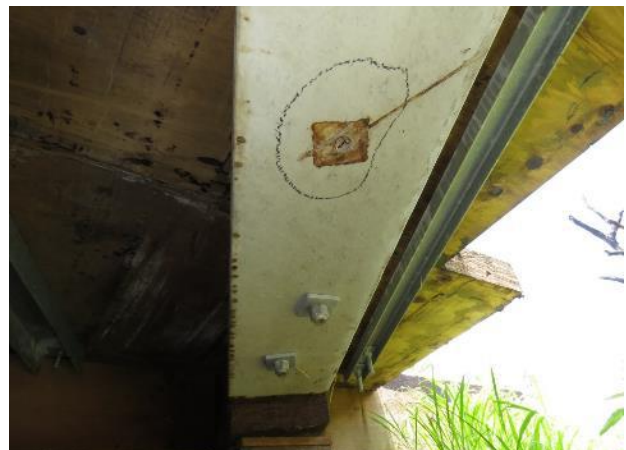
Figure 5.22: View of fibre tear off noted at soffit of girder

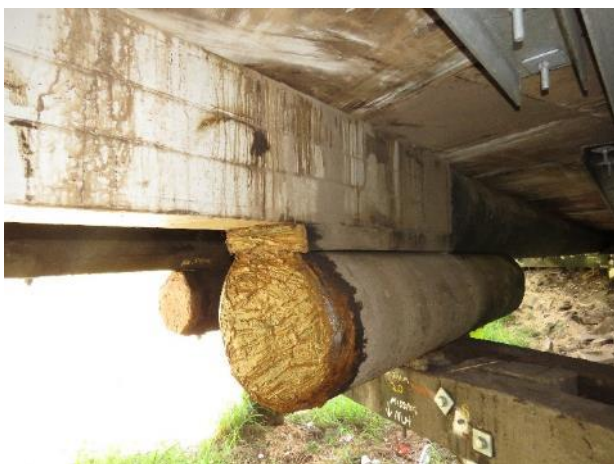
Figure 5.23: View of typical water stain at the FRP girder

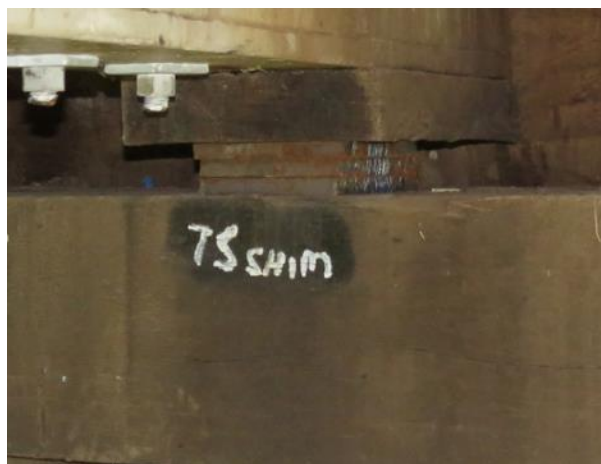
Figure 5.24: View of minor corrosion of steel packers

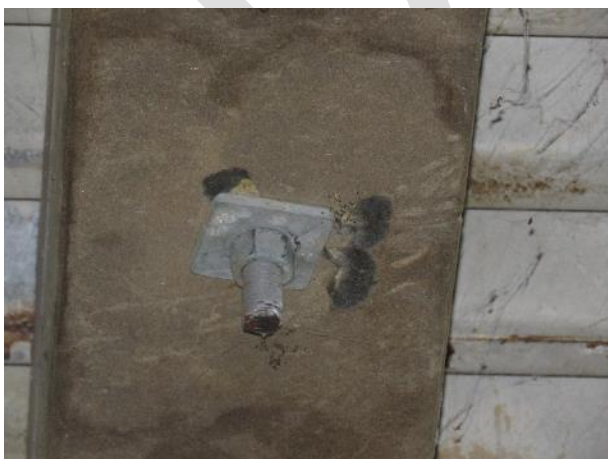
- loss of composite and exposed fibres at the soffit of the FRP girder at several bolts holding down the deck (Figure 5.26), likely due to the installation process
- water stains and discoloration at various locations at the side face and at the soffit of the girder (Figure 5.27)
- minor bolt corrosion at all bolt locations (Figure 5.28)
- minor corrosion of the steel trough deck around the contact areas with the FRP girder (Figure 5.29)

Figure 5.26: Loss of composite and exposed fibres at bolt location

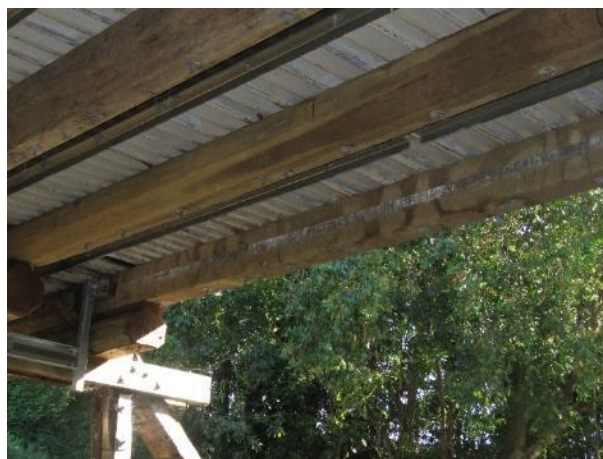
Figure 5.27: Water stains along FRP girder

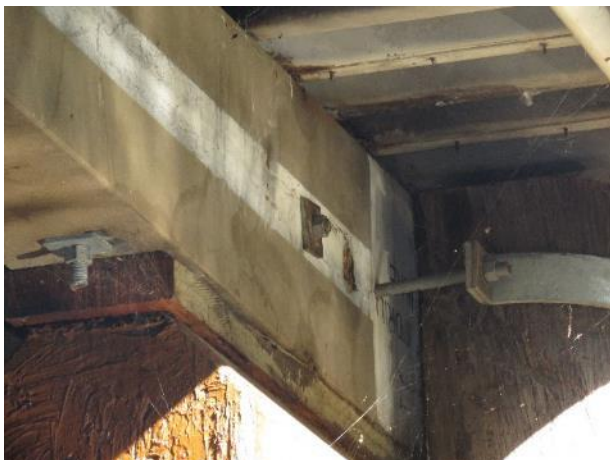
Figure 5.28: Typical minor corrosion of bolts

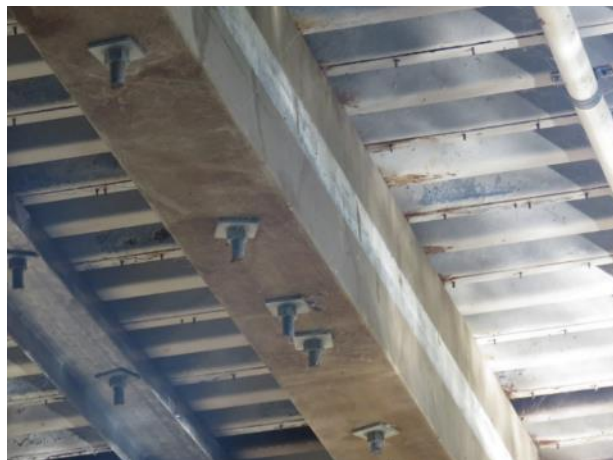
Figure 5.29: Corrosion of steel trough in contact with the FRP girder

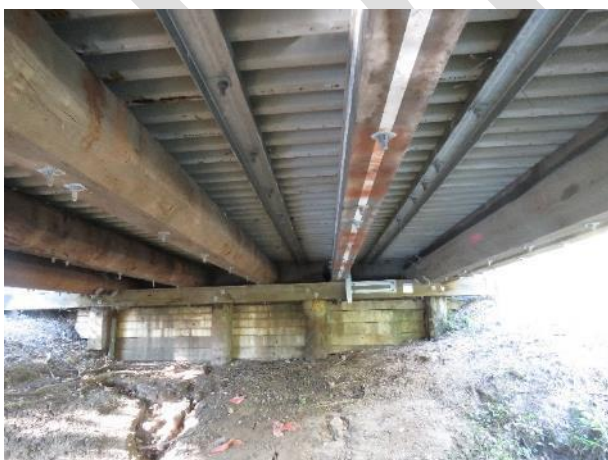
Figure 5.32: Rust-like water stains at the soffit of S1-G2

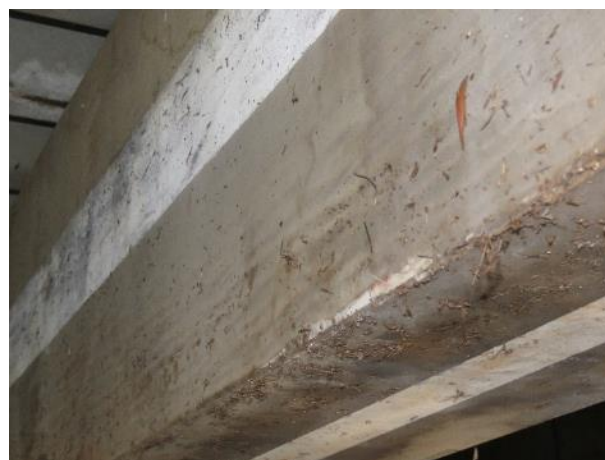
Figure 5.33: View of typical wave shape water stains noted at both faces of FRP girders

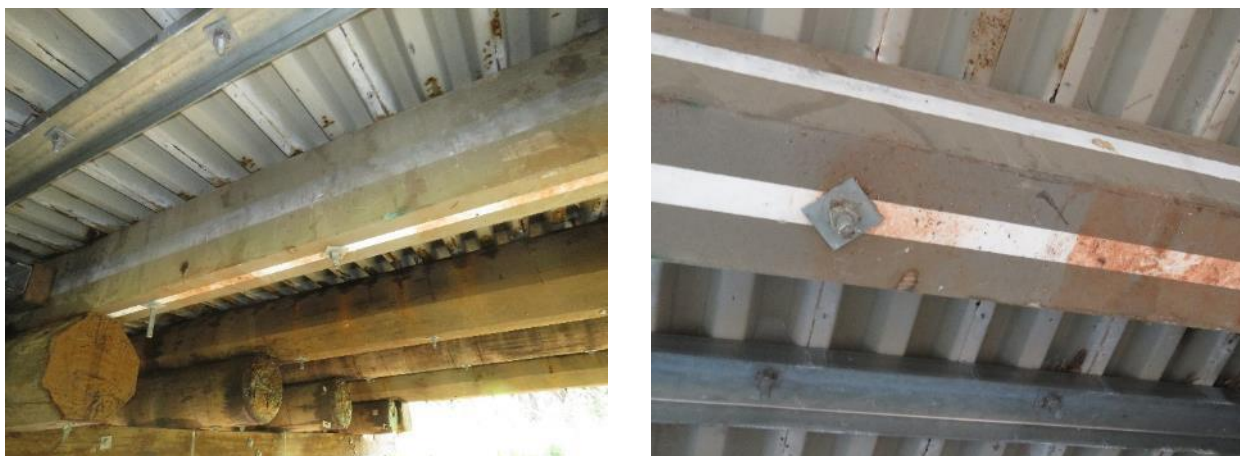
Figure 5.34: Loss of composite and exposed fibres on S3-G2

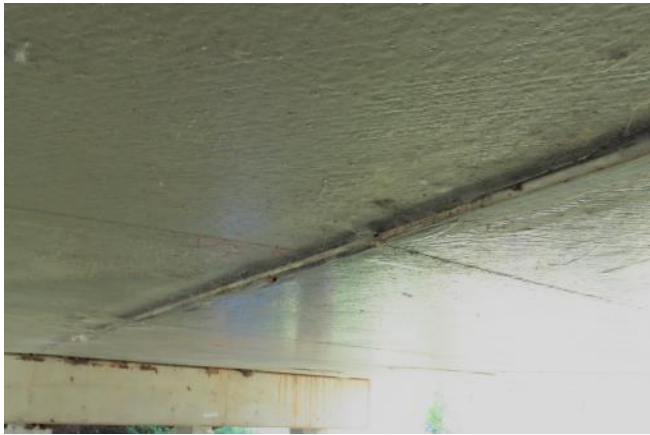
- Differential deflections at mid-span between units 2 and 3 at the underside of the units (Figure 6.7). These differential deflections were opposite in direction between span 1 (the deflection in unit 2 was about 16 mm lower than unit 3) and span 2 (the deflection in unit 3 was 25 mm lower than unit 2). The epoxy grout had completely failed at these locations.
- Exposed fibre and localised damage at the soffit of unit 2 and 3 at various areas (Figure 6.8)
- Damage to the fibre on a small area due to physical impact on the external FRP girder under the kerb unit (Figure 6.9).
- Deterioration of the coating at various locations around the mid-span at the soffit of unit 4 on span 1 (Figure 6.10).
- Water stains at the abutment headstocks (Figure 6.11) There was a significant water leak on the left-hand side of the pier headstock (Figure 6.12).

Figure 6.7: Differential profile at soffit of units 2 and 3 at mid-span

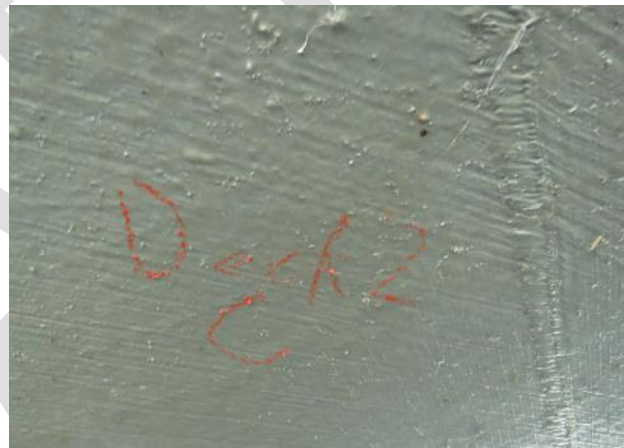
Figure 6.8: Fibre tear and exposed at underside of unit 3 on span 2

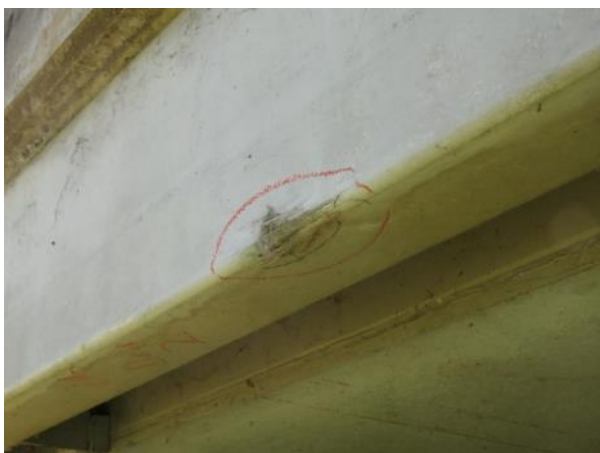
Figure 6.9: Damage on external FRP girder on Span 2

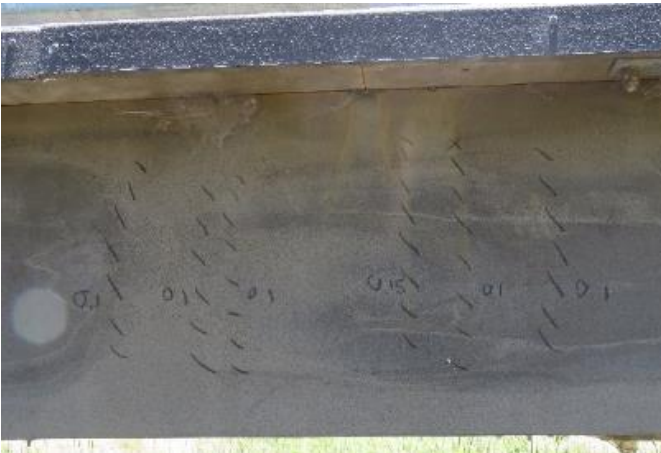
Figure 6.17: Vertical cracks at various areas on external side face of G1 and G3

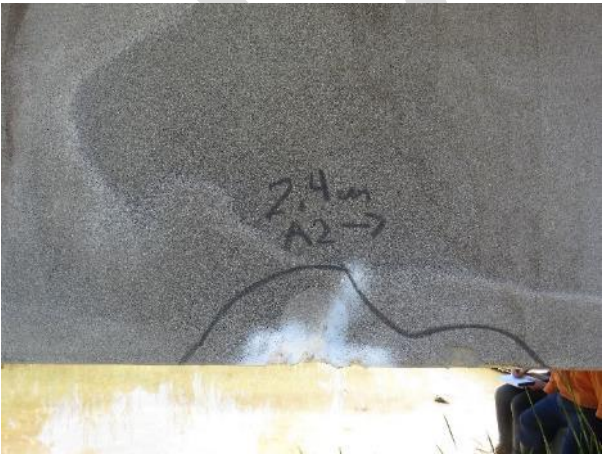
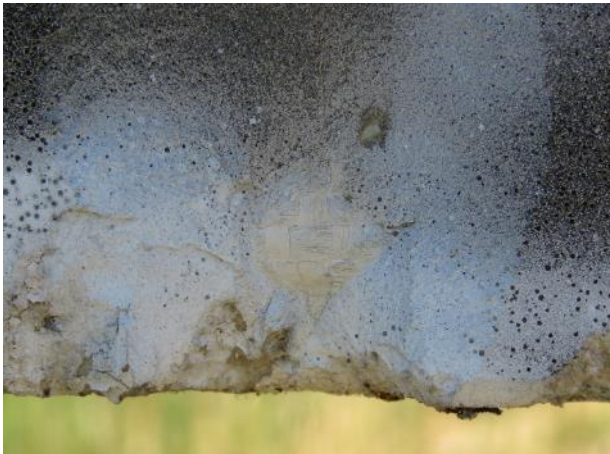
Figure 6.19: Typical spall with exposed fibre along lower edge of girder G3

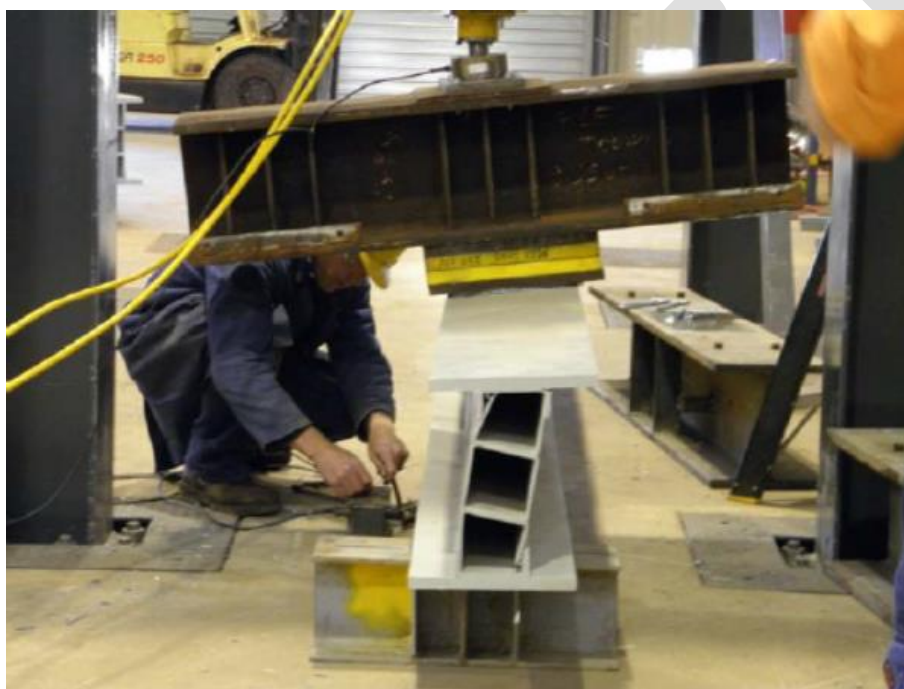
Figure 7.1: Failure of WCFT S2 girder in ultimate shear test
