FINAL REPORT

Project Title: S28: Review of Performance of Concrete Pipe Culverts
(Year 1 - 2017/18)

ARRB Project No: PRG17022

Client: Queensland Department of Transport and Main Roads

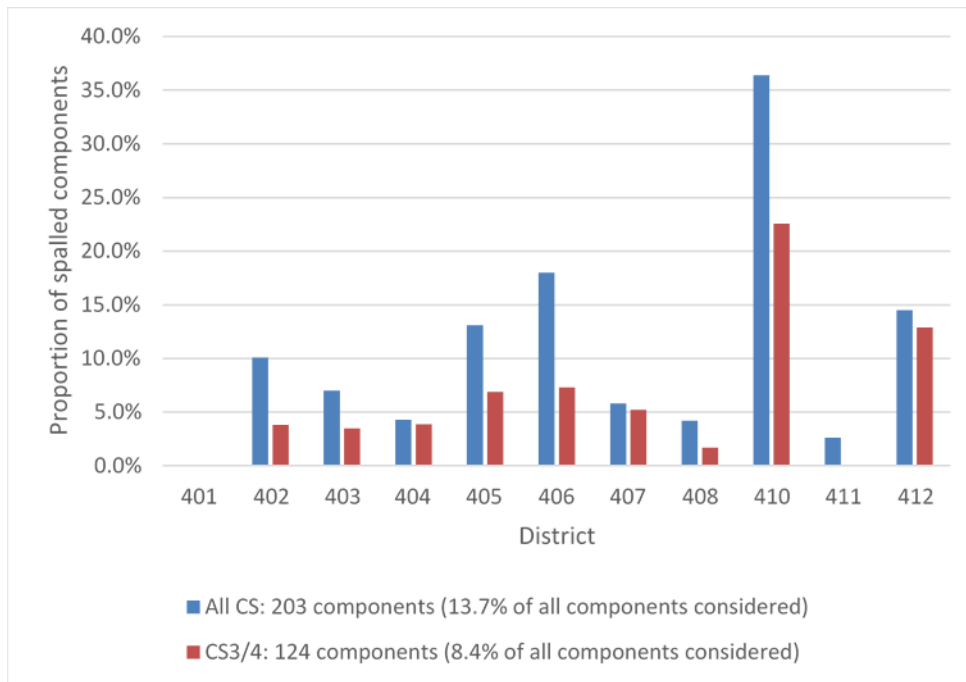
Figure 3.13: Spalled 80P components in each district rated in any CS and rated in CS3/4 only as proportions of all components considered for the district

- District 410 has by far the highest proportion of spalled components; 23.2% of components in the district are rated in CS3/4 and reported as being spalled (Figure 3.13; Table A 20; Table A 21).
- The high rates of spalling in district 410 seem to correlate with the reported high rates of longitudinal cracking for the district (28.0% of all considered components in the district are longitudinally cracked). Further investigation showed that 10% of all components considered for the district are both spalled and longitudinally cracked.
