FINAL REPORT

Project Title: S3 GUN-Sandgate Road Bridge Load Testing Report (2016/17)

ARRB Project No: PRG16022

Client: Queensland Department of Transport and Main Roads

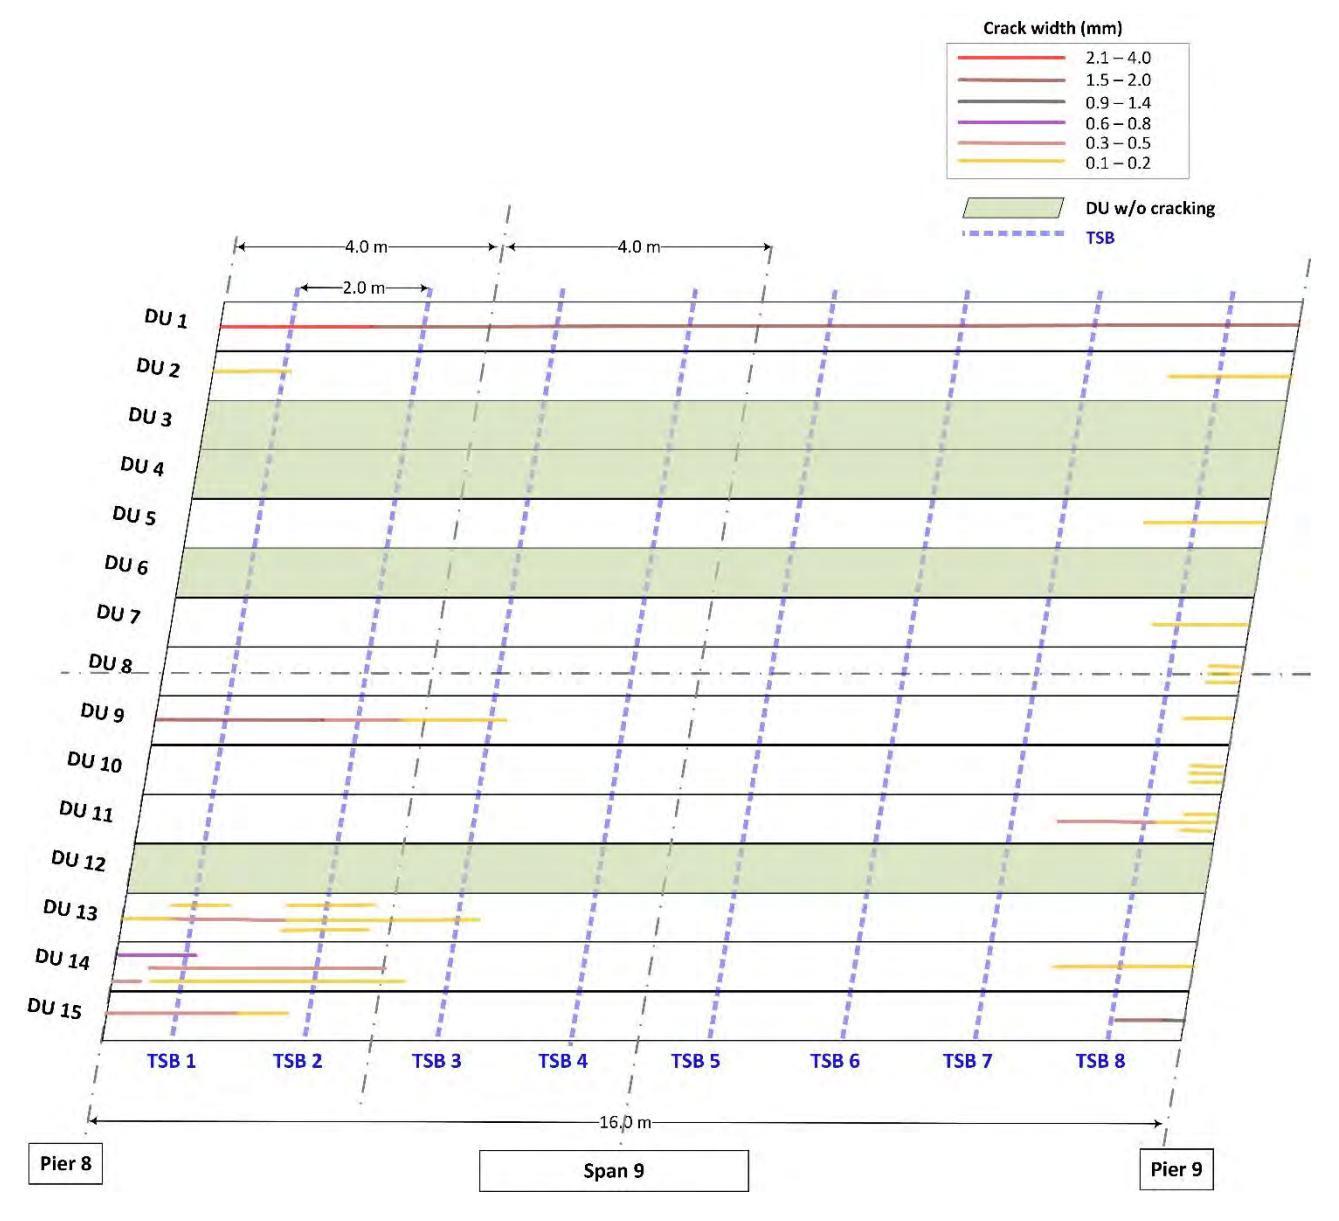
The condition of the structure at the time of testing is summarised in Table 2.2, while the crack layout refers to the R3 map reported in Appendix B. The southernmost unit, DU1, had a 1.5–4.0 mm wide crack across the entire span due to defective drainage. As for R3, most of the

other DUs exhibited minor longitudinal cracking 2.0-2.8 metres from the supports, with a crack width ranging from 0.1-0.9 mm (see Figure 2.4).

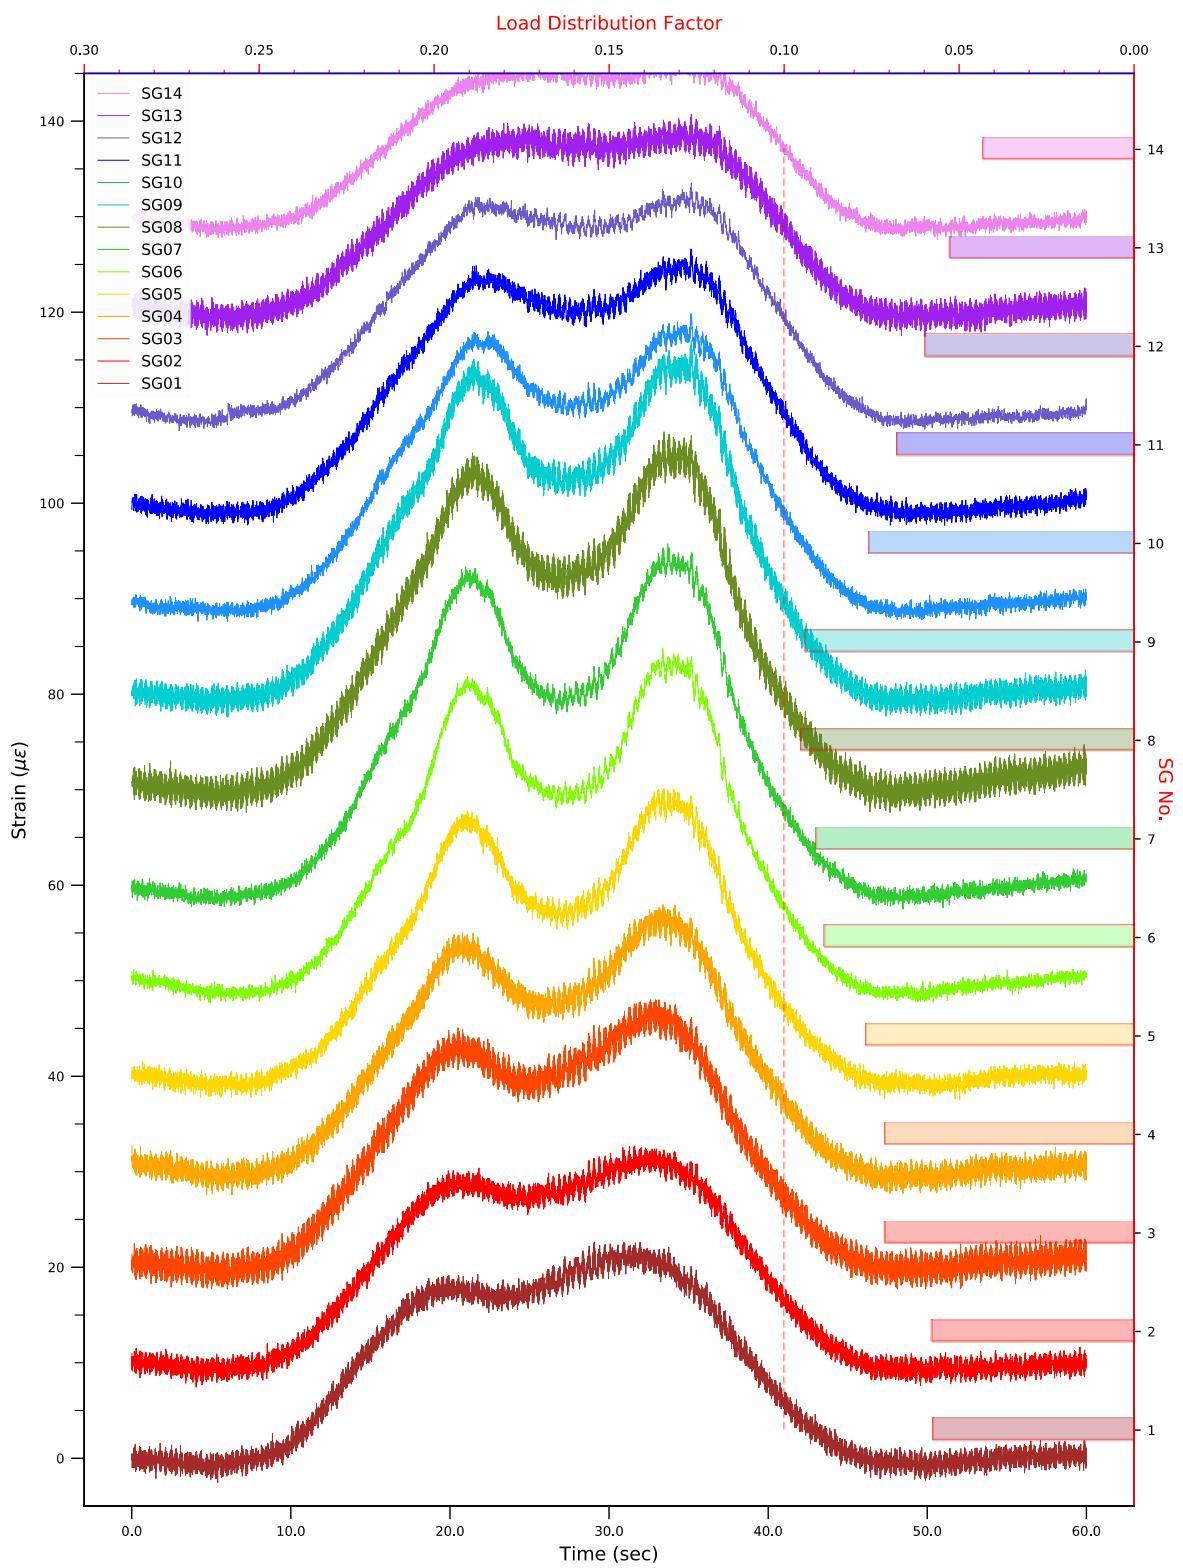
Figure 10.12: Tensile strains in undamaged stage

Notes: This Figure shows the strains measured for Run 2.2, i.e. with the 62.5 tonne truck travelling along the central path of the undamaged bridge (D02). The maximum strain was 37 μ (DU9) and the maximum LDF was 9.46% (DU9). The strain time-histories recorded by each SG on the deck soffit in the midspan are stacked with an offset of 10 μ e, with SGB1 at the bottom of the plot. Each SG number matches the DU number to which it is attached, as indicated by the labels on the right vertical axis. The related LDF is plotted on the right with values indicated by the top horizontal axis. The vertical red dashed line marks LDF = 10%. For SGs layout see Figure 7.3.

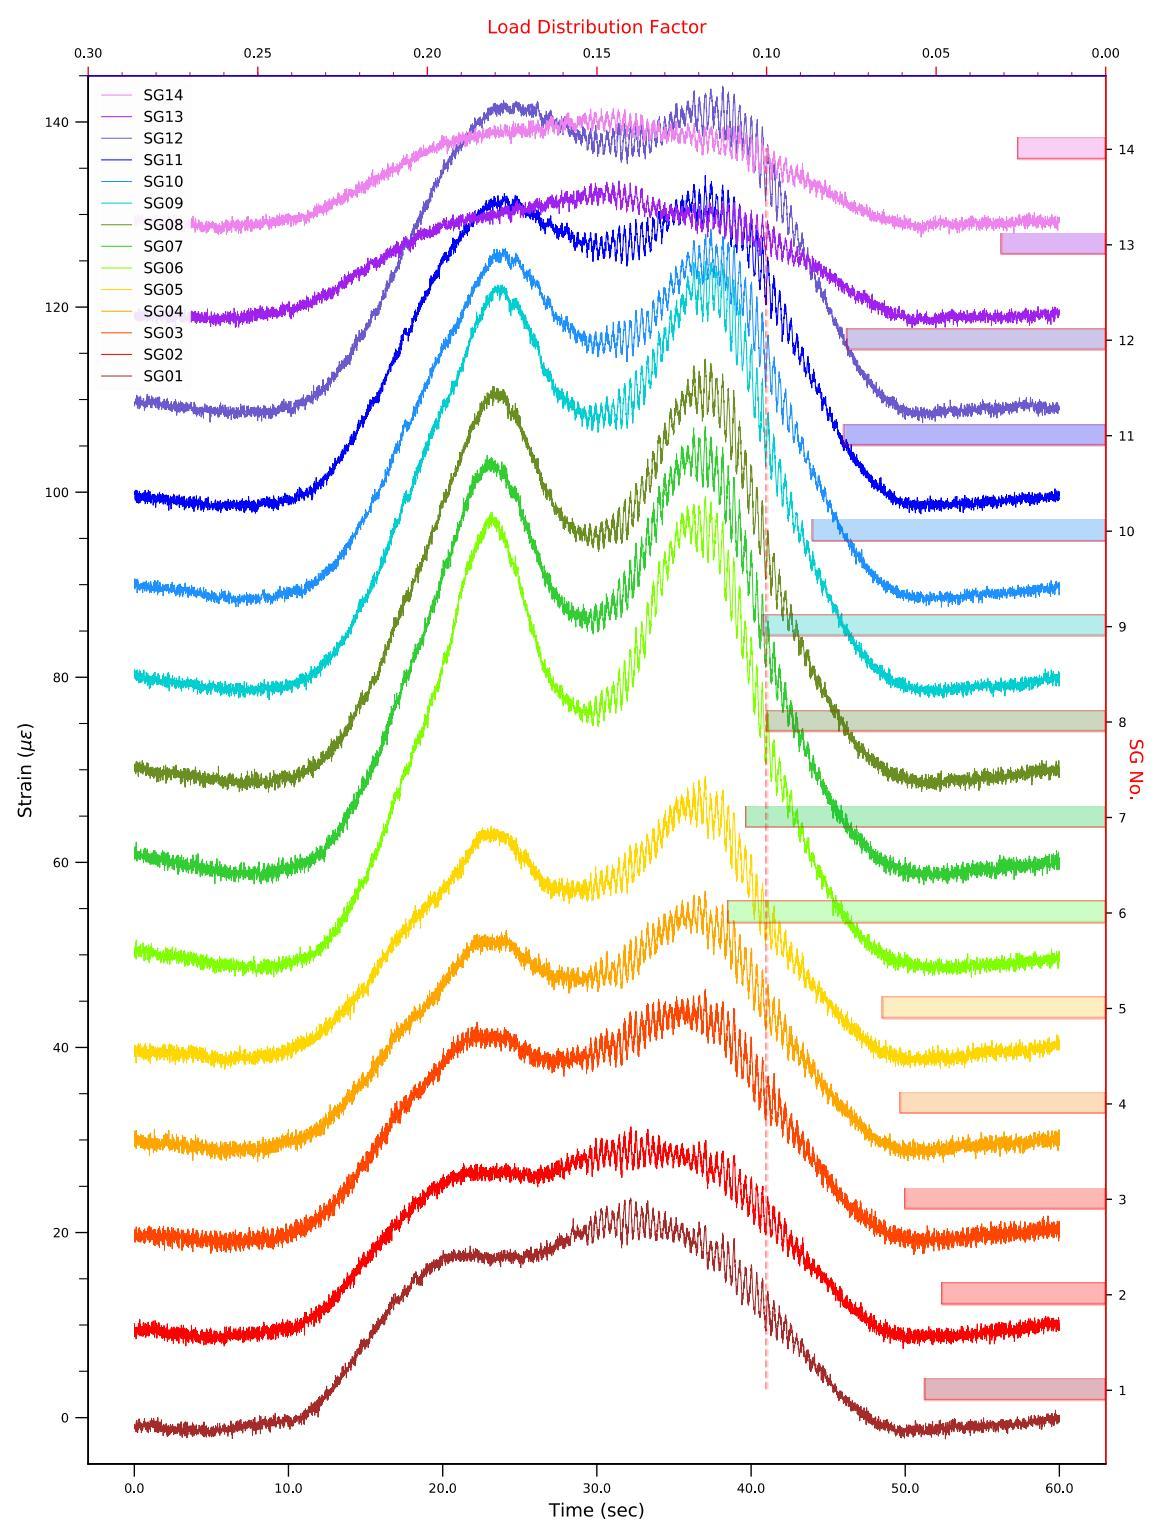
Figure 10.13: Tensile strains in last damaged stage

D02 and last damaged stage D4C is shown in Figure 10.12 and Figure 10.13 respectively. The maximum compressive strain (ϵ *min*) measured in the damaged deck was 58.9 $\mu\epsilon$ (DU7; D4C).

Notes: This Figure shows the strains measured for Run 10.2, i.e. with the 62.5 tonne truck travelling along the central path of the bridge after all TSB severing was complete (D4C). The maximum strain was 49.5 $\mu\epsilon$ (DU7) and the maximum LDF was 11.10% (DU7). The strain time-histories recorded by each SG on the deck soffit at the midspan are stacked with an offset of 10 $\mu\epsilon$, with SGB1 at the bottom of the plot. Each SG number matches the DU number to which it is attached to, as indicated by the labels on the right vertical axis. The related LDF is plotted on the right with values indicated by the top horizontal axis. The vertical red dashed line marks LDF = 10% (see SGs layout in Figure 7.3).

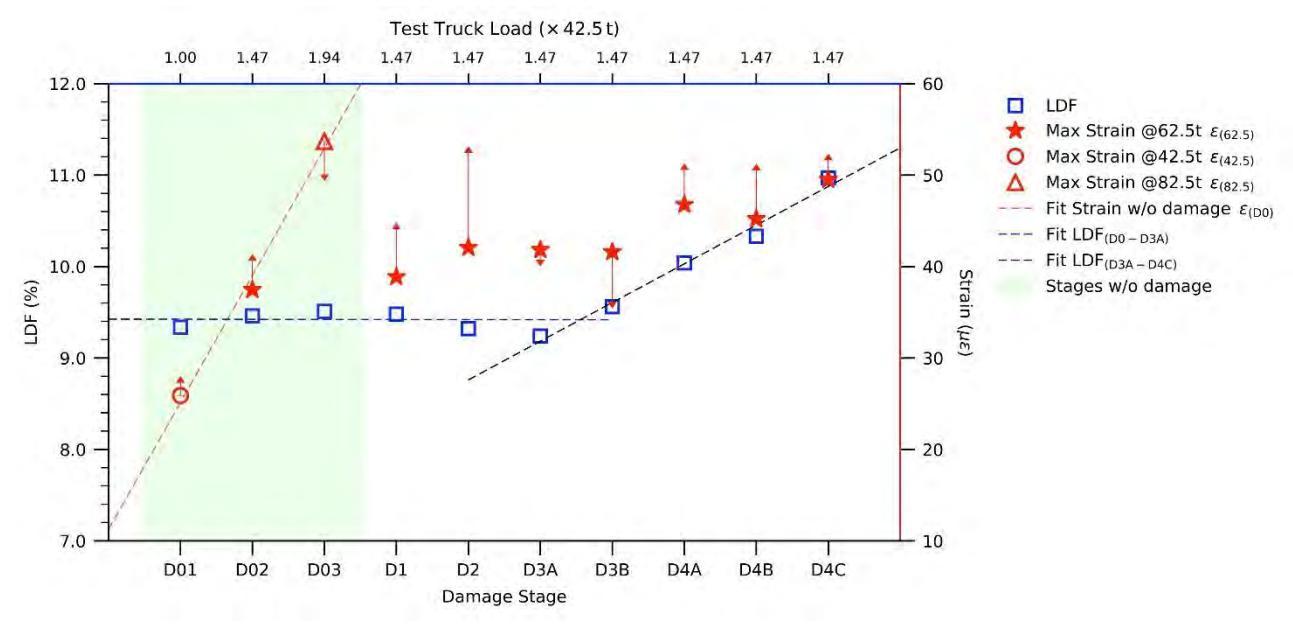
Figure 10.14: LDF distribution for load tests

A summary of the maximum tensile strains recorded in all the tests, with the truck running along the central path, is plotted in Figure 10.14. It can be seen that, after TSB damage, the deck behaviour departed from the linear response measured in the undamaged state. The TSB severing resulted in a strain increase in the most loaded DUs, from D0 to D4C, of 32%. Such an increase is less than the 43% strain increment measured under the 82.5 tonne truck, i.e. right after the 62.5 tonne run in the initial tests (D02 and D03). Using the linear fit of the D0 strains, the undamaged bridge would reach a maximum strain of 49.6 $\mu\epsilon$ under a load of 75.6 tonne, or approximately 1.21 × 62.5 tonne.

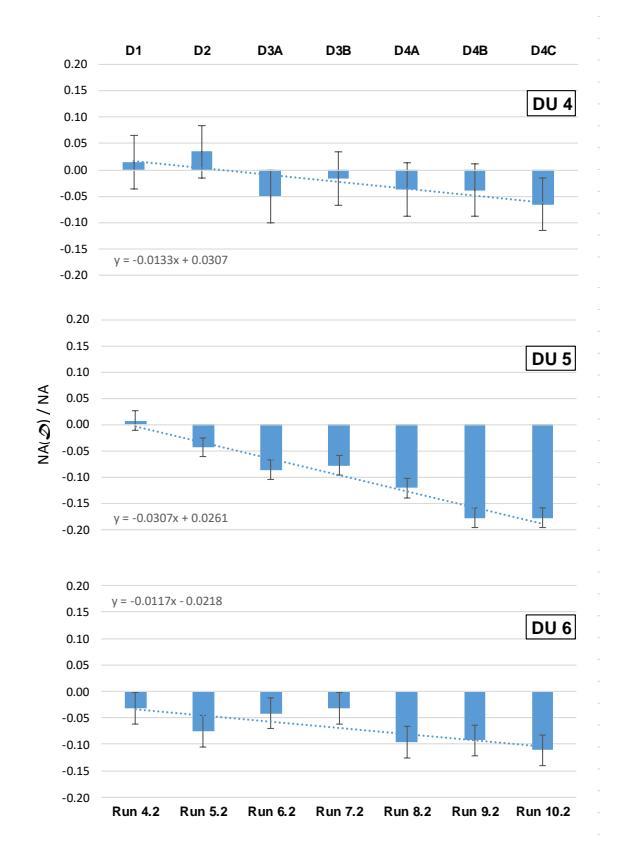
Figure 10.18: NA position variation, DU4-9

In the absence of observable transverse cracking during or after the damaged stages (see R3, and Appendix B), the change of the NA position by 10–18% (Figure 10.18 and Figure 10.19), downward from the initially identified location, is primarily due to an increase of the normal forces. As expected, the severing of the TSBs forced the few DUs, within the load pattern, to take the majority of the normal forces. Since the NA position is critical to the cross-sectional capacity, the measured change in the load transfer mechanism ultimately resulted in a deck characterised by a load bearing capacity of approximately 18% less than that of the original superstructure, this being the decrease in capacity controlled by the most loaded unit.

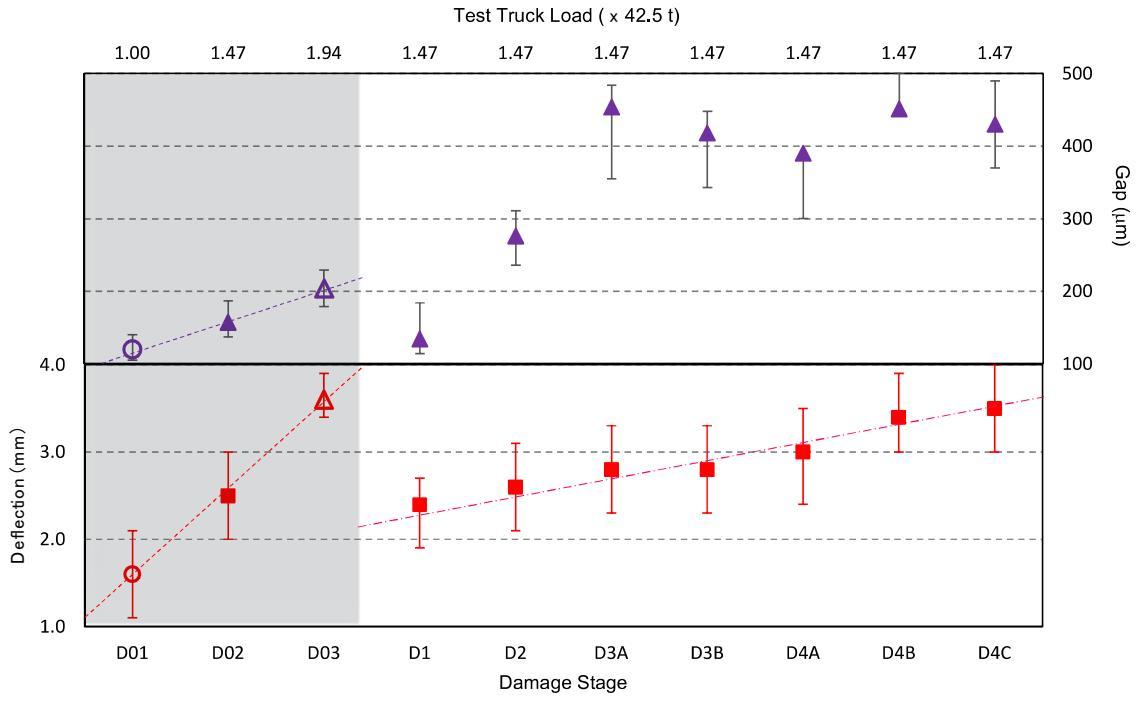
Figure 10.20: Maximum deck movements

The maximum measured deflection (δ_{max}) was 3.5 mm in stage D4C for DU7. The data from D1 to D4C could be fit either with a bilinear (as seen for LDF values in Figure 10.13) or a linear fit. However, an overall increase was measured with the gradual TSB damage, with a final deflection $30\pm8\%$ greater than the correspondent measurement in the undamaged stage. Similarly to the maximum strains, the deflection associated with the final damaged stage was close to that measured in D03, i.e. under a load that is 30% greater than what was used in D4C.

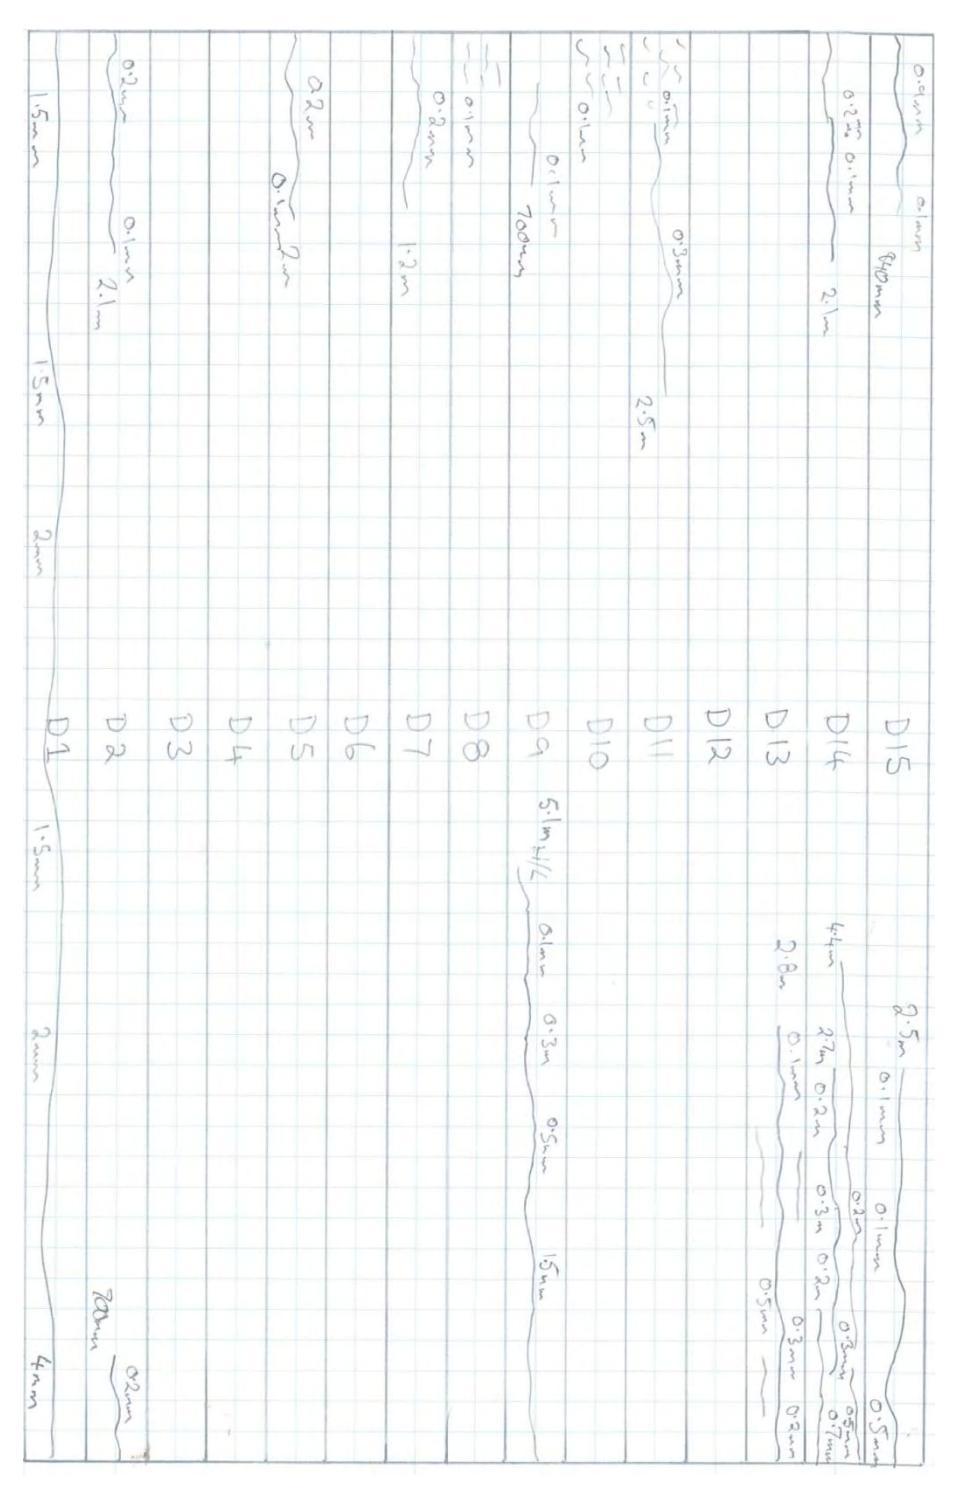
Figure B 1: Cracking pattern on each DU in Span 9

At the time of the sensor installation, as noted in the Level 2 inspections (R2, R3), 11 out of the 15 DUs in Span 9 exhibited longitudinal cracking to a varying extent. This was likely caused by alkalisilica reaction (ASR), and mostly localised within 2.8 metres from the supports (see Appendix B).
