FINAL REPORT

Project Title: P15: Queensland Trial of High Standard Granular Base
TrackStar Alliance Project
(Year 4 - 2016/17)

ARRB Project No: PRP16023

Client: Queensland Department of Transport and Main Roads

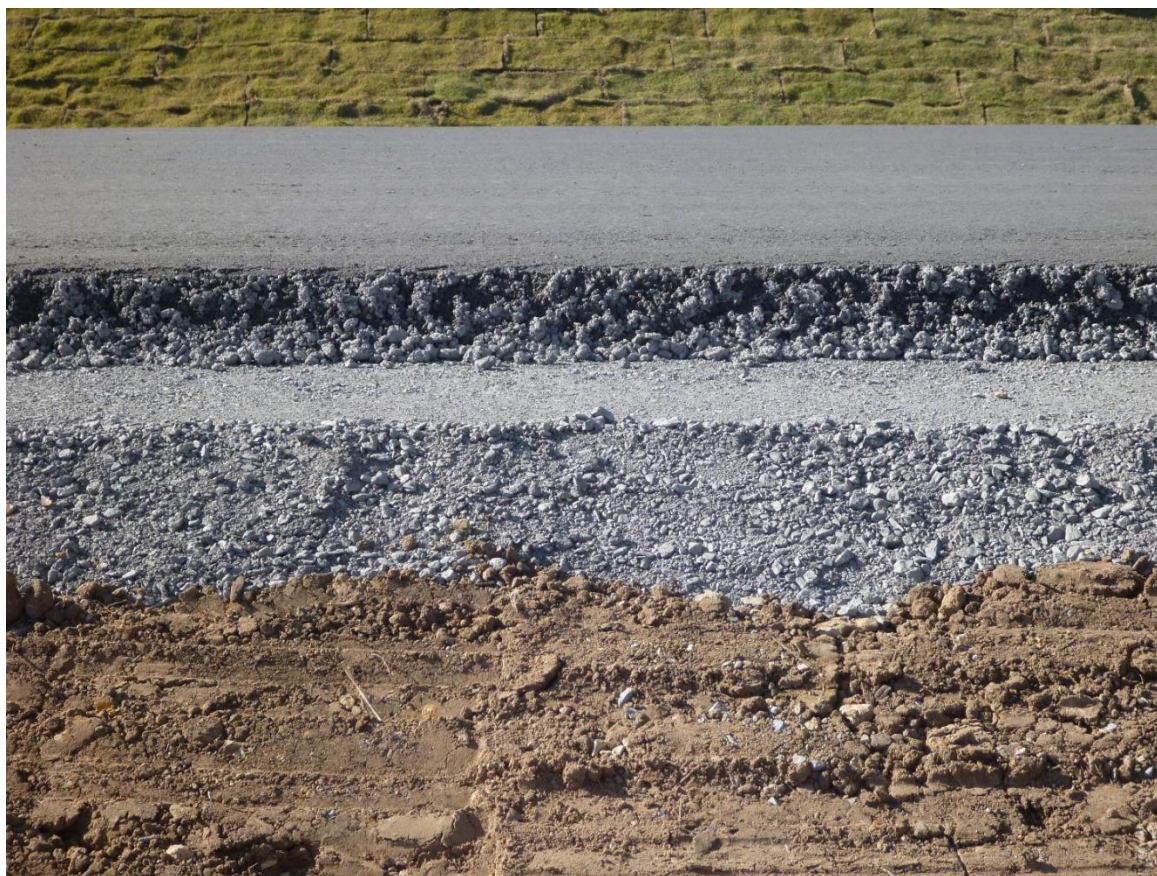
Figure 4.4: Pavement cross-section including lower HSG base, upper subbase, lower subbase and natural subgrade

The structural design was accomplished using the mechanistic method (TMR 2013a). Design inputs for the HSG base included elastic modulus of 500 MPa for the top sublayer, degree of anisotropy of 2.0, and Poisson's ratio of 0.35.

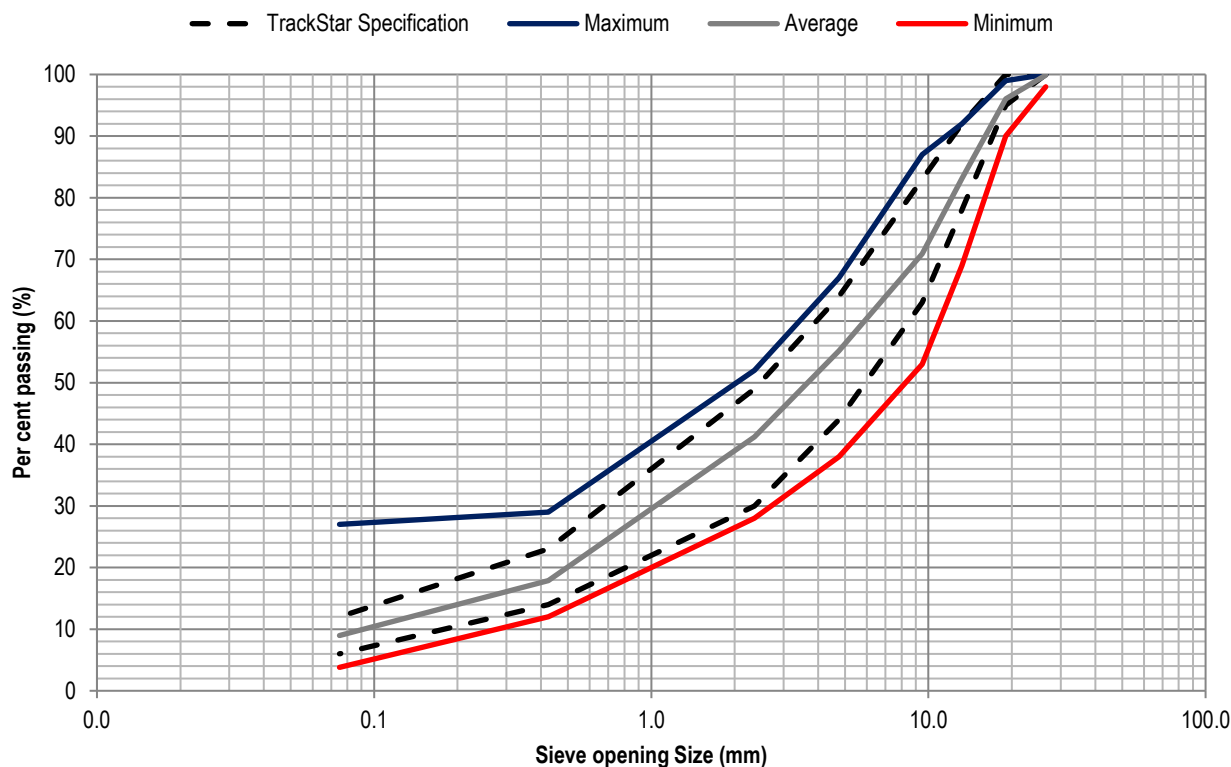
Figure 4.13: Particle size distribution conformance summary for HSG material

The individual particle size distribution measurements were highly variable, with some values considerably outside of project specification limits. Given the HSG material was mixed on the quarry floor (Section 4.5.2) rather than being metered on conveyor belts, the variability in gradation presented in Figure 4.13 is not unexpected. The particle size distribution conformance testing results for both the stockpile and pavement HSG base material is presented in Table 4.6.

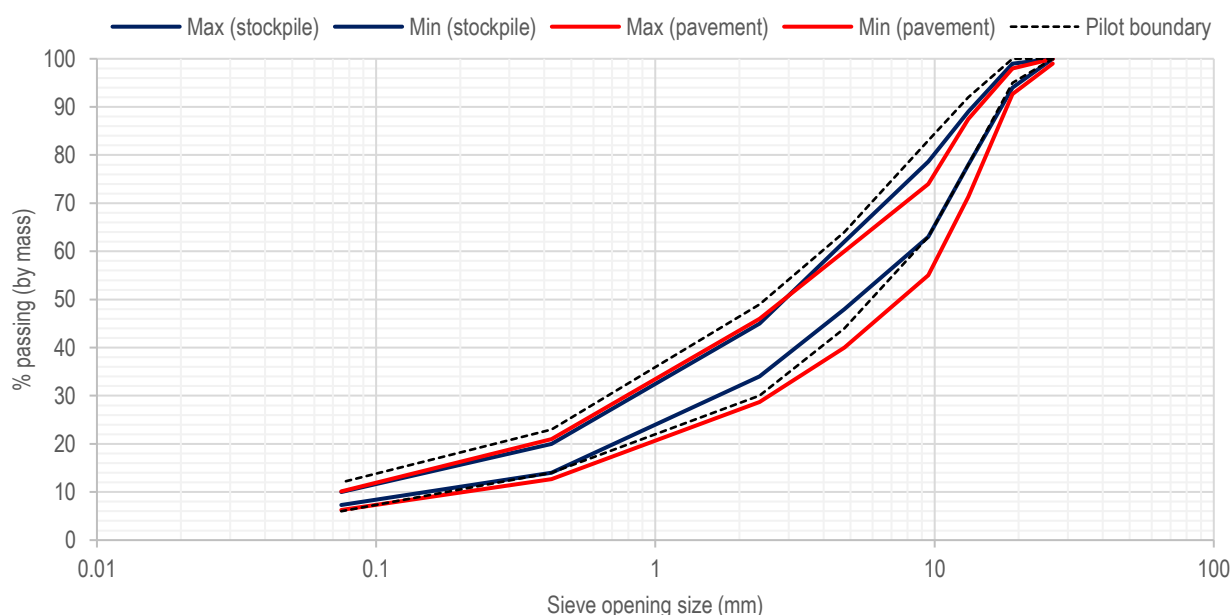
Figure 4.15: Comparison of stockpile and pavement PSD results

The most significant variation is observed in the relative proportion of the samples passing the 13.2 mm, 9.5 mm, 4.75 mm and 2.36 mm sieve opening sizes. Reference to the mean particle size distribution for all HSG materials supplied to the project would indicate that the in-pavement samples were coarser than those obtained from stockpile. The relationship between the percentage passing the project specification (Annexure MRTS05.01) control sieves of stockpile and in-pavement samples on a per-lot basis is presented in Figure 4.16.

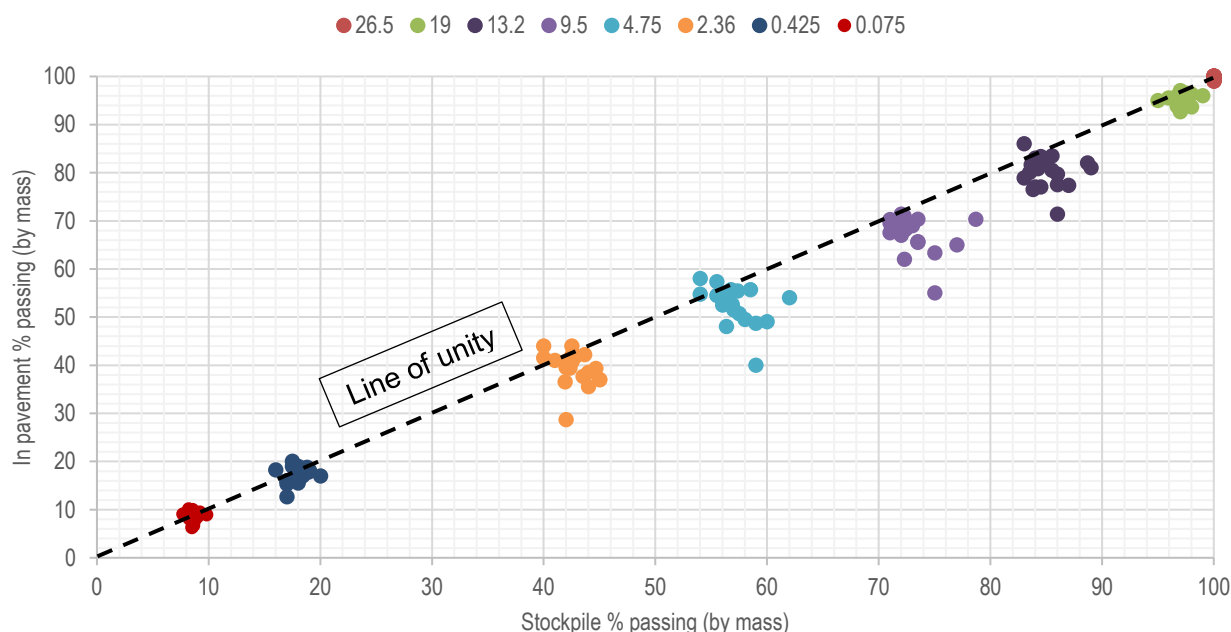
Figure 4.16: Relationship between pavement and stockpile PSD results

As can be observed in Figure 4.16, the largest and smallest particle sizes, including 26.5 mm, 19.0 mm, 0.425 mm and 0.075 mm, are present in uniform proportions. However, a greater proportion of the intermediate size particles from 13.2 mm to 2.36 mm are present in the pavement samples. The ratio and absolute difference of the percentage of particles passing the project specification control sieves for pavement and stockpile samples are presented in Table 4.7.

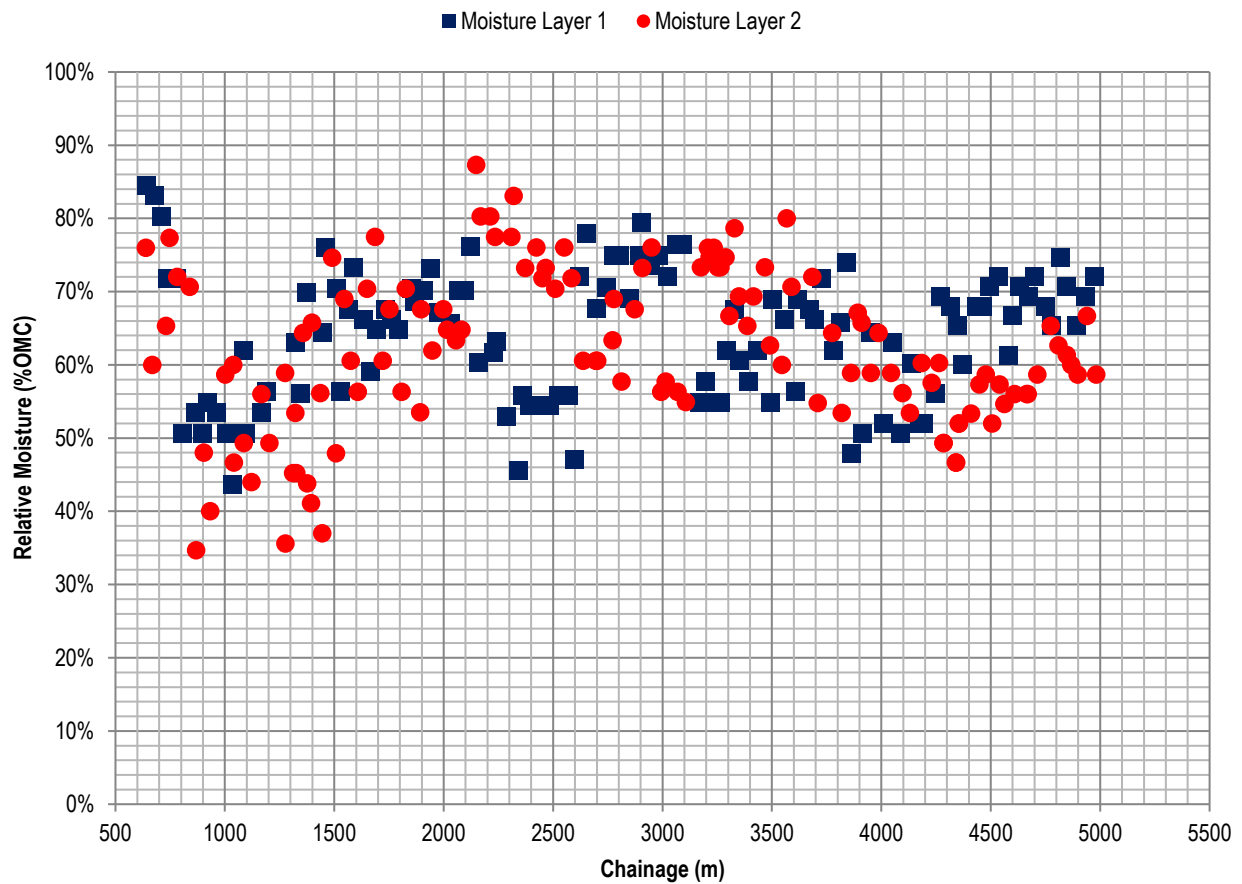
Figure 4.19: Relative moisture content measured following compaction

Relative moisture values ranged from 33% to 86% of OMC. It should be noted that the relative moisture values were determined using the nuclear density gauge following compaction. Almost all of the sampled lots were found to be conforming. The measured RDD values for each 110 mm thick HSG base layer are presented in Figure 4.20.

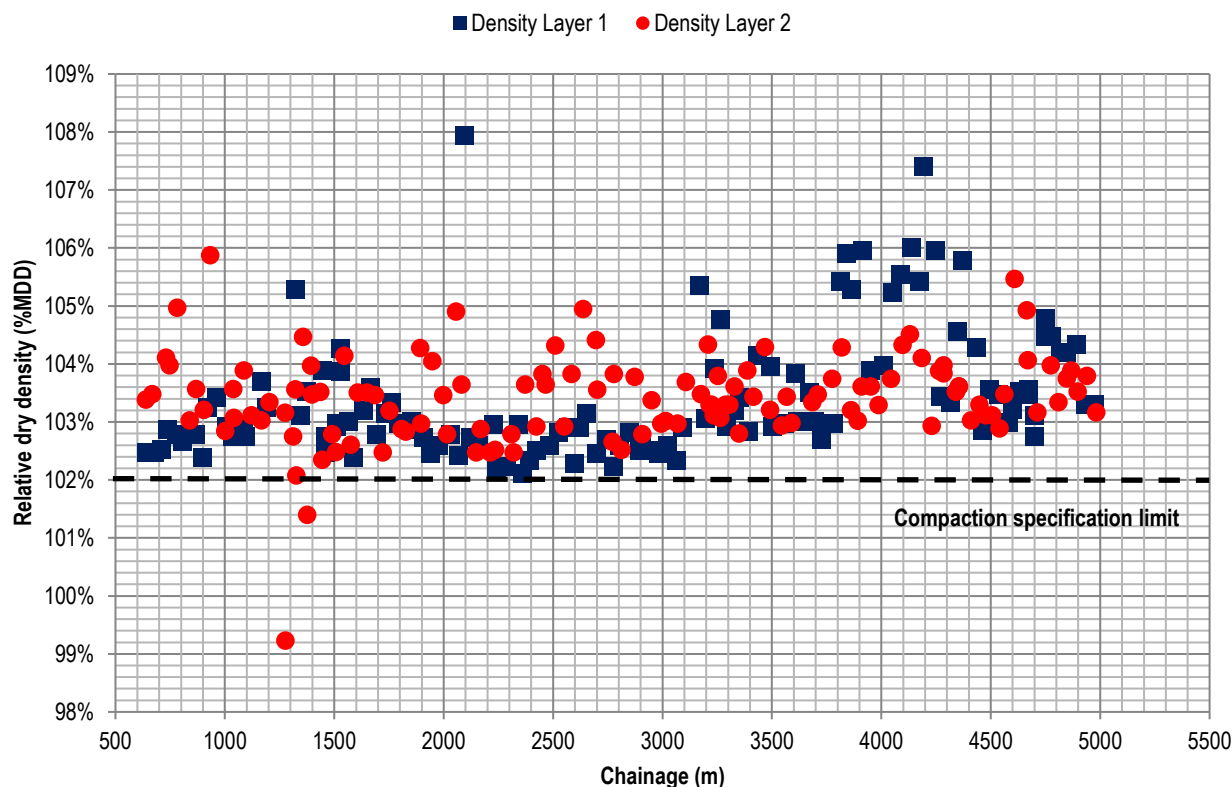
Figure 4.20: Relative density measured following compaction

Measured RDD values ranged from 99% to 108% of MDD, with a mean of approximately 103%. In comparison, VicRoads (2011) requires a minimum 100% characteristic relative dry density determined according to modified Proctor compactive effort. It is noted that there are no reliable conversion of MDDs determined between standard and modified compaction energy.

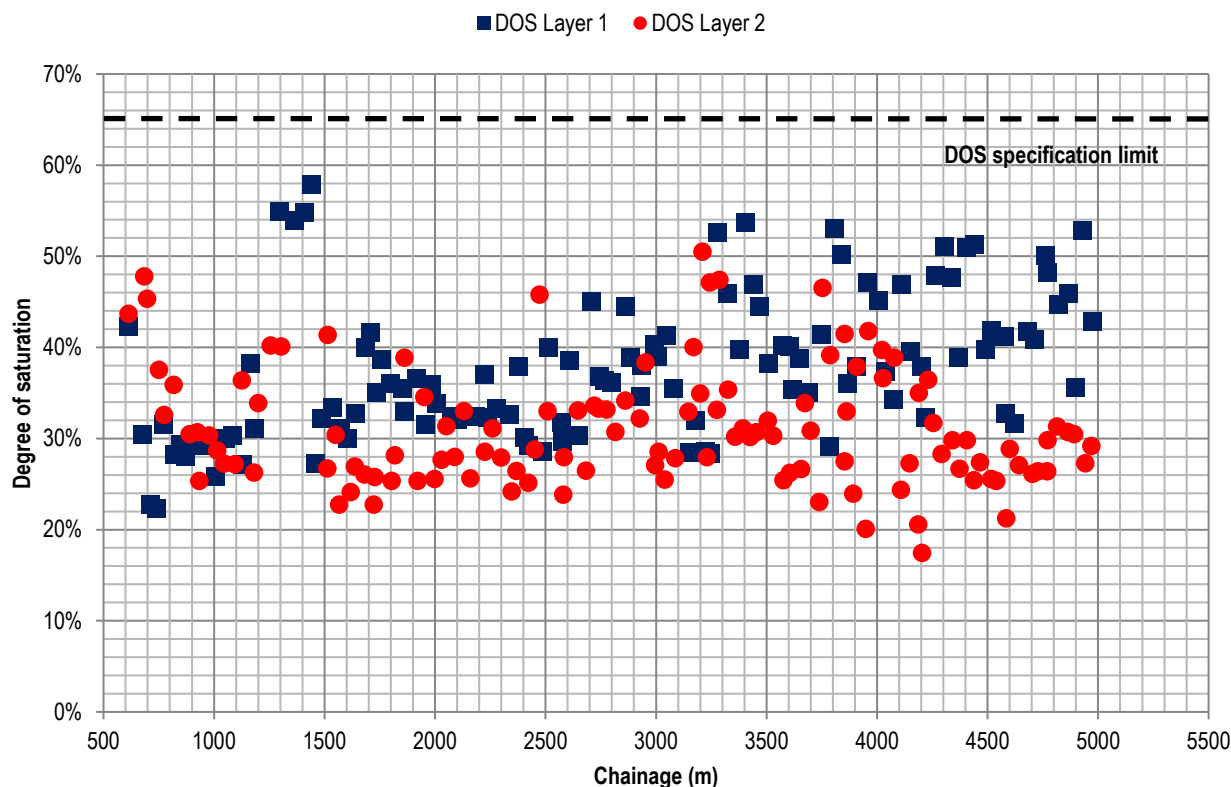
Figure 4.21: Degree of saturation (DOS) measured prior to sealing

Measured DOS values ranged from 17% to 58%, with a mean of approximately 35%. All of the sampled lots conformed to the DOS specification requirement.

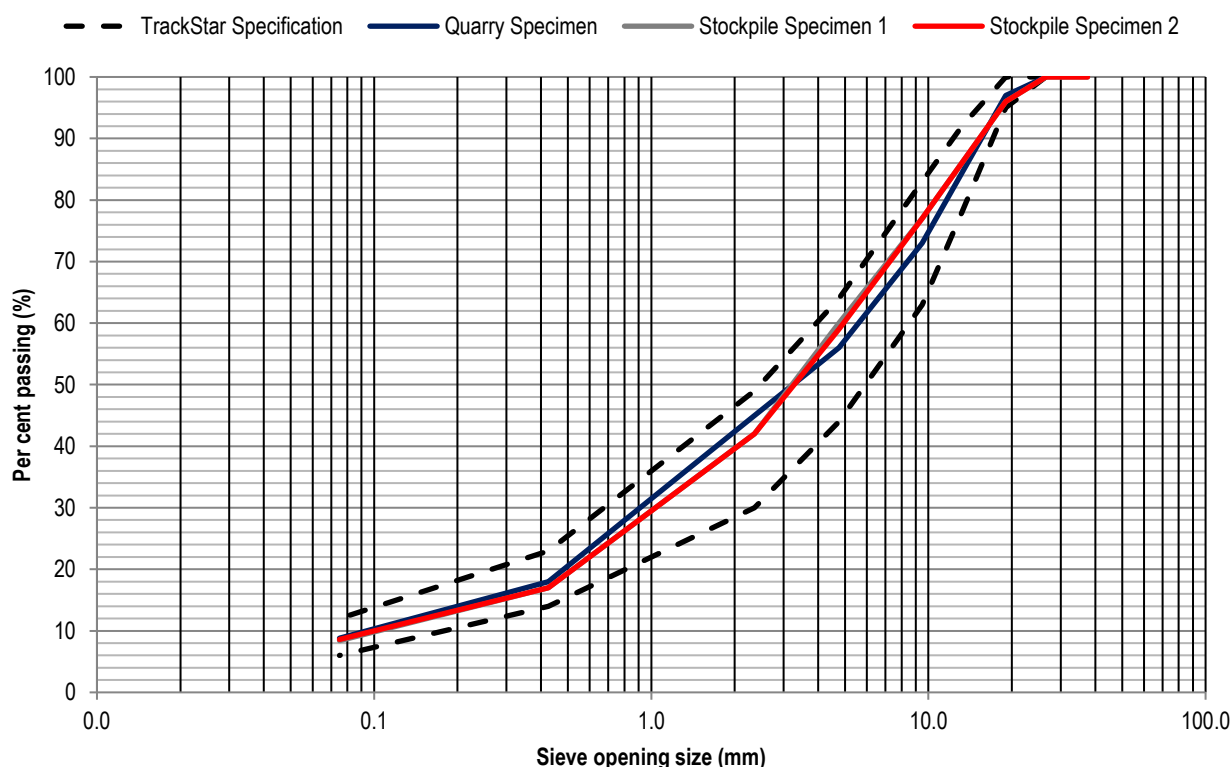
Figure 5.1: HSG base particle size distribution confirmation testing summary

With the exception of the degradation factor for stockpile Specimen 1 (43), the properties of both the quarry and stockpile specimens were found to conform to the project specification. Some variation between the quarry and stockpile particle size distribution specimens can be observed, but all of the results fall within the middle third of the grading pilot boundary limits for the HSG base. The stockpile specimen collection sites were separated by approximately 1.0 km and collection times were separated by five days. The level of consistency can also be observed between specimens collected at the quarry site and those obtained from stockpiles on site. The

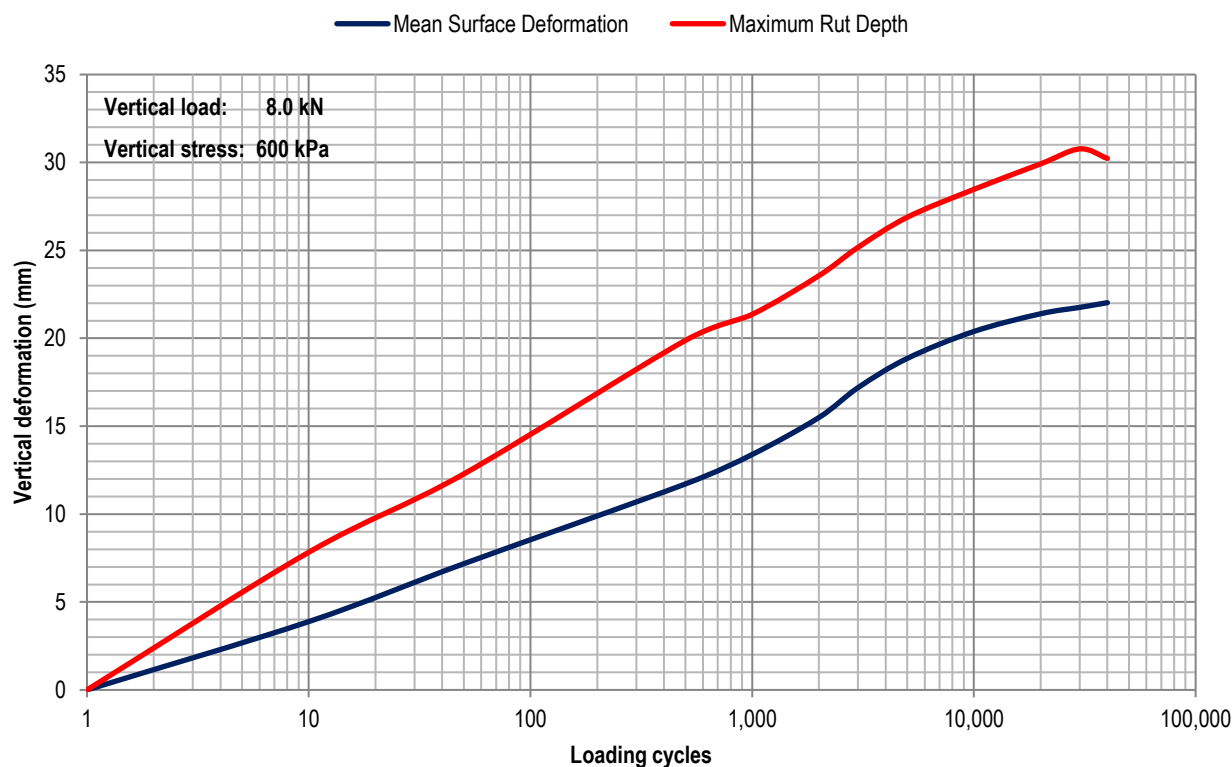
Figure 5.2: Wheel-tracking summary results

A broadly applicable correlation between wheel tracking results and in-service performance has not yet been developed. However, performance in the wheel-tracking test is indicative of the deformation potential of granular materials. The results indicate that the material may be

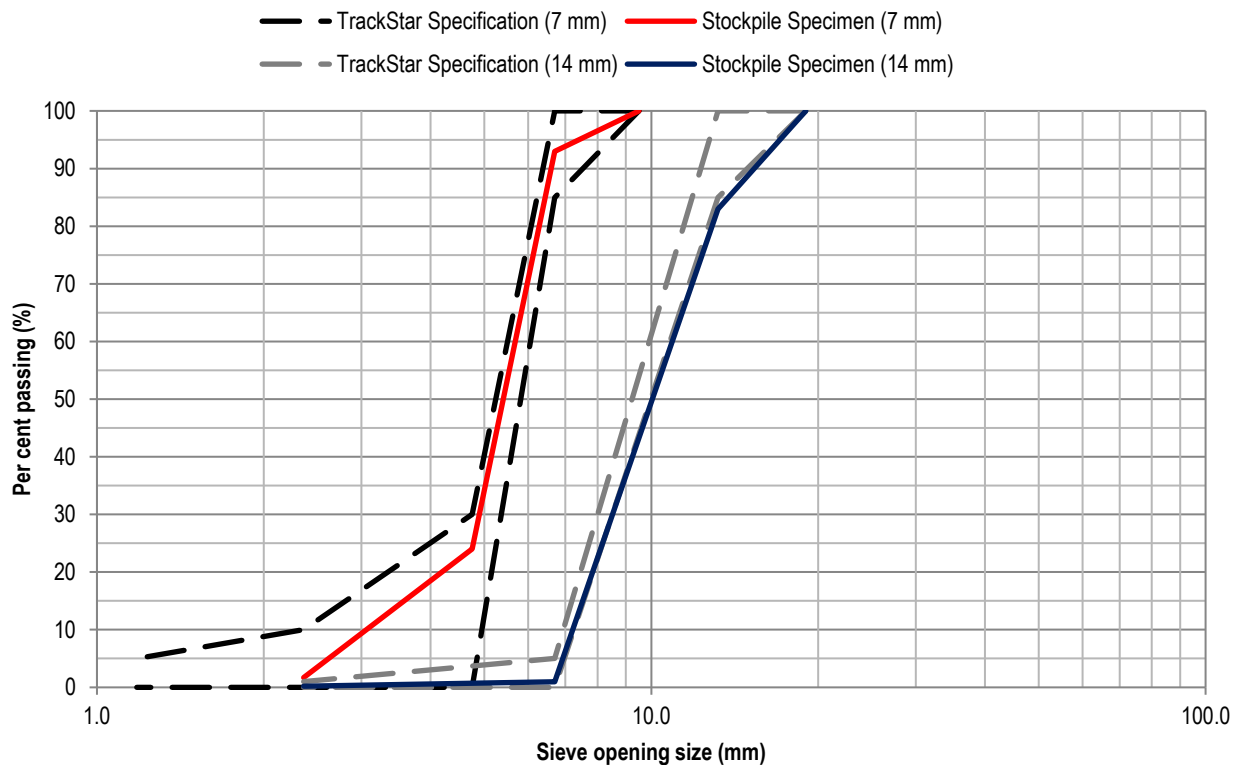
Figure 5.3: Cover aggregate particle size distribution confirmation testing summary

For the material properties investigated, both the 7 mm and 14 mm cover aggregate samples conformed to the project specification. The average ALD of 4.2 mm and 8.8 mm are very similar to the 4.4 mm and 8.3 mm measured during construction as a part of conformance testing. Additionally, the particle size distribution of the 7 mm cover aggregate conformed to MRTS11. However, the 14 mm specimen is nonconforming, with excess coarse material (83%) retained on the 13.2 mm opening size sieve.

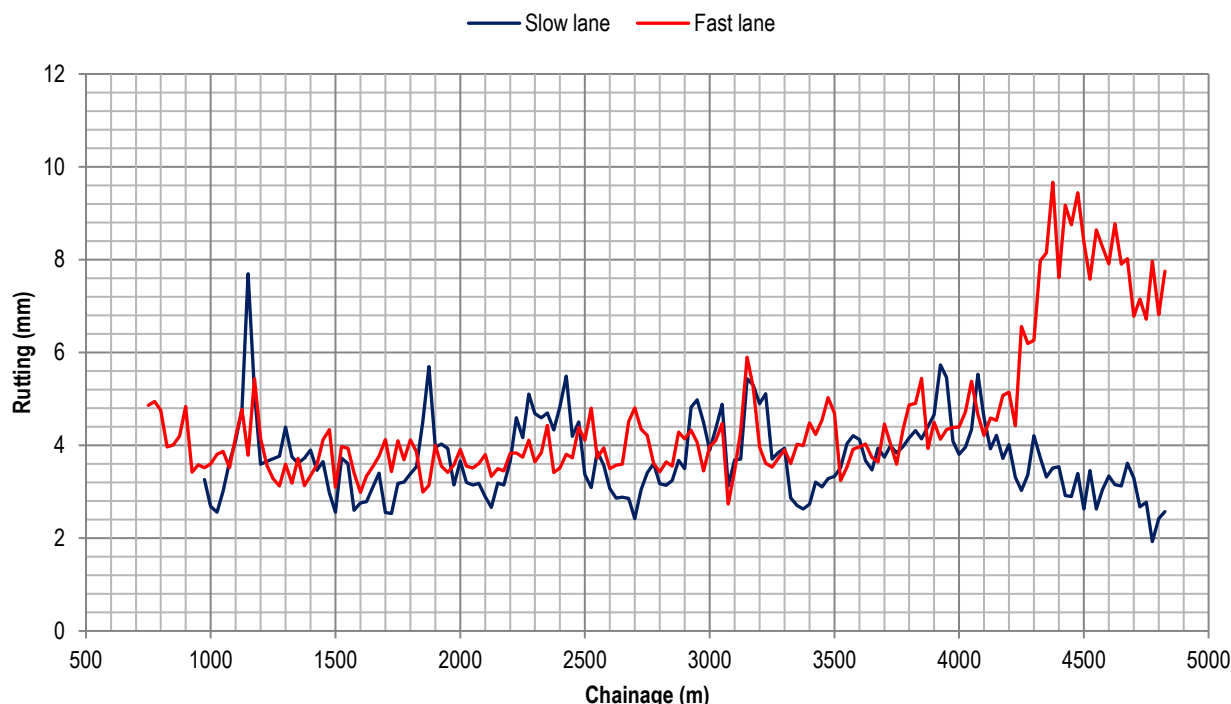
Figure 6.3: Summary results from post construction rutting assessment

A number of measurements between project chainage 4300 and 4800, and exclusively in the fast lane, exhibited rutting in excess of 7 mm. Further investigation of the results revealed that the extreme values were reproduced in both survey runs and are isolated in the outer side of the fast lane, adjacent to a drainage feature. Subgrade replacement with Class A select fill to depths of 500 mm and 1000 mm was conducted for the pavement sections between project chainages 4405 m and 4880 m due to low in situ foundation support (< 3% CBR). The isolation of high values to the fast lane adjacent to the edge drain suggests either consolidation as a result of increased moisture content or permanent deformation of pavement layers under construction traffic. The source of the lateral surface deviation is best confirmed through structural evaluation (FWD) and will be discussed further in Section 7.

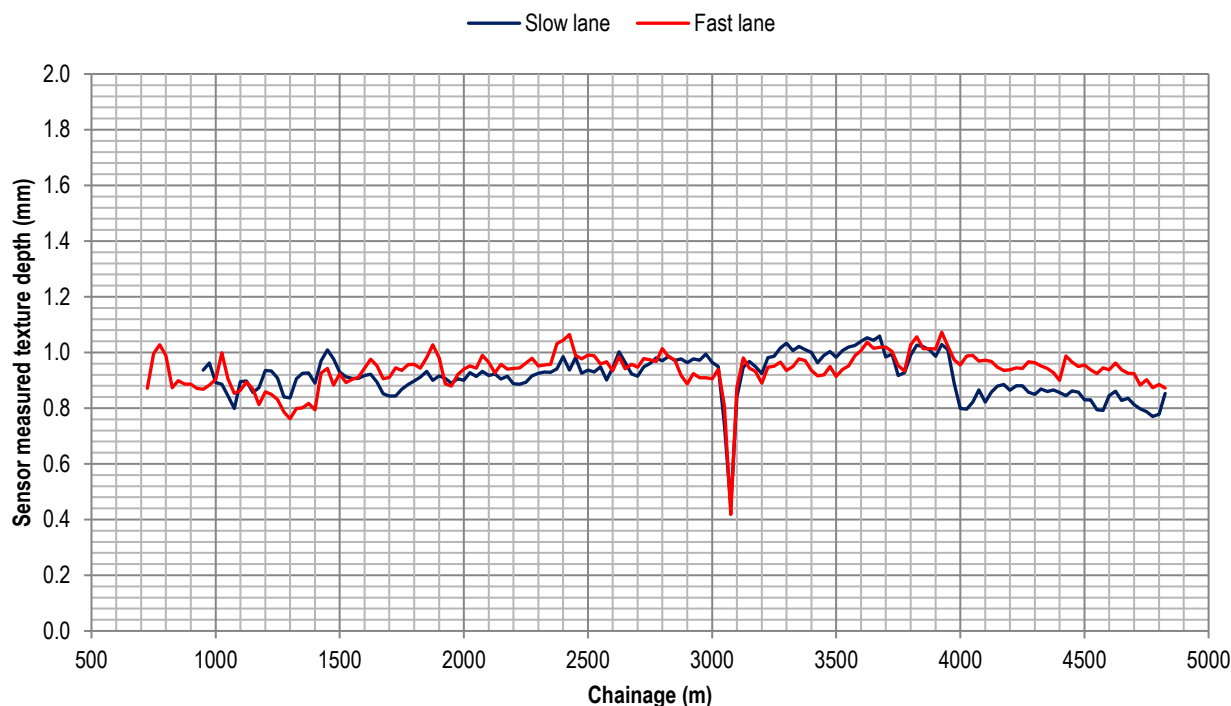
Figure 6.4: Summary results from post construction texture assessment

A minimum requirement for surface macrotexture does not currently exist in Queensland. Austroads (2011a) recommends a minimum mean texture depth of 0.6 mm for highways with travelling speeds greater than 80 km/h. All of the measured road sections exceed the Austroads (2011a) recommended limit. It is generally accepted that better texture depth provides reduced road noise and improved surface moisture transport. Greater texture depth values provide lower social impact and increased user safety, and should be monitored if not explicitly required for compliance. The measured surface texture is generally consistent both longitudinally and transversely. However, deviation between the slow and fast lane can be observed between project chainages 3950 and 4800.

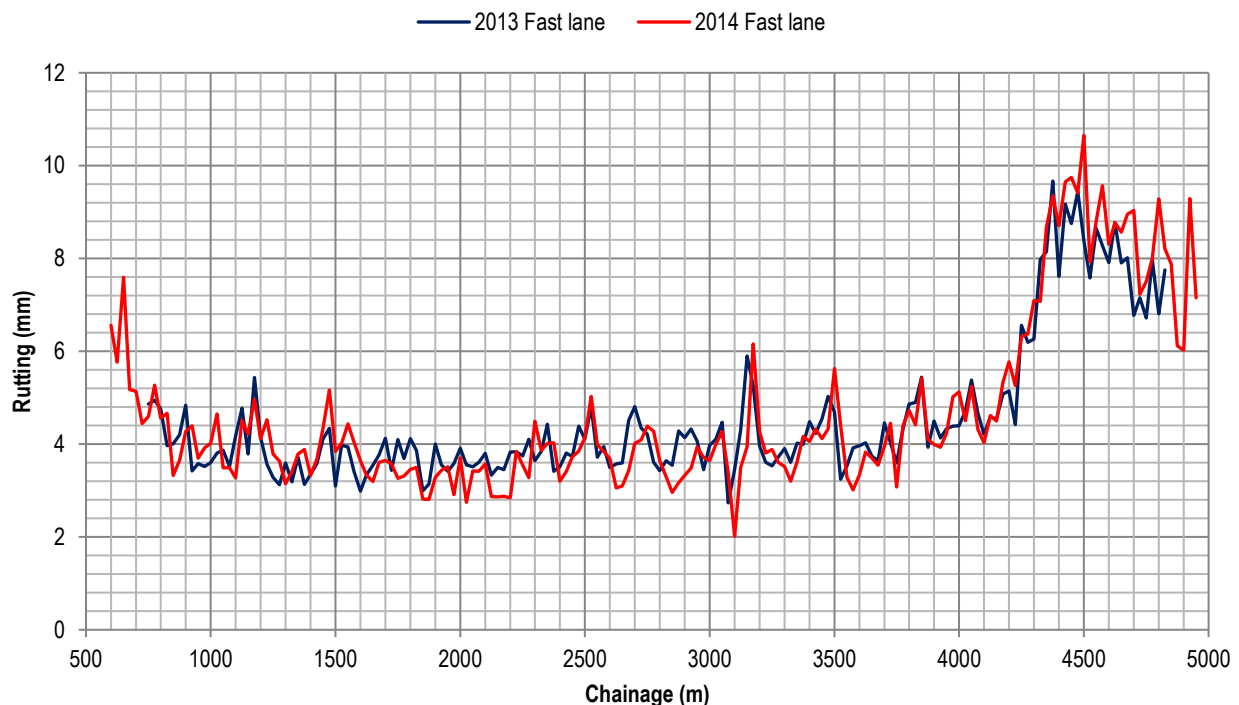
Figure 6.9: Summary results from 12-month rutting assessment of the fast lane

The excessive rutting measurements collected during the post-construction assessment between project chainages 4300 m and 4950 m have been replicated in the 12-month surface condition assessment. The mean rutting values over this section of the alignment have also increased by approximately 1.0 mm. Following the post construction assessment, the cause of the deformation

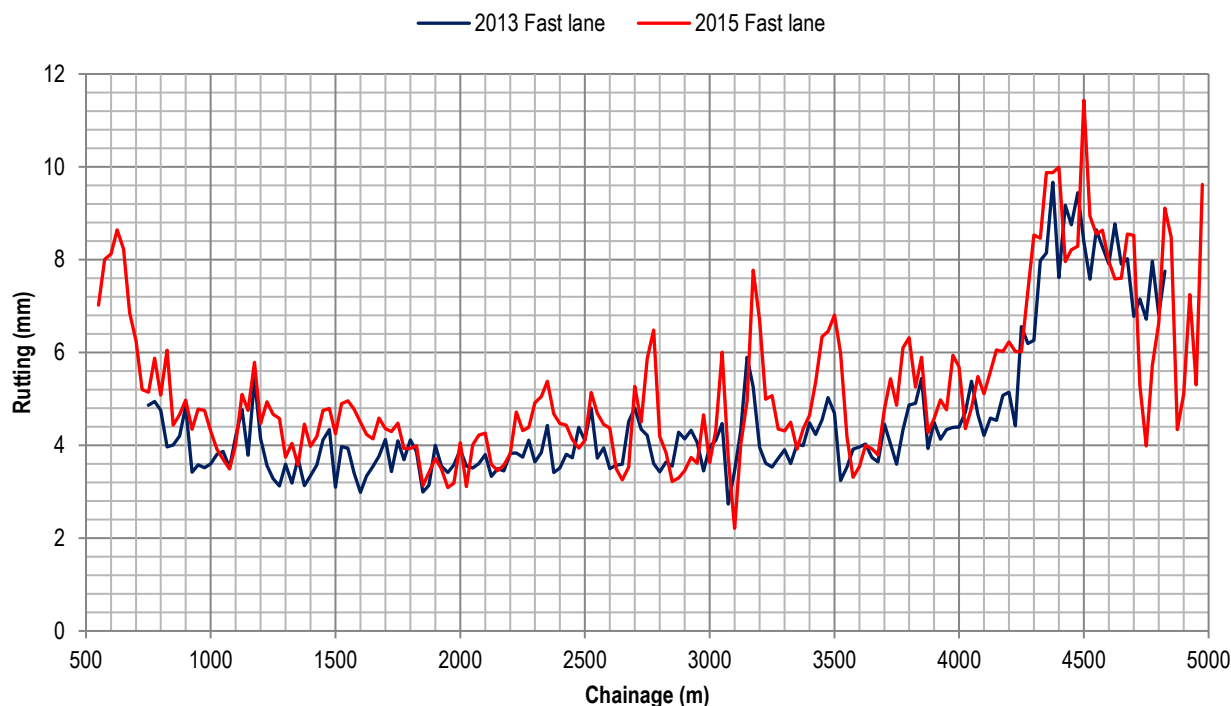
Figure 6.15: Summary results from 24-month rutting assessment of fast lane

The excessive rutting measurements collected during the post-construction assessment between project chainages 4300 m and 4800 m have been replicated in the 24-month surface condition assessment. The mean rutting values over this section of the alignment have increased by approximately 0.20 mm, which is less than the relative increase of approximately 0.45 mm for the total trial section. The reduced relative rutting rate supports the hypothesis that the excessive deformation is the result of poor construction practice (inadequate compaction) and the section is nearing a densification equilibrium state. However, intervention may still be required should the mean rutting values in the section exceed 15 mm.

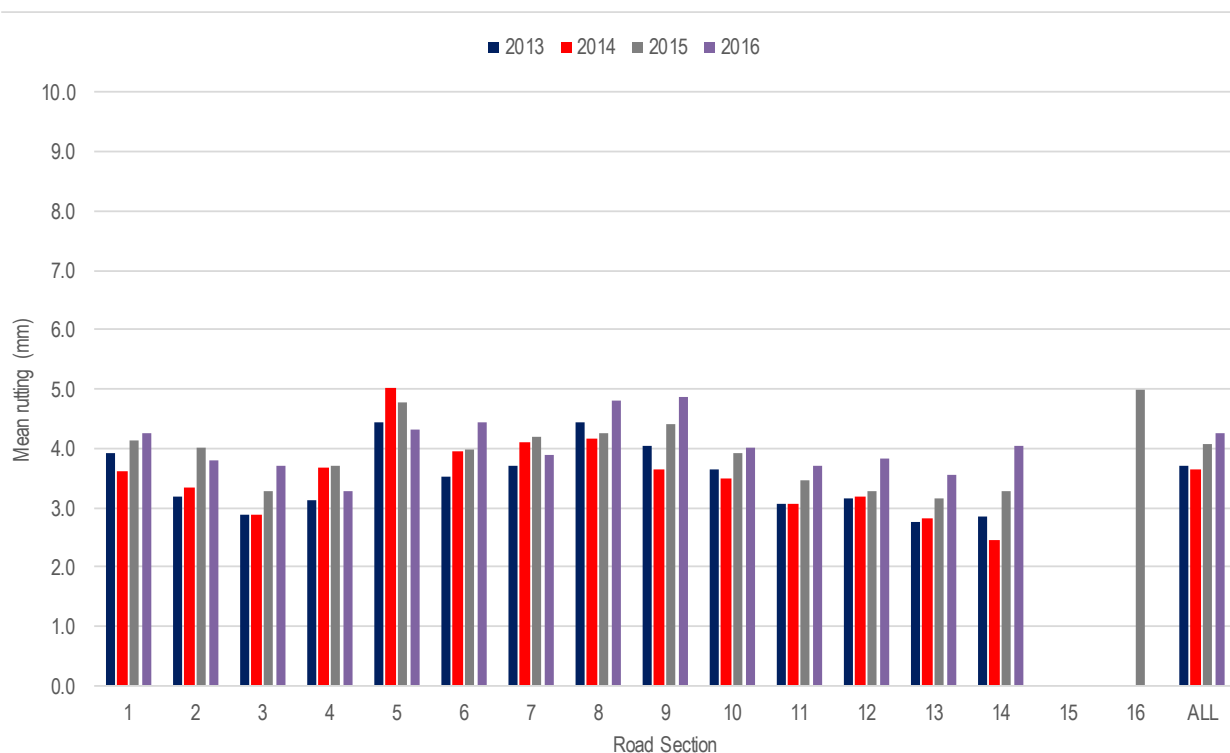
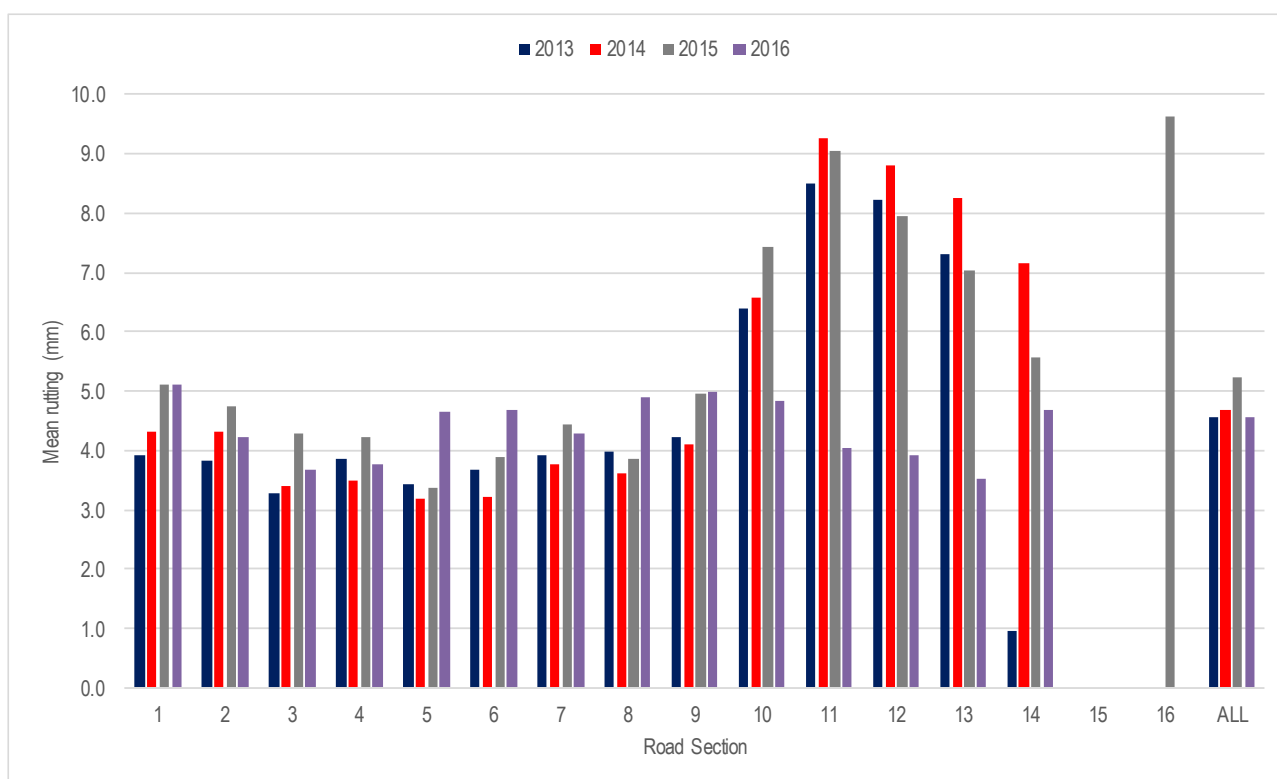
Figure 6.26: Mean rutting values for slow (top) and fast (bottom) lane by assessment year

Note: Sections 10 – 14 reported a decrease in the mean rutting in the fast lane. The reasons were explained in Section 6.5.2.

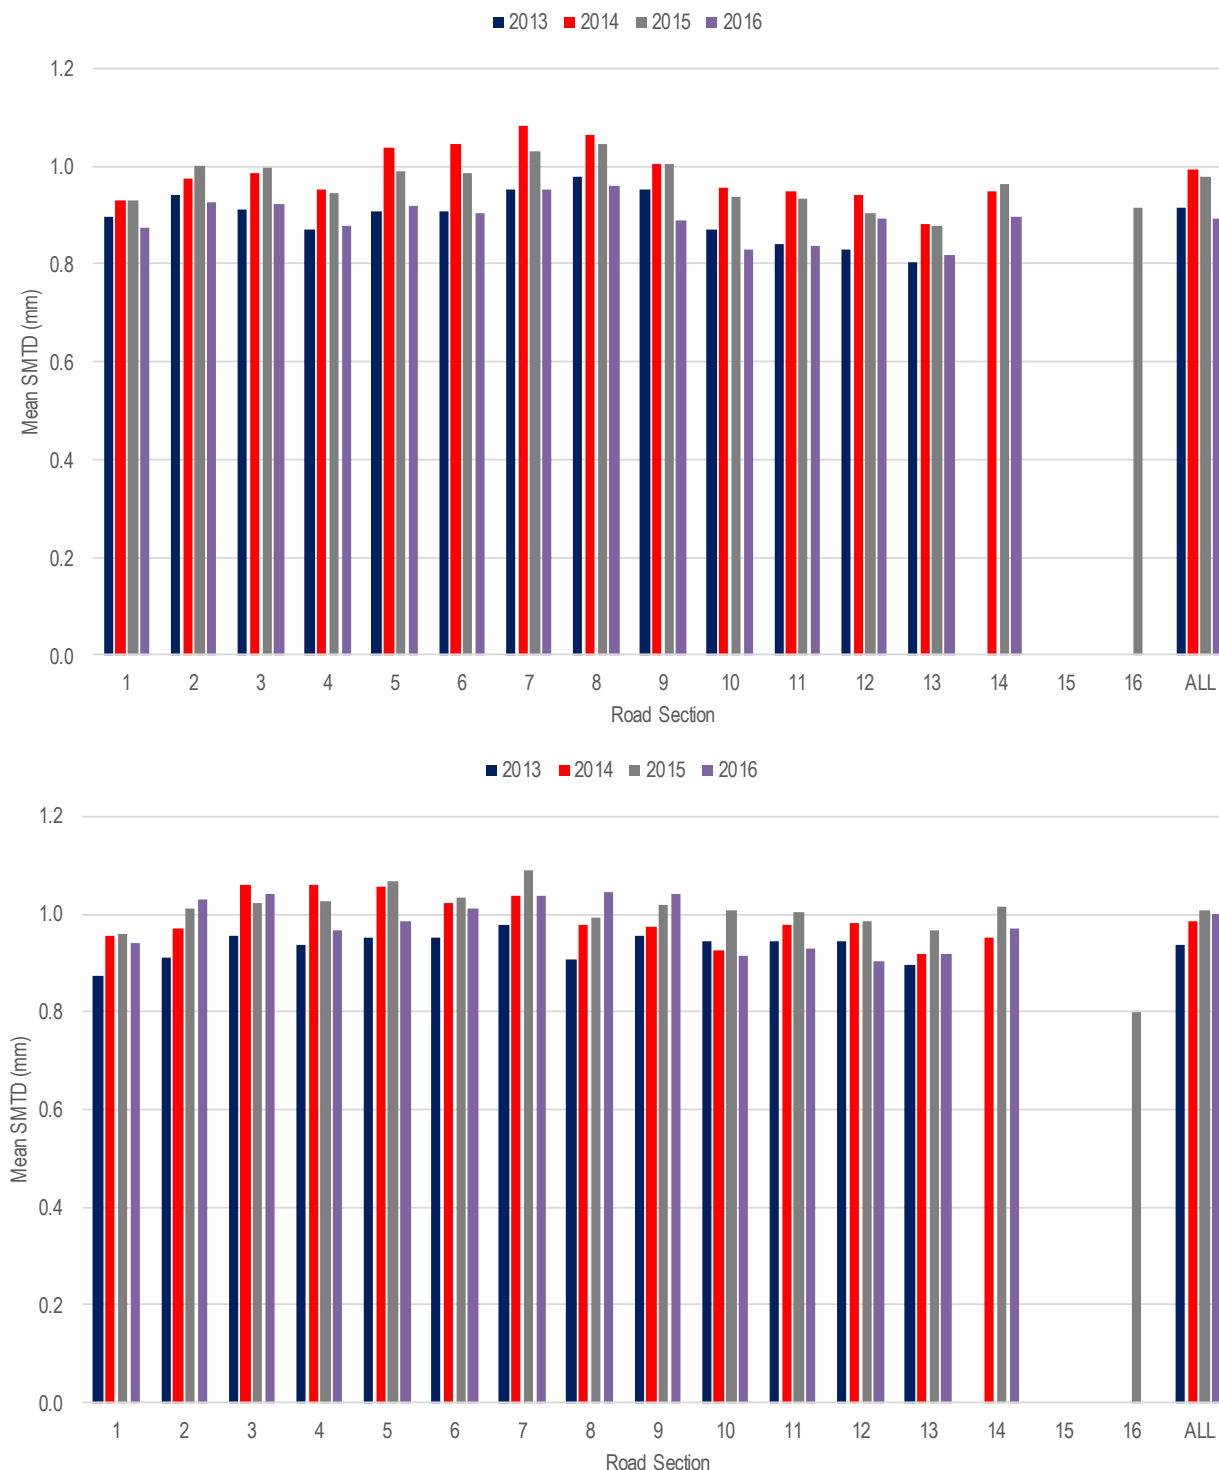
Figure 6.28: Mean surface texture values for slow (top) and fast (bottom) lane by assessment year

For most of the road sections, there is a decrease in the mean SMTD during 2015 and 2016. This is consistent with the understanding that as the aggregates in the sprayed seal surface polished under traffic, there will be a loss in texture depth with age. The relative linear progression rates, presented in millimetres per month, are shown in Table 6.7 and the same dataset is plotted in

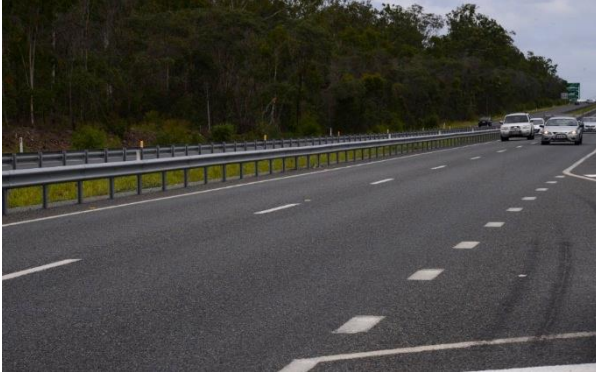
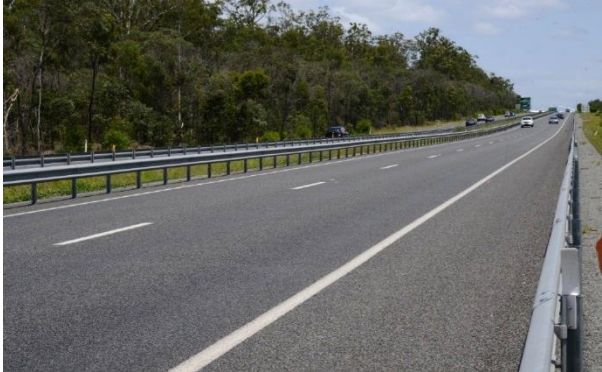
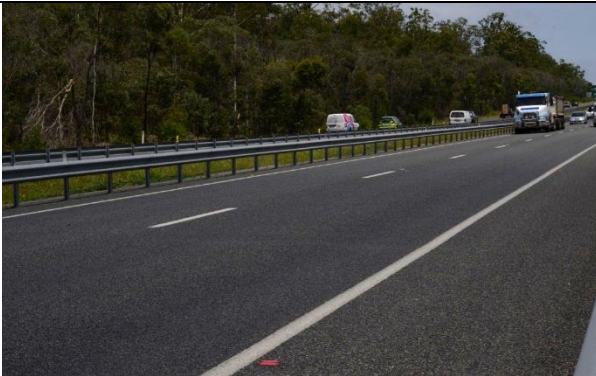
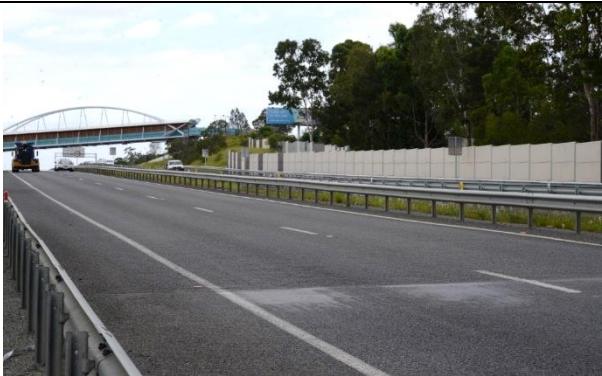
Figure 6.30: Photograph from site visit

<p>Typical condition of the northbound lanes</p>	<p>Typical condition of the northbound lanes</p>

<p>Slow lane with medium rutting</p>	<p>Flushing and minor rutting at the change of sprayed seal interface near the south end of the project</p>

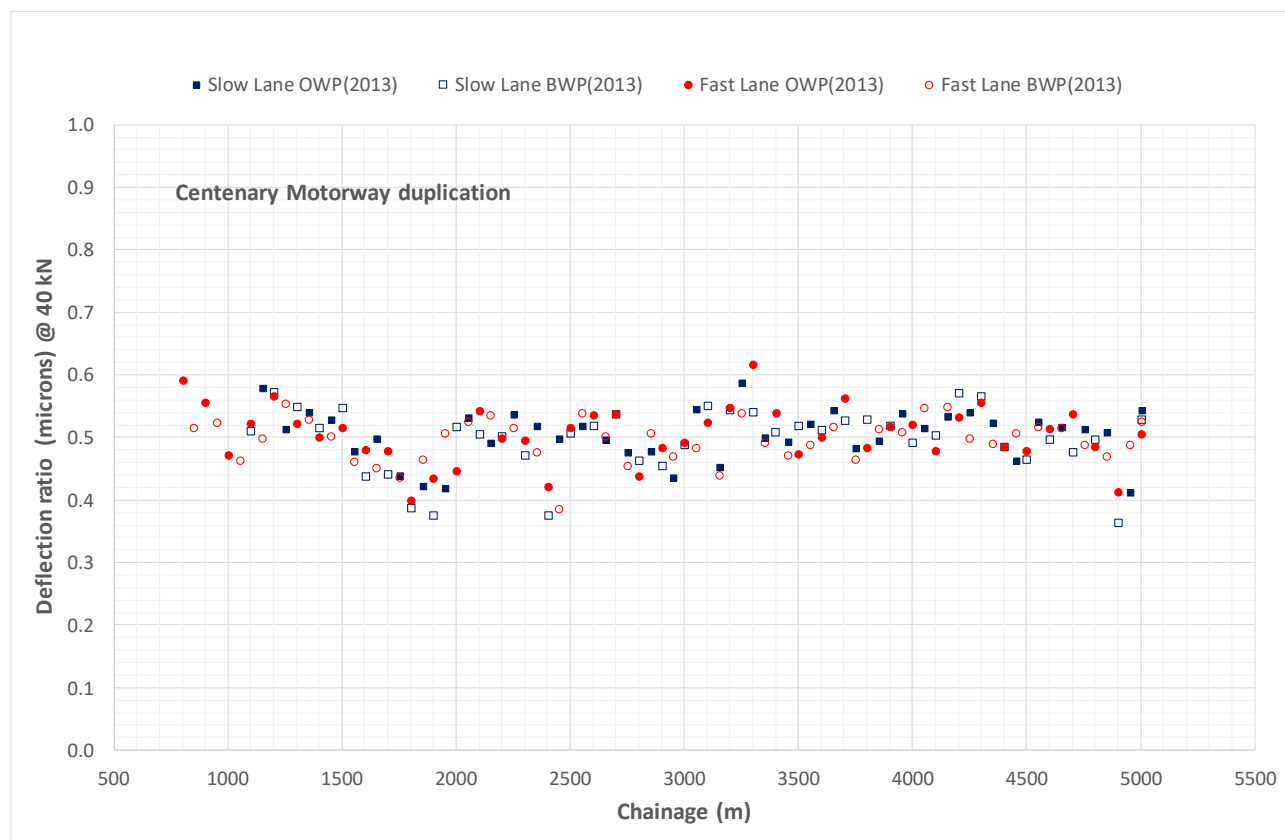
Figure 7.4: Deflection ratio for HSG trial pavement in 2013

Review of the calculated DR values shows great consistency along the alignment, similar to the D_0 measurements. However, almost all of the values are below the 0.6 performance threshold recommended in the TMR *Pavement Rehabilitation Manual* (TMR 2012a). Newly constructed or rehabilitated unbound granular pavements undergo an initial 'settling' period, during which construction and traffic loads induce particle rotation and relocation until a dense, stable fabric is achieved (Bartley Consultants 1997). As the testing was conducted early in the pavement life, it is assumed that the DR values will increase as the particle orientations stabilise and the equilibrium moisture content is reached.
