# FINAL REPORT

Project Title: AS/ISO 13822 Framing Investigation into the  
Assessment of Deck Unit Bridge and Transverse  
Stressing Bar Deficiencies (A variation of S29)

ARRB Project No: PRG17026

Client: Queensland Department of Transport and Main Roads

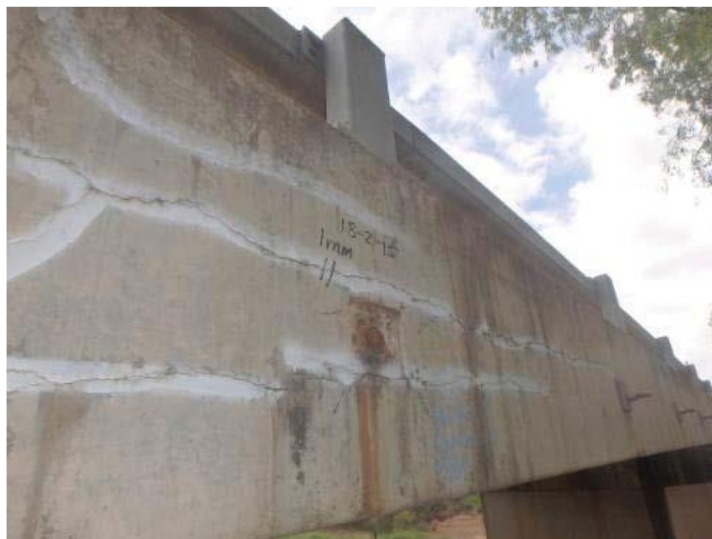
Full length crack running from A1 to A2 down bridge centreline

First TSB on RHS was broken
