# FINAL REPORT

Project Title: Long-term performance of FRP replacement components and structures (Year 3 - 2017/18)

ARRB Project No: PRG17033

Client: Queensland Department of Transport and Main Roads

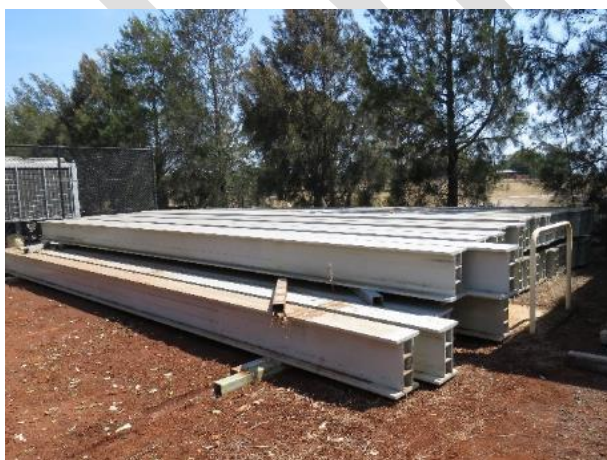
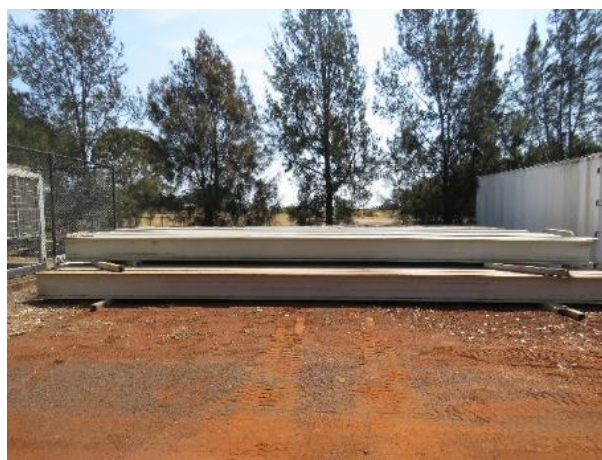
Figure 3.1: WCFT FRP girder stockpile at USQ

The WCFT girders stockpiled at the USQ Toowoomba campus were inspected on 19/09/2017. The girders had been stacked in two layers (Figure 3.1) since circa 2012. Due to limited space and lifting capacity, only 12 girders were transported to a nearby yard for detailed inspection, including five S1, five S2 and two S3-type girders (Table 3.1). Anecdotally, these girders showed typical deterioration and damage, and representing the common condition of the remaining girders. All girders were previously marked with unique identification numbers, including the girder number and the production lot.

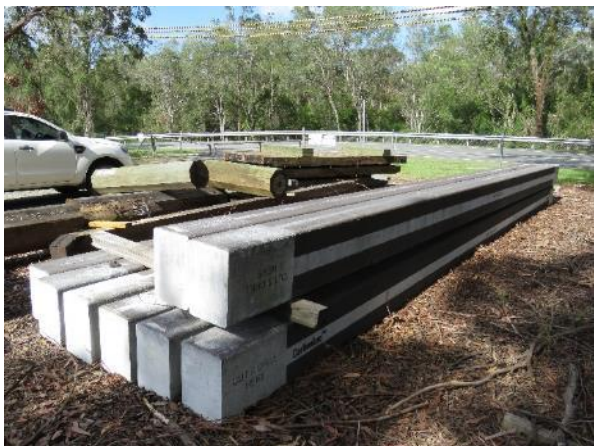
**Figure 3.17: LOC FRP girders stockpiled at Nerang**

The eight LOC400 girders at Nerang were stacked in two layers with ground contact (Figure 3.17). Due to the limited space between the girders, only visible areas were inspected. The girders were hand-marked with numbers from 2–11, without number 1 and 3. Girders 2, 6, 7, 8 and 9 had a thicker paint coating layer compared with the other girders.

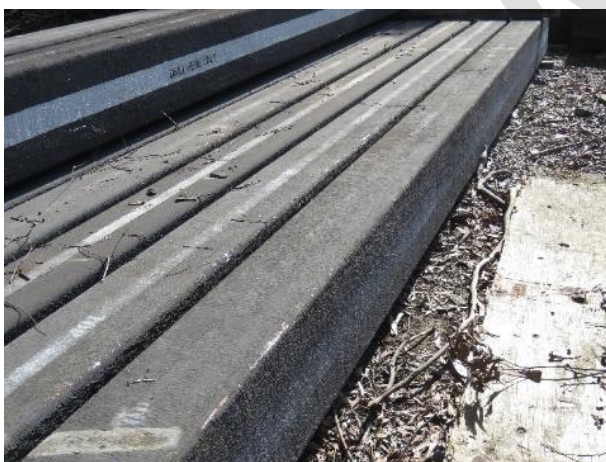
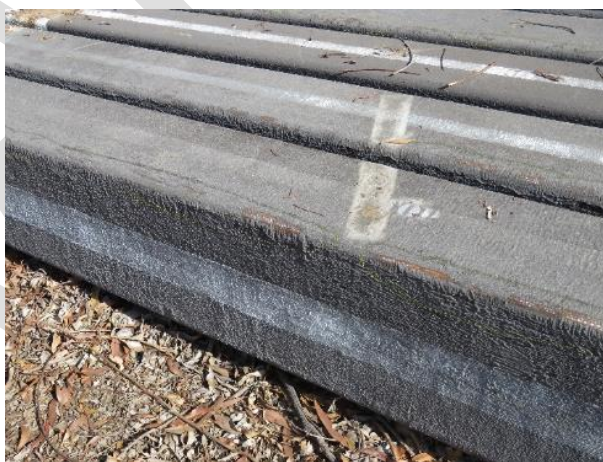
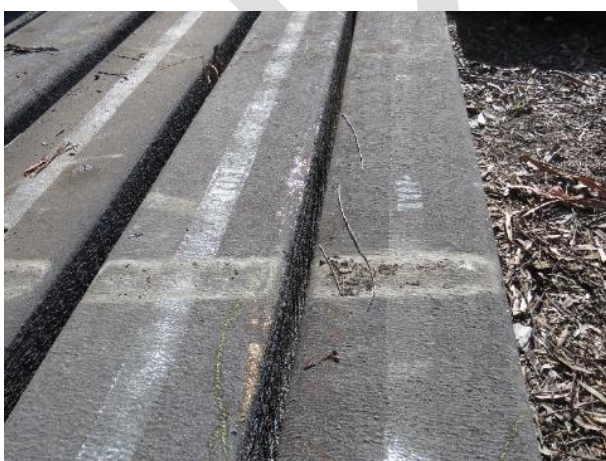
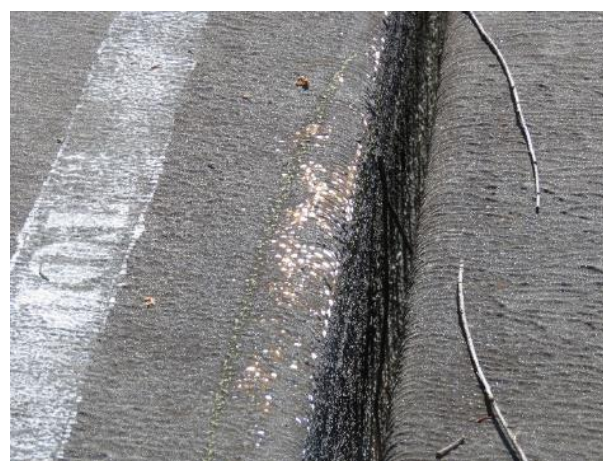
In general, the girders had a fair defect rating (2B – see Section 2.5). The most pronounced deterioration observed was a loss of the coating at isolated areas along the top edge of the girders (Figure 3.18). There was a minor tear of the FRP material at the edge of girder 6 due to physical impact (Figure 3.19). There were no signs of material degradation.

**Figure 3.18: Typical loss of coating at girder top edges**

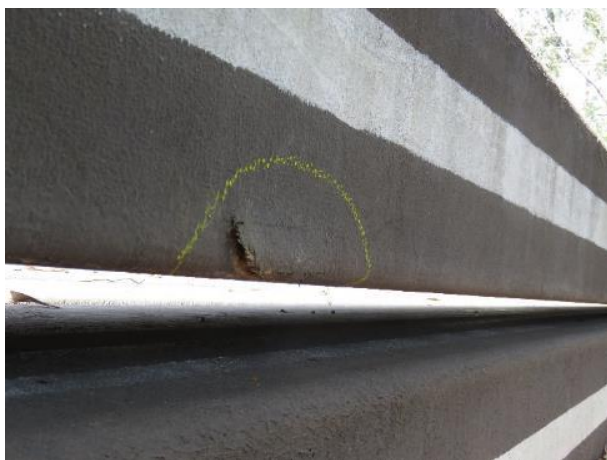
Figure 3.19: Minor tear of the FRP material due to physical impact

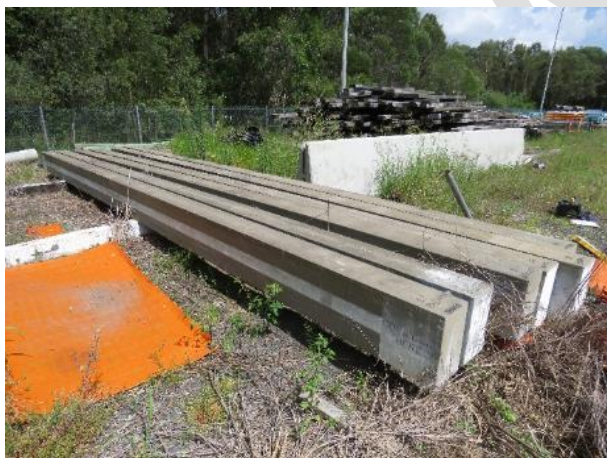
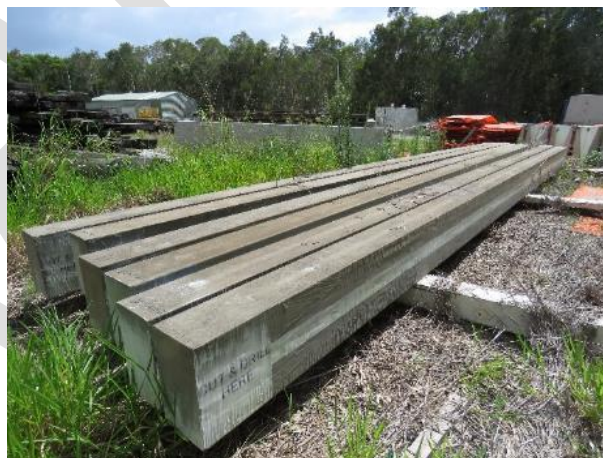
Figure 3.20: LOC FRP girder stockpiled at Maroochydhore RoadTek

The six LOC420 girders at Maroochydhore were located next to each other on packers off the ground (Figure 3.20). Due to the limited space between the girders, only visible areas were inspected. The girders were hand-marked with numbers 1, 5, 9, 11, 17 and 20.

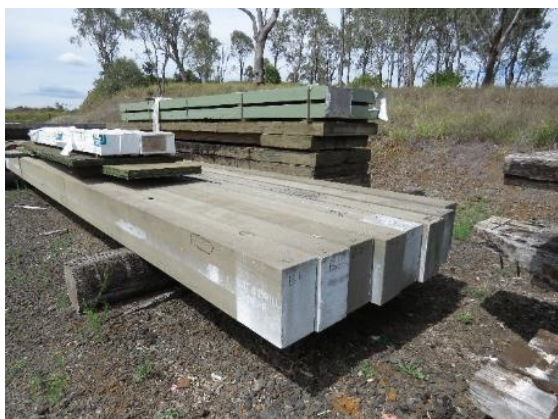
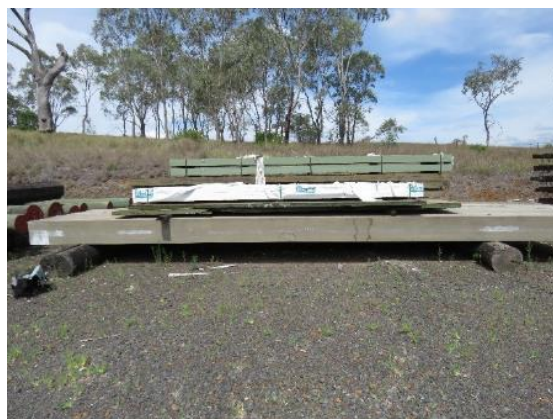
Figure 3.26: LOC FRP girder stockpiled at Maroochydhore RoadTek

The FRP LOC420 girders at Charlton were located next to each other on timber logs (Figure 3.26). Due to the limited space between the girders, only visible areas were inspected. There was no numbering on these girders.

Similar to the girders of the same type (LOC420) stored at Maroochydhore, the girders stored at Charlton had similar defects but were less severe:

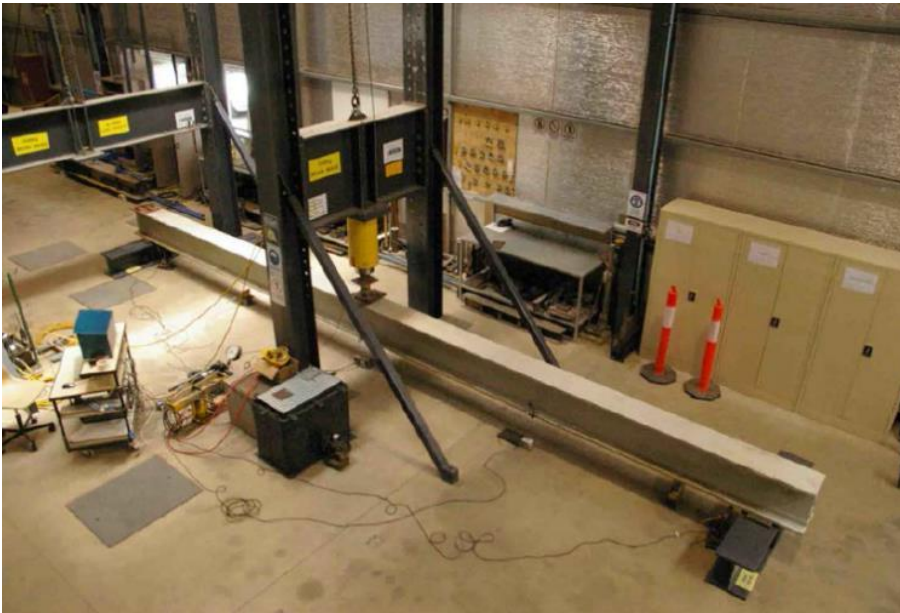
Figure 4.2: Typical setup for bending tests

No new defects or defect propagation was observed during the bending tests.

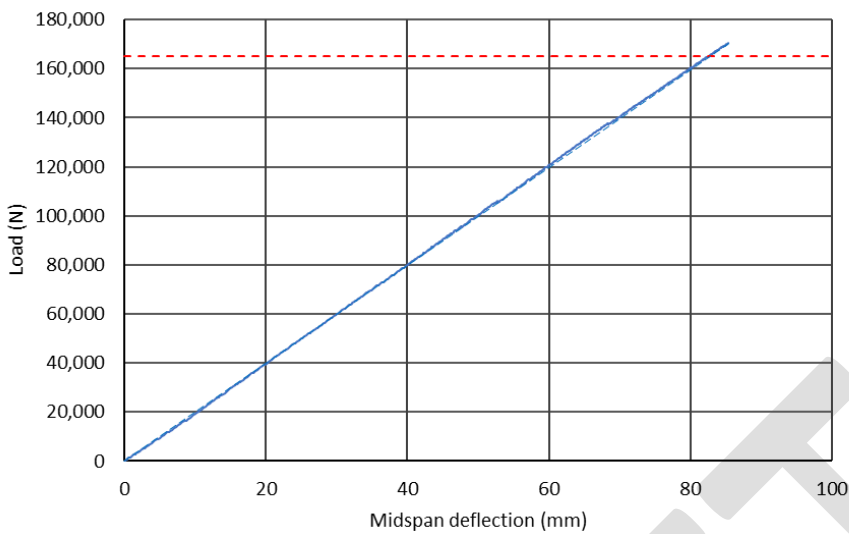
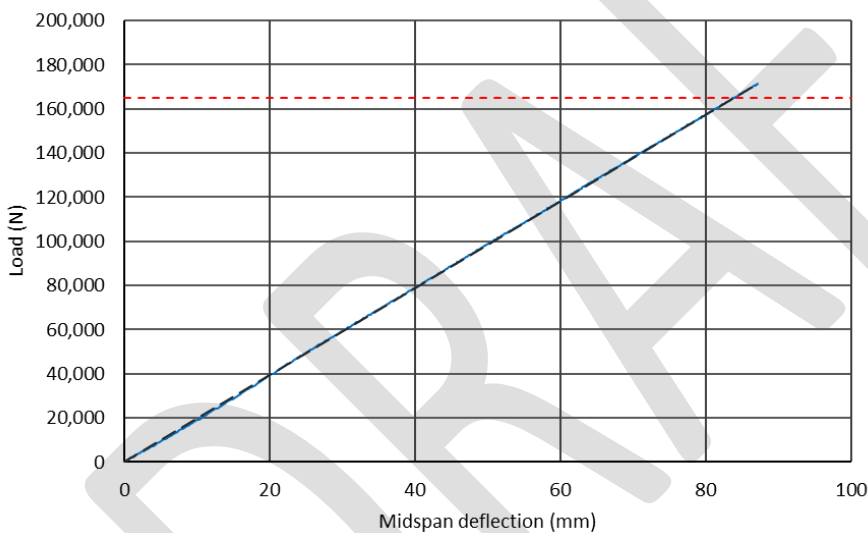
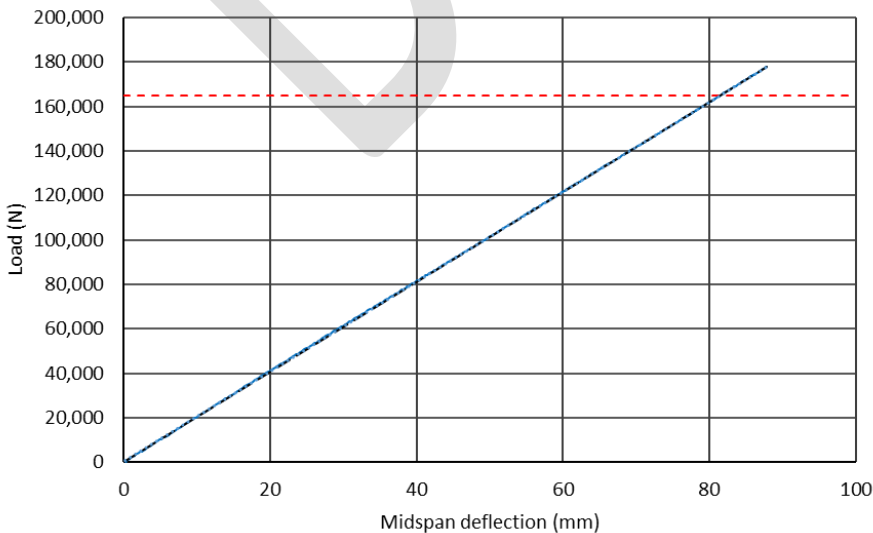
The load-deflection curves based on the bending tests conducted in 2017 on the selected girders described in Section 4.1 are plotted in Figure 4.6 to Figure 4.8. It can be seen that the load-deflection coincides with a relatively straight line, indicating that all the girders behaved in a linear elastic manner. The deflection of girders G1-3, G2-3 and G3-3 at a load of 165 kN were 82.24 mm, 83.91 mm and 81.65 mm, respectively. These deflections were within the deflection ranges derived from the past tests of the corresponding girders of the same production stage.

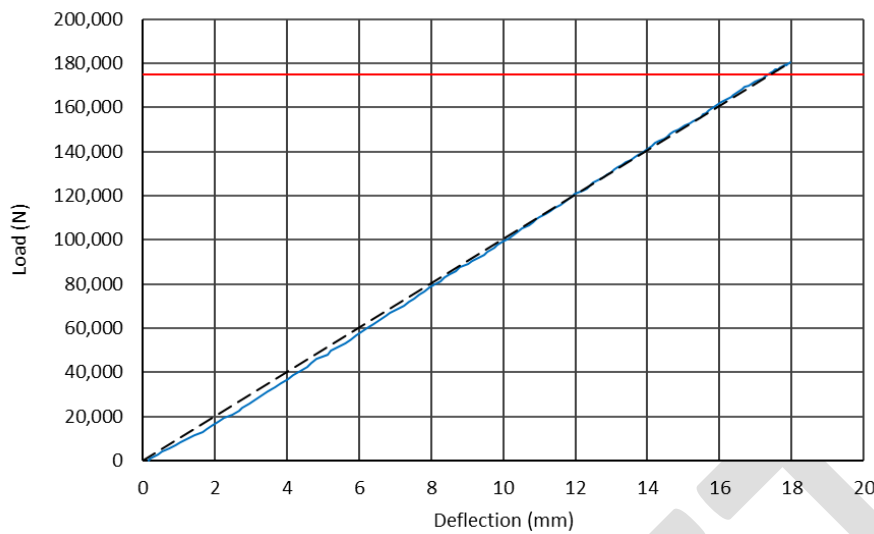
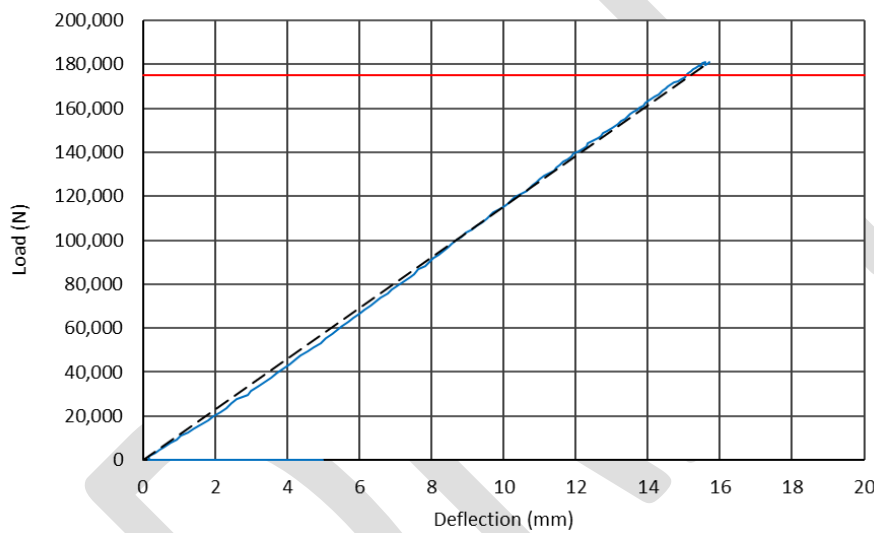
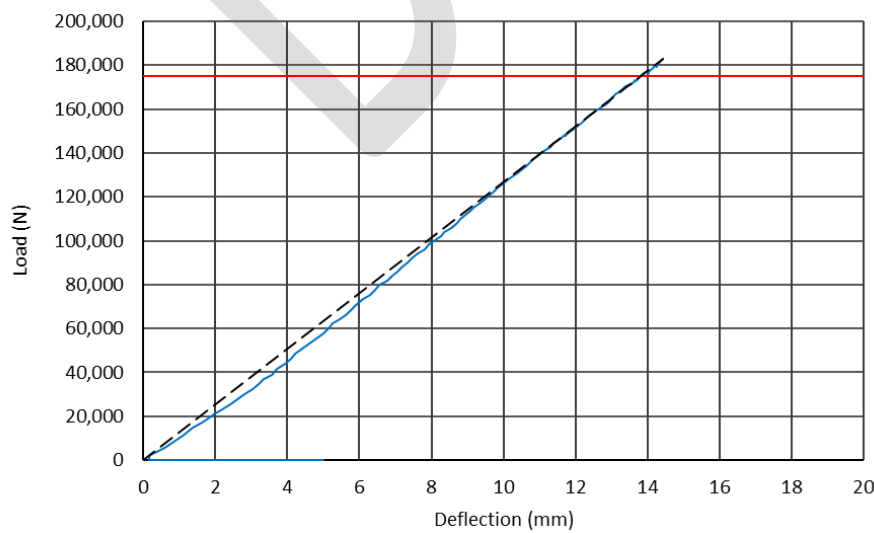
The load-deflection curves, based on the shear tests conducted in 2017 on the same girders described in Section 4.1, are shown in Figure 4.14 to Figure 4.16. The deflection data was recorded under the load, i.e. 1.0 m from the support. It can be seen that, in all cases, the load-deflection exhibits a non-linear manner at the low load levels but returns to linear at a higher load level. This might be due to the effects of the seating.

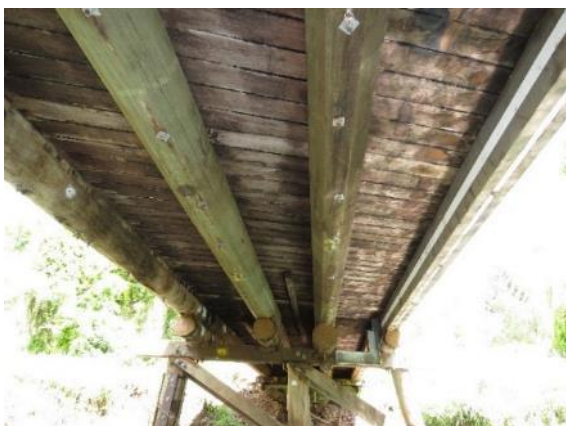
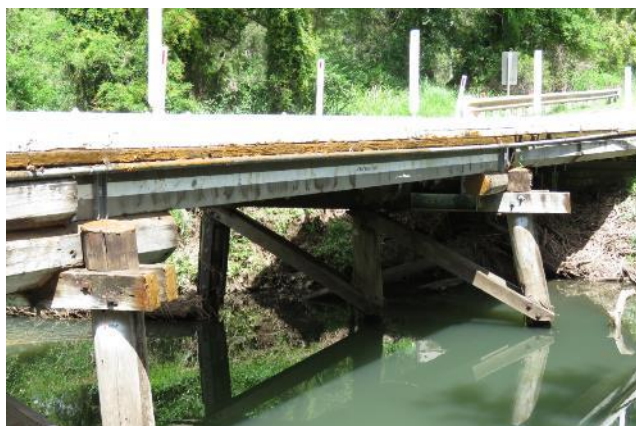
**Figure 5.1: Coulson Creek Bridge – replacement FRP girder on span 2**

One LOC400 girder was installed in 2014 to replace the external timber girder on span 2 (Figure 5.1). Annual Level 2 inspections carried out on the bridge since 2014 indicate that the FRP girder remains in good condition with a condition rating of condition state (CS) 2.

(a) view of the FRP girder from below

(b) view of the FRP girder from side

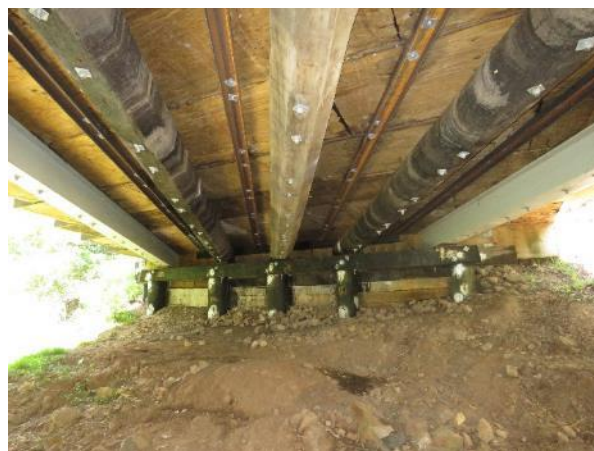
(b) View of FRP girders on Span 1

Two Type S1 WCFT girders (S1-G1 and S1-G5) were installed in 2011 to replace the external timber girders on span 1 (Figure 5.6). Annual Level 2 inspections carried out on the bridge since 2014 indicate that the FRP girder remains in CS2, and both girders have a sagging profile of 15-30 mm at mid-span.

According to the latest L2 inspection report (September 2016), the structure was in fair condition with a condition rating of CS2. For the FRP girders, the sag remains unchanged; all bolting is tight and there is no cracking in the girders; the packers are working properly.

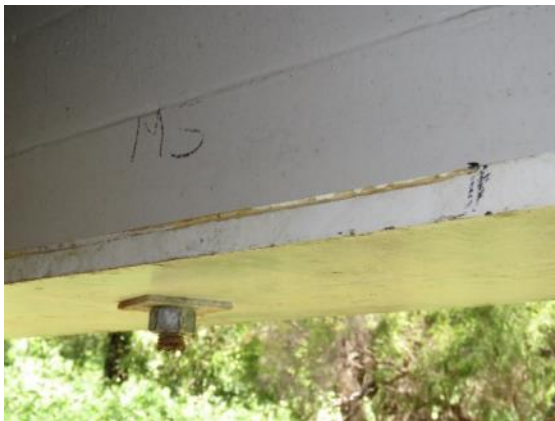
Figure 5.7: Delamination of flange plate at several locations on S1-G1

- Both girders sagged at the middle section, as indicated in the previous inspection reports.
- Delamination of the composite material at the bottom flange layer of S1-G1 at several locations (Figure 5.7).

It should be noted that the delamination and loss of bond are considered significant defects for the FRP girders. Particular care should be taken to monitor any propagation of these defects.

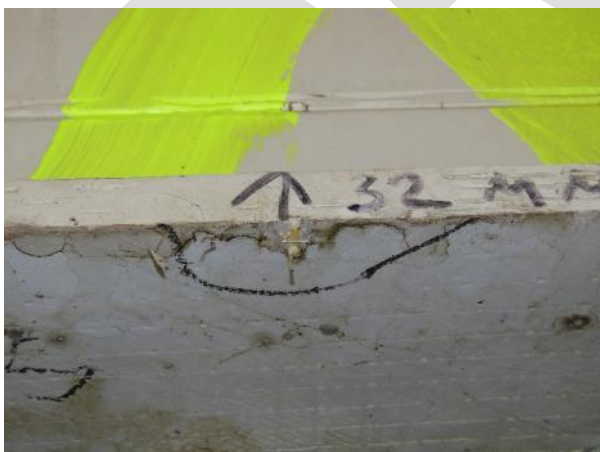
Figure 5.8: Minor chipping of the coating at the soffit on LHS on end 2 of S1-G1

- Minor chipping of the coating at the soffit of girder S1-G1 (Figure 5.8).
- Tear of a fibre strip at almost every bolt position; this is likely due to the installation of the bolts holding down the deck (Figure 5.9).

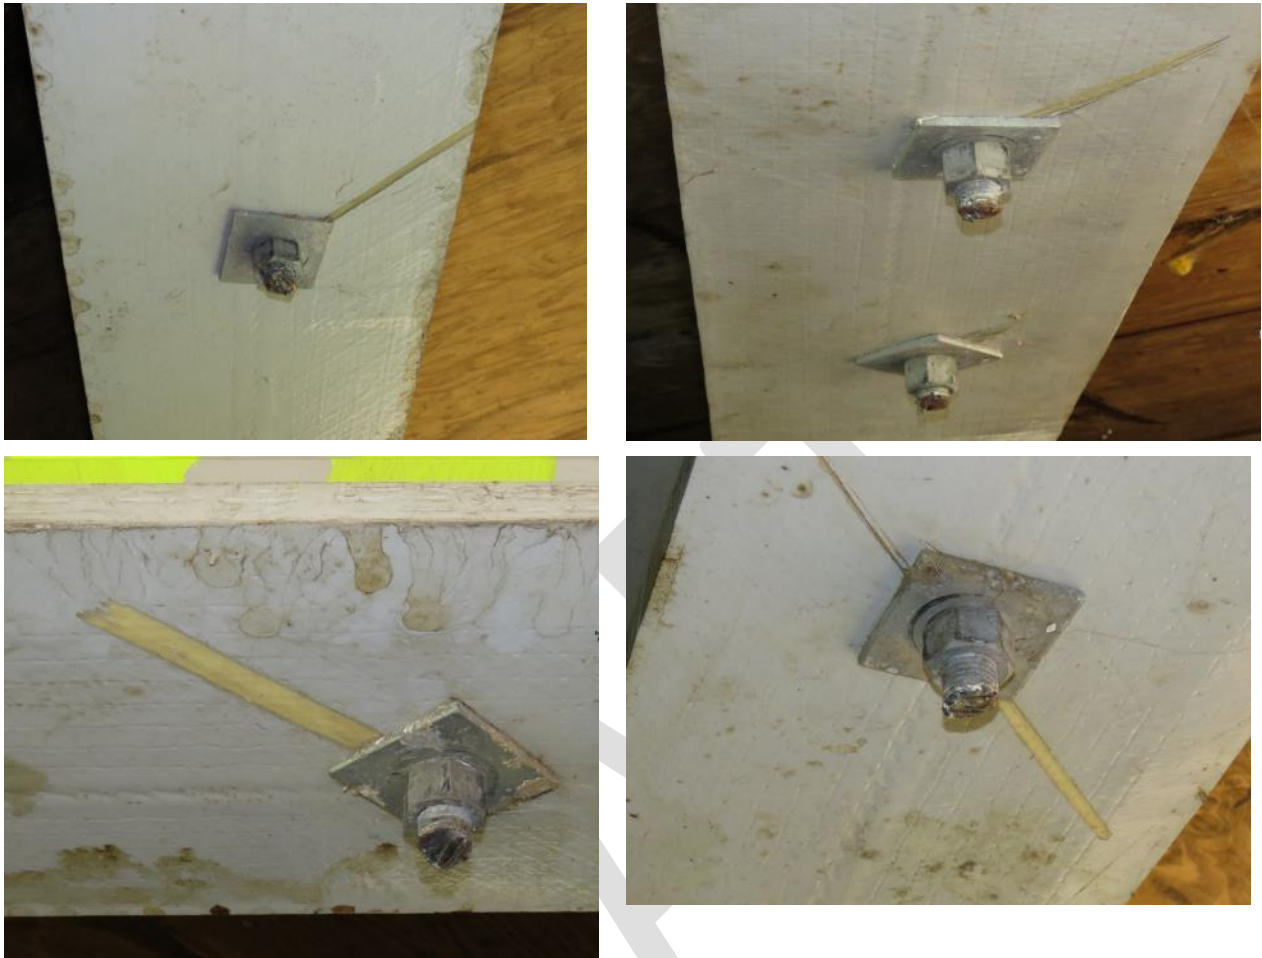
Figure 5.9: Strip of fibre removed at the soffit of girder, close to a bolt connection

- Minor corrosion on all bolt nuts (Figure 5.9).
- Multiple areas of water stains or discoloration at the underside of the girders (Figure 5.8 and Figure 5.9).

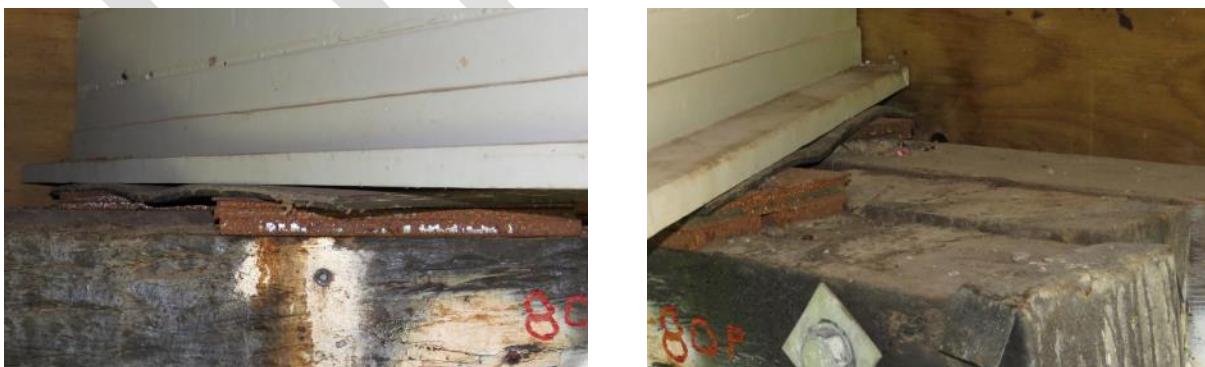
Figure 5.10: Bulging of rubber pads at bearings

- Bulging of the rubber pads at supports with corroded steel bearing plates (Figure 5.10). It is noted that the abutment end of the FRP girders was supported on two discrete points while the other end was supported continuously on corbels.

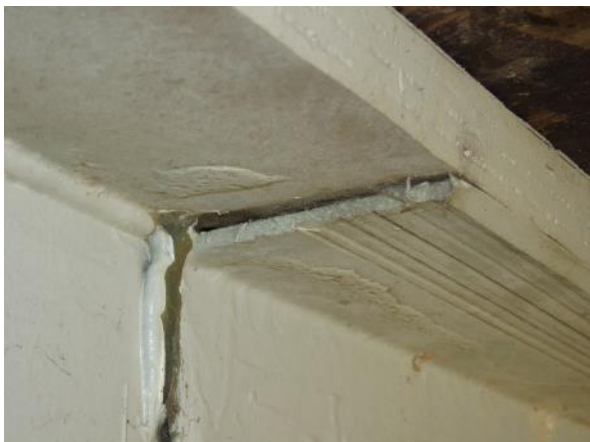
Figure 5.11: Loss of bond between the angle and flange of the girder

- Loss of bond between the angle and the flange of the girder (Figure 5.11).
- Wasp nests on several locations on the web of the girders (Figure 5.12).

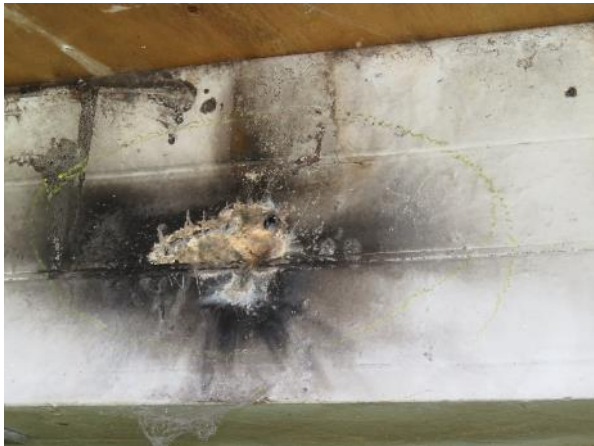
Figure 5.20: View of a burning area noted at right hand side of FRP girder S1G2

- A small burnt surface area (100 x 100 mm) due to fire damage at a location 2.5 m from the abutment on the external face of girder S2-G1, with fibres exposed and fire marks around the hole (Figure 5.20).
- A number of bolt holes were left open on the sides and at the bottom of both girders (Figure 5.21). Several holes were not well rounded with blooming fibres.
- A strip of fibre was removed at some unused bolt holes, possibly due to the hole drilling process (Figure 5.22).
- Water stains on the outer surfaces of the girders (Figure 5.23).
- Minor corrosion of steel packers located at the abutments between the FRP girder and the headstock (Figure 5.24).

In general, all FRP girders on this bridge had moderate defects (a rating of 3B), with the small fire-damaged area and the pre-drilled holes on the sides and bottom of the girders. Whilst water stains were observed on the surface of the girders, there was no evidence of material degradation. There was a good level of interaction with other bridge components, and a good contact between FRP girder, timber packers and corbels.

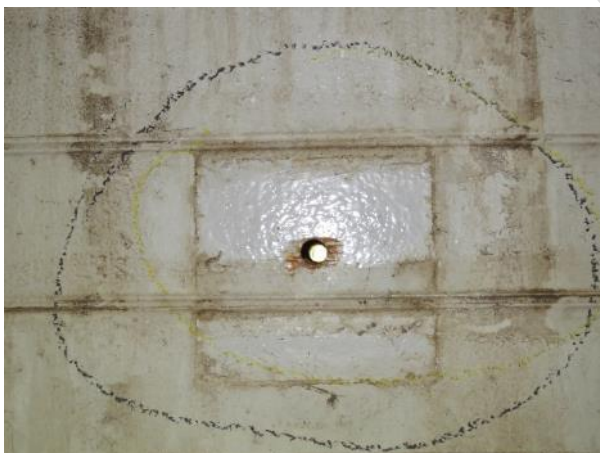
(a) View of a unused hole on the side face of the girder

Figure 5.21: Unused bolt holes on FRP girders

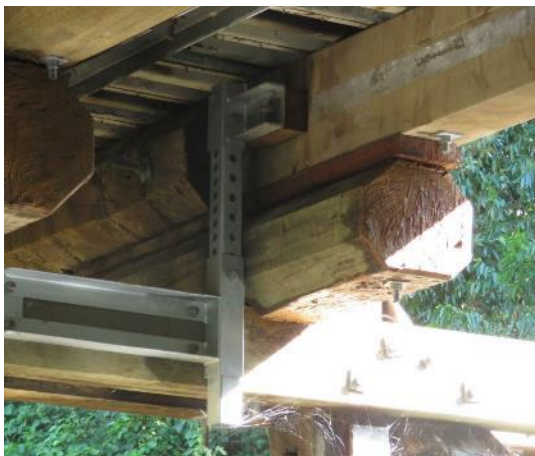
Figure 5.30: Good contact with packers and corbel

In general, all FRP girders on this bridge had a defect rating of 3B, with the major damage comprising small areas of exposed fibres around the bolts and water stains on the girder's surface. There was no evidence of material degradation. There was a good level of interaction with other bridge components and good contact between the FRP girder, timber packers and corbels (Figure 5.30).

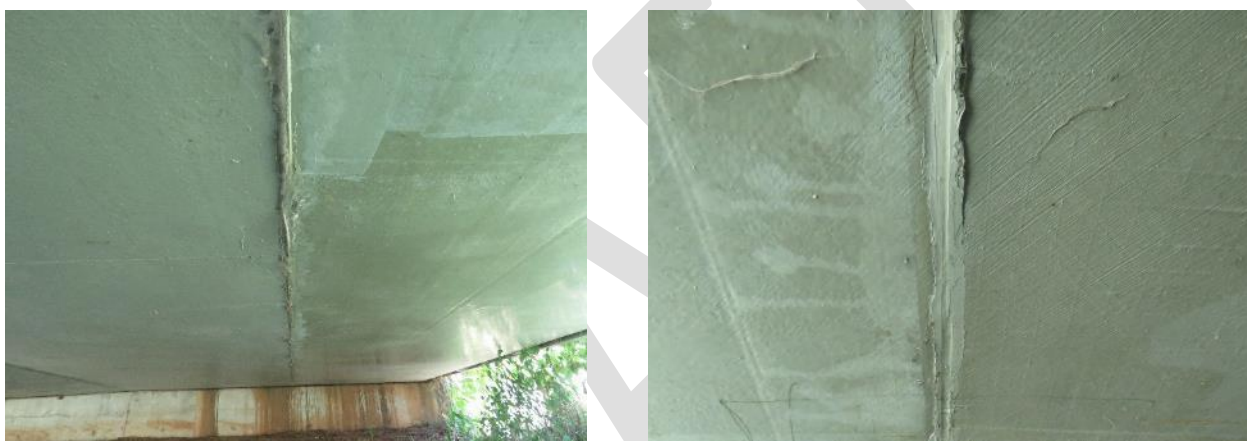
Figure 6.3: Different finished surfaces of units

- Different coatings appear to have been used at the soffit of different units, resulting in different surface finishes (Figure 6.3).

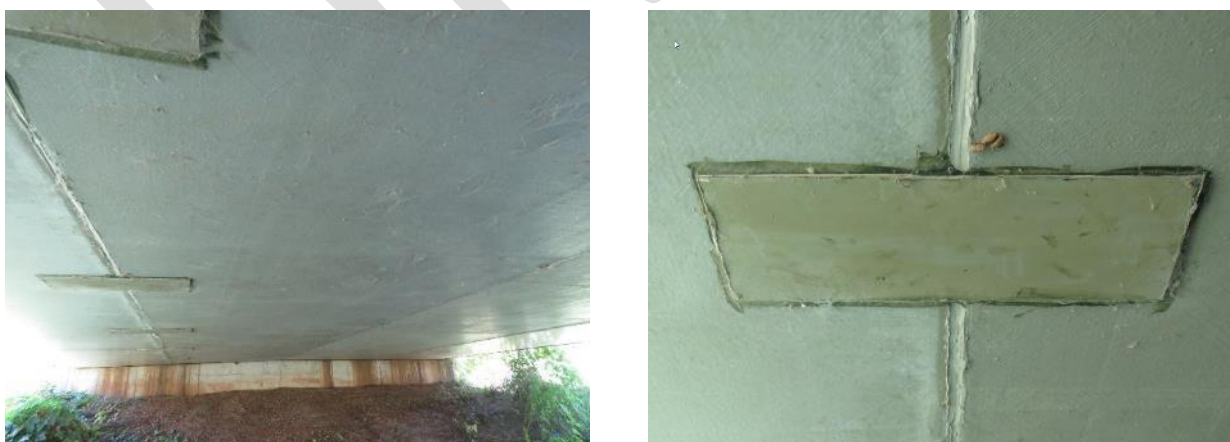
Figure 6.4: Transverse pads at soffit of bridge

- The gaps between units were filled with high-strength grout. Five transverse pads were glued to the underside, bridging the gap between units 3 and 4 on span 1 and between units 1 and 2 on span 2 (Figure 6.4).
- A smaller FRP girder was installed on the left-hand side of the structure, possibly to prevent logs from hitting the FRP units during flooding (Figure 6.5). This is different from the original design shown in Figure 6.1. This girder was hung on the concrete slab underneath the kerb and is not supported on the pier.
- A sheet was installed at the pier end of the right-hand side unit on span 2 (Figure 6.6), possibly for level adjustment. The remaining units sit directly on concrete on the pier and abutments.

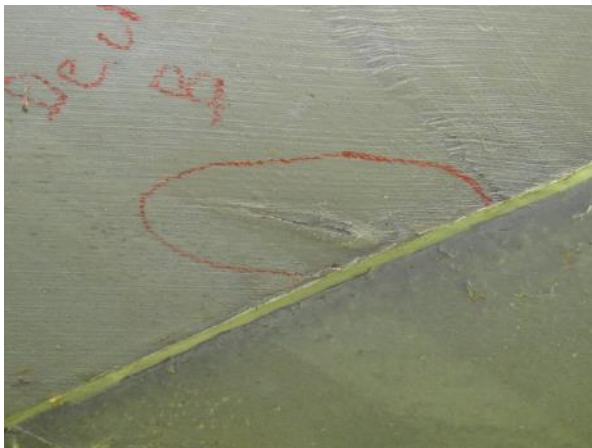
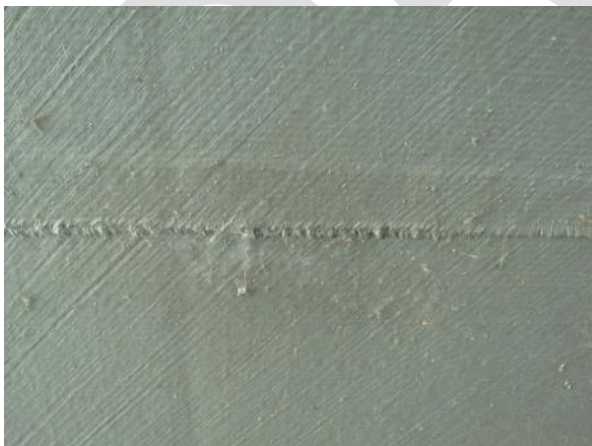
Figure 6.8: Fibre tear and exposed at underside of unit 3 on span 2

- Differential deflections at mid-span between units 2 and 3 at the underside of the units (Figure 6.7). These differential deflections were opposite in direction between span 1 (the deflection in unit 2 was about 16 mm lower than unit 3) and span 2 (the deflection in unit 3 was 25 mm lower than unit 2). The epoxy grout had completely failed at these locations.
- Exposed fibre and localised damage at the soffit of unit 2 and 3 at various areas (Figure 6.8)
- Damage to the fibre on a small area due to physical impact on the external FRP girder under the kerb unit (Figure 6.9).
- Deterioration of the coating at various locations around the mid-span at the soffit of unit 4 on span 1 (Figure 6.10).
- Water stains at the abutment headstocks (Figure 6.11) There was a significant water leak on the left-hand side of the pier headstock (Figure 6.12).

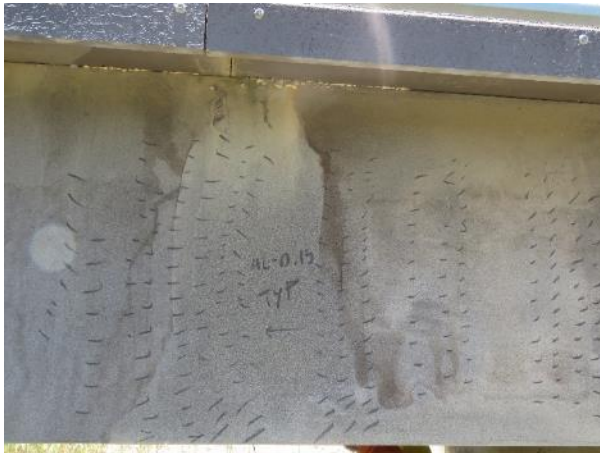
On girder G3

- Multiple vertical minor cracks (up to 0.15 mm wide) on the external side faces of girder 1 and girder 3, typically located at the areas affected by moisture due to water leak from the deck (Figure 6.17) Noting that there was no cracking at the internal side faces of the girders, even at the areas with water stains (Figure 6.18), this cracking may indicate material degradation due to UV since the external faces are exposed to direct sunlight, coupled with moisture effects.

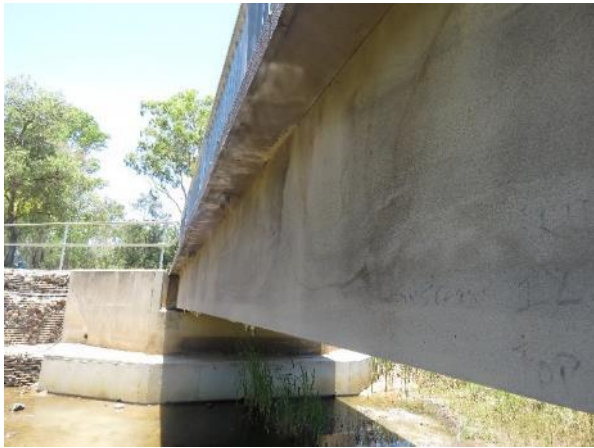
Figure 6.20: Water stains at external face of girder G1

- Water stains along all of the girders due to water leaking from the bridge deck, causing discoloration (Figure 6.20 and Figure 6.21).
- Excessive epoxy adhesive at the underside of the girders (Figure 6.22).

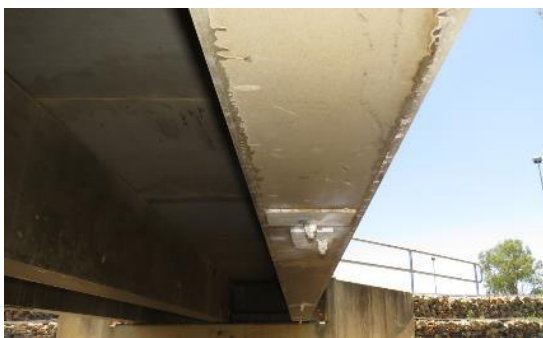
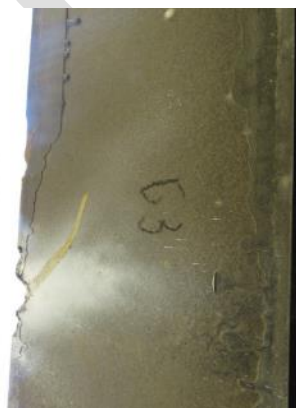
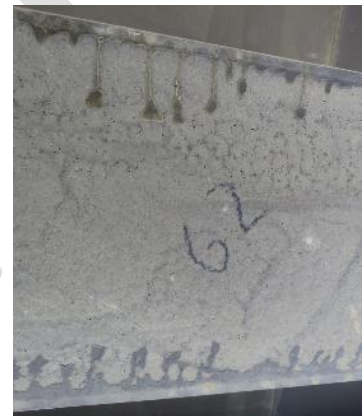
Apart from these defects, all connection details such as steel plates, angles and bolts were in good condition (Figure 6.23).

Figure 6.23: Connection details

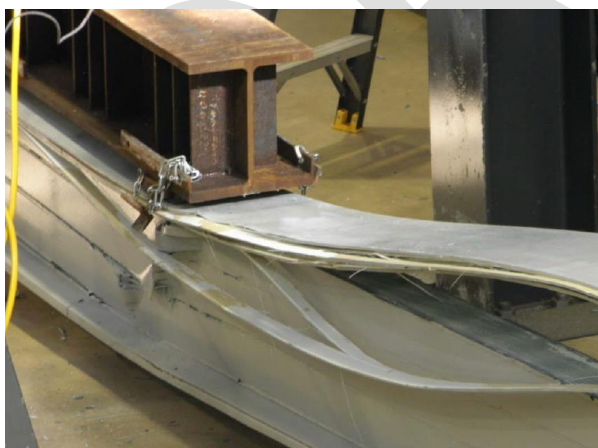
Failure of S1 girder in bending

Four-point bending testing was also conducted. Both the S1 and S2 girders failed at 400 kN, while the S3 girder was loaded to 340 kN and then used in the ultimate shear test. The failure modes in bending of S1 and S2 girders shown in Figure 7.3. These failures were brittle, due to the failure of the glue lines between the flange plates (on the S1 girder) and between the web cells (on the S2 girder).

**Figure 7.3: Failure of WCFT girders under 4-point bending test**

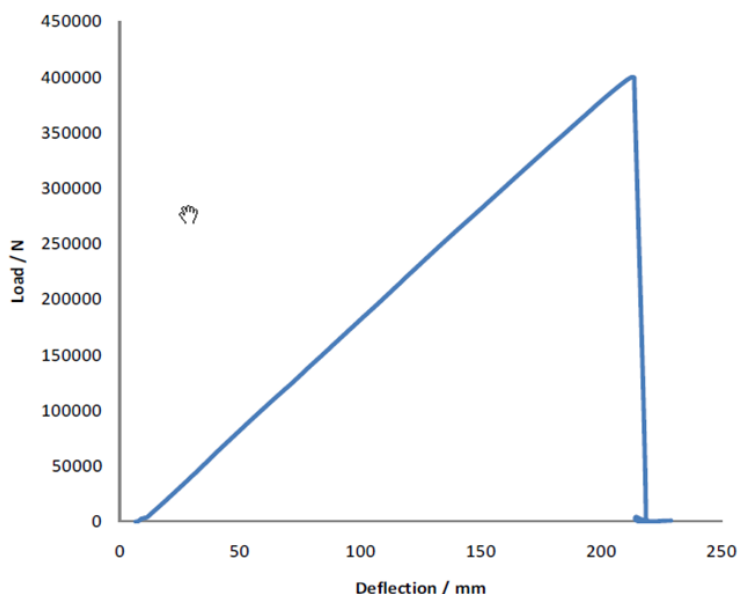
The load-deflection curve for the S2 girder is shown in Figure 7.4. It can be seen that the girder behaved linear-elastic up to failure at a deflection at mid-span of 213 mm.

Figure 7.4: Load-deflection curve of S2 girder under 4-point bending test

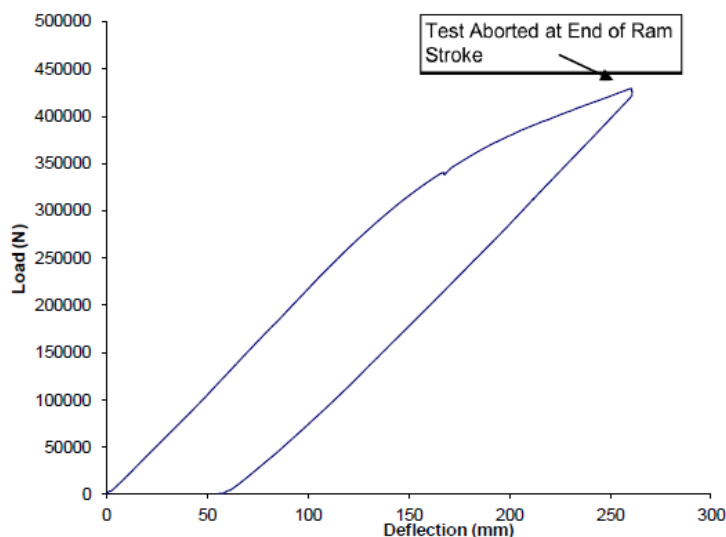
It was reported by Aravinthan et al. (2012a) that, with a span of 9000 mm in the 4-point bending tests, the two girders tested behaved linear elastic up to 340 kN which is equivalent to a 660 kNm bending moment before the steel started to yield. The test was abandoned at the end of the stroke of the hydraulic cylinder at a load of 429 kN and a maximum deflection of 261 mm. This load is equivalent to an 836 kNm bending moment which is 26% higher than the ultimate bending moment of 660 kNm required by TMR. The tested girder exhibited a ductile behaviour post yield.

Figure 7.5: Load-deflection curve of LOC girder under 4-point bending test, 9000 mm span

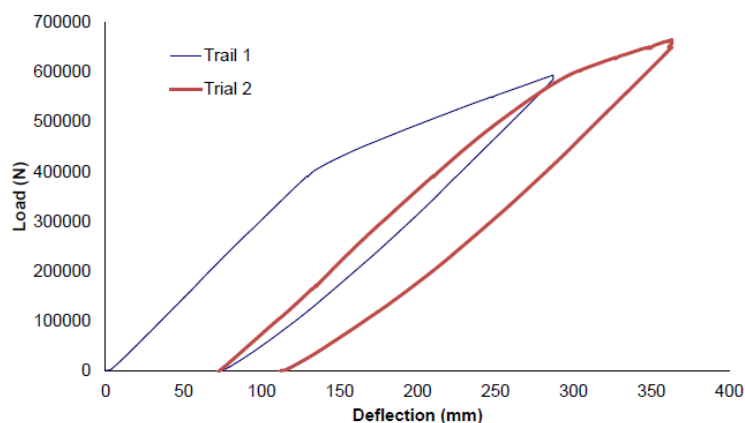
Another bending test was conducted on the stage 2 LOC girder with a shortened span of 8000 mm (Aravinthan et al. 2012c). The girder failed at an ultimate load of 664.7 kN, which is equivalent to a bending moment of 1128.8 kNm and a deflection of 388.7 mm at mid-span. The load-deflection curves for two load cycles are plotted in Figure 7.6.

Figure 7.6: Load-deflection curves of LOC girder under 4-point bending test, 8000 mm span
