FINAL REPORT

Project Title: S28: Review of Performance of Concrete Pipe Culverts
(Year 1 - 2017/18)

ARRB Project No: PRG17022

Client: Queensland Department of Transport and Main Roads

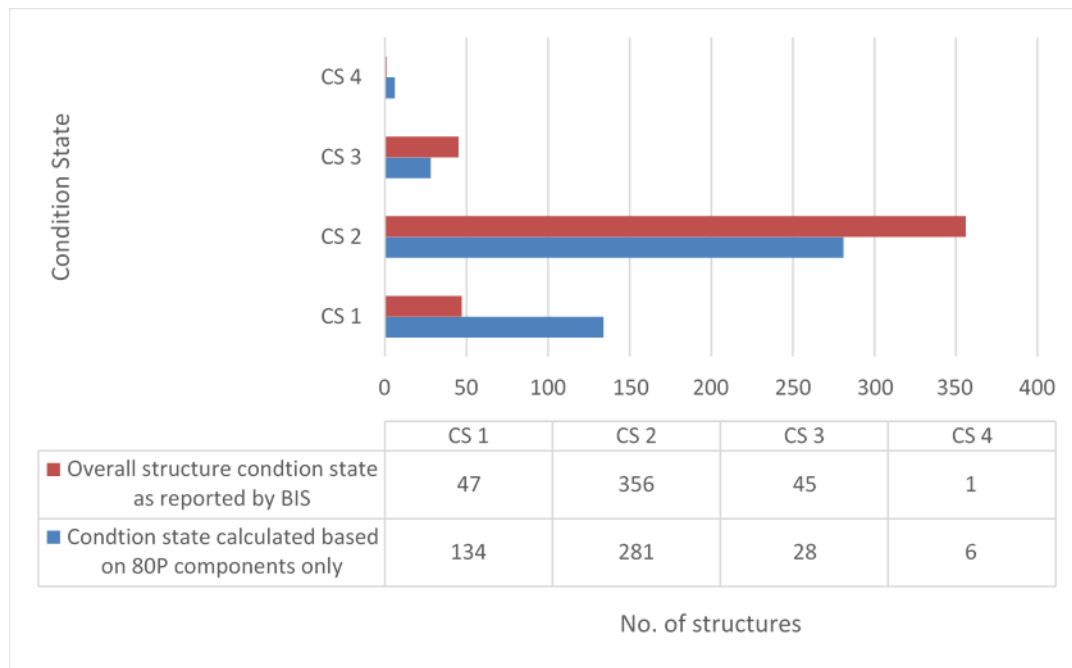
Figure 3.3: Overall structure CS as reported by BIS vs. overall CS based on 80P components only

Table 3.2 presents this correlation between component condition rating and overall condition rating. There were six structures where the highest condition rating of its components is CS4 while they were overall rated CS3. This contradicts the current guidelines in the *Structures Inspection Manual* (Part 3, Section 3.7.3.3), which requires that if 25% or more of a principal structural component is rated CS3 or CS4, the overall structure shall be rated in CS3 or CS4, respectively.

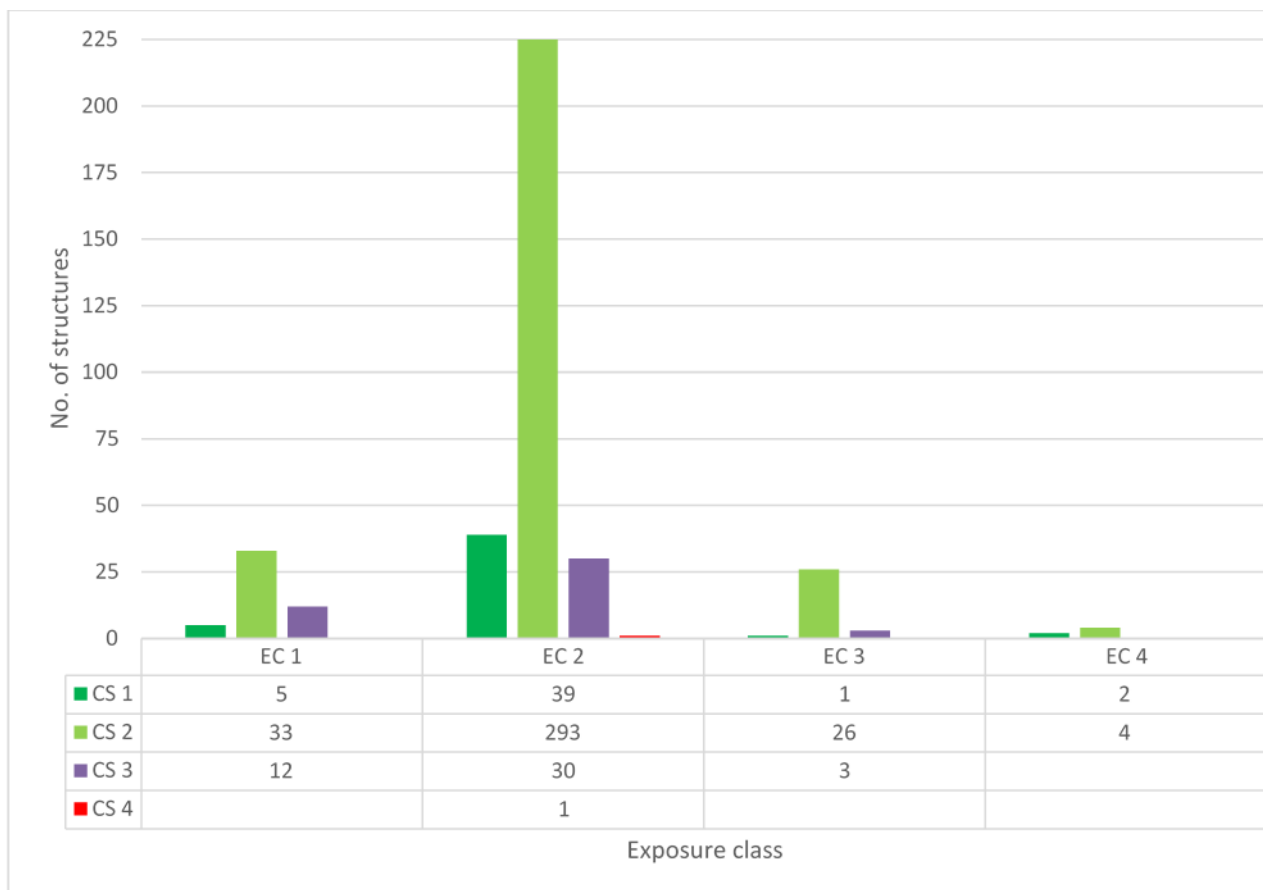
Figure 3.6: Overall structure CS as reported in BIS vs. environmental exposure class

An analysis of the environment exposure class against the overall condition rating of the structure considering 80P components only found that there was no structure in CS3/4 for exposure class 4. Additionally, Figure 3.6 shows that most of the structures are reported as being in exposure class 2. It was speculated that exposure class 3 and 4 may have only been used for recently constructed pipes, but Figure 3.7 shows that there is an even temporal spread of structures in exposure class 3. For exposure class 4 however, four out of the six structures in the class have been constructed since 2010, which supports the possibility that exposure class 4 alone may have only recently come into use.

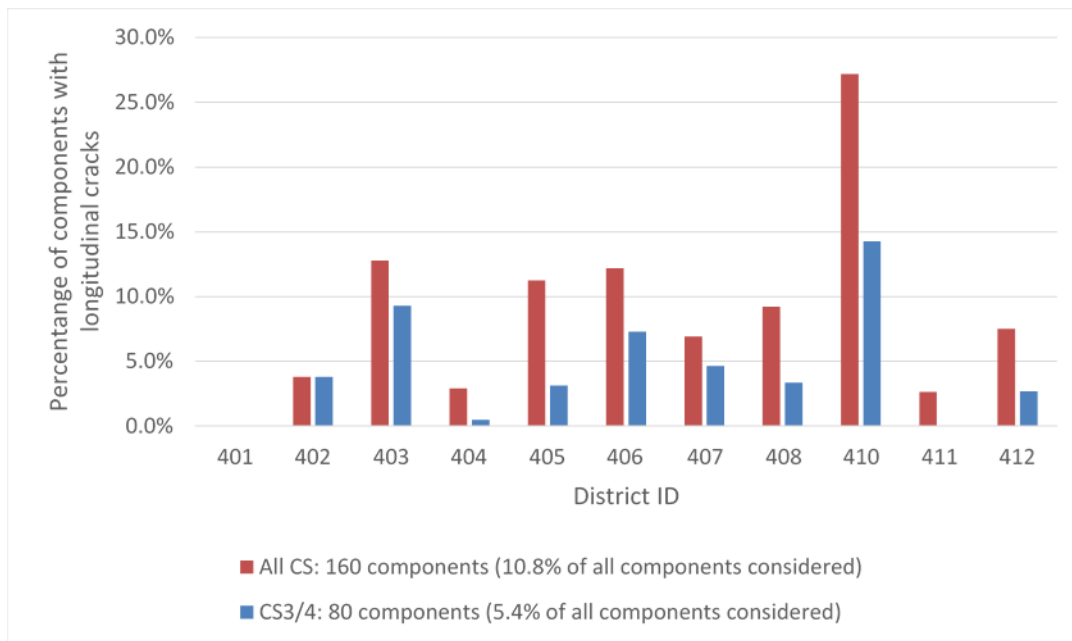
Figure 3.10: Longitudinally cracked 80P components in each district rated in any CS and rated in CS3/4 only as proportions of all components considered for each district

- District 410 has by far the greatest number and percentage of reported longitudinally cracked components of any district for all CS at 27.2% of components considered for the district (Table 3.7; Figure 3.10). The reason has not been narrowed down but contributing factors could include: age, design and construction specifications, or supplier/manufacturer and/or installation parameters. Inspection records should also be checked for consistency with the inspection manual. The average age of components in district 410 is 37 years, which is greater than the population average of 33 years (Figure 3.9), but since there are several other districts with similar average component ages no definitive correlation between the older component age and the prevalence of defects can be made.

- Conversely, districts 401, 404 and 411 have significantly lower instances of CS3/4 longitudinal cracking defects of between 0 and 0.5% of the components considered for each district (Table 3.7; Figure 3.10). A likely cause for the low instances of cracking in districts 401 and 411 is the fact that there are very few reported culverts in the districts (Table 3.1). This is not the case in district 404 however, and the low prevalence of cracking warrants investigation to determine why, and if there can be any lessons learnt. Importantly, inspection records should also be checked for consistency with the inspection manual. It is possible that the low number of defects is due to pipes with defects being replaced, but Table 3.3 shows that the majority of components in district 404 were constructed from the 1970s to the 1990s, which makes replacement of old pipes an unlikely cause in this case.

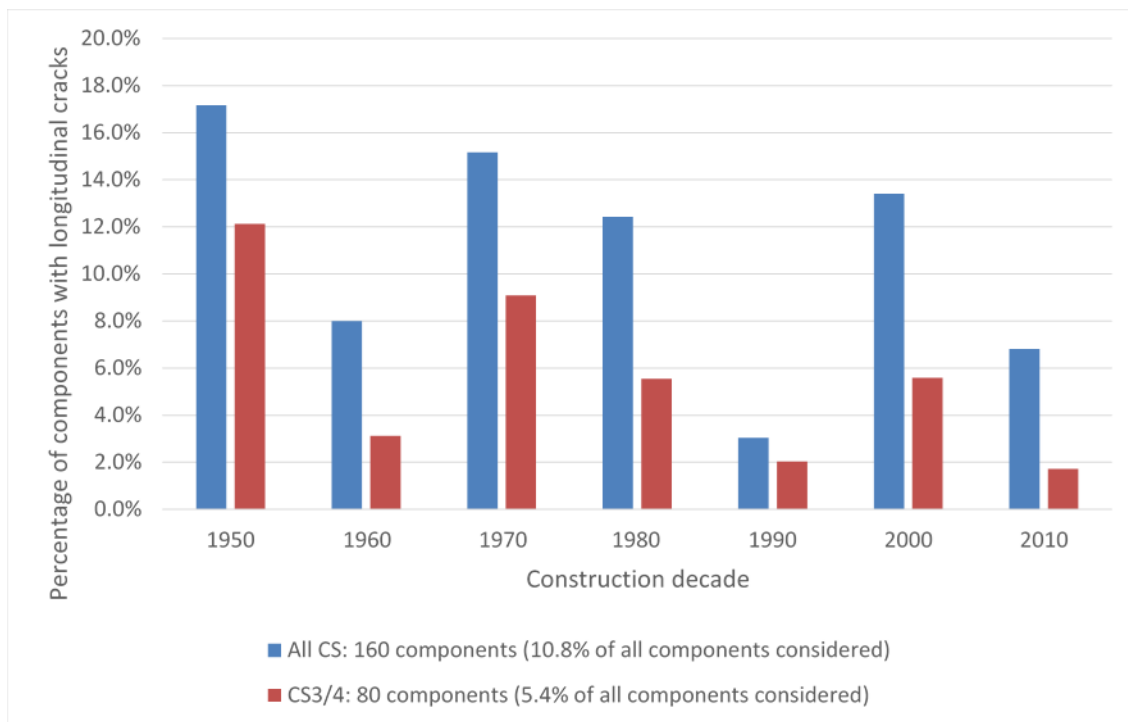
Figure 3.11: Longitudinally cracked 80P components constructed in each decade rated in any CS and rated in CS3/4 only as proportions of all components considered for each decade

- Grouping components by decade of construction shows significant variation but no discernible trend other than a weak increase in cracking with age which is expected (Table 3.8; Figure 3.11).

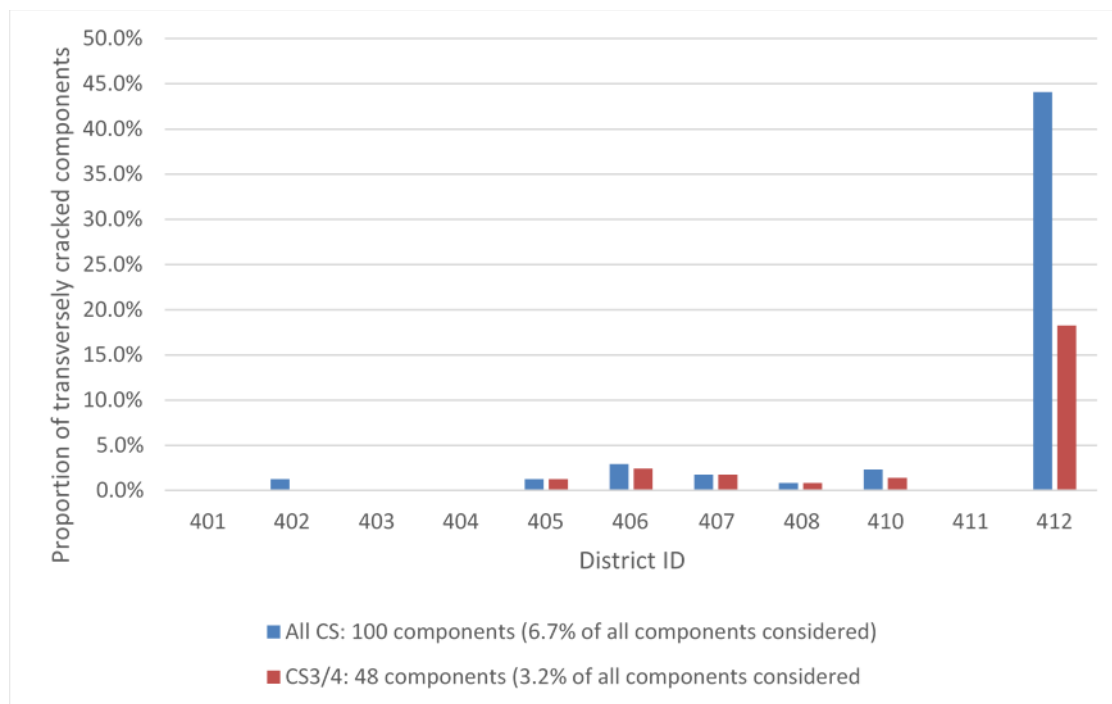
Figure 3.12: Transversely cracked 80P components in each district rated in any CS and rated in CS3/4 only as proportions of all components considered for each district

- District 412 stands apart with a large number of components in CS3/4 with transverse cracking (18.4% of all components in the district) (Figure 3.12). Transverse cracking does not generally impact the structural integrity of a pipe but can become an issue if a crack widens enough to allow backfill to enter the pipe and leave voids (Al-Saleem & Langdon 2014). Transverse cracks are commonly caused by unevenness/poor compaction of bedding, loads during construction and settlement of pipes (Al-Saleem & Langdon 2014). Investigation showed that 65% of the components in CS3/4 with transverse cracking in district 412 were installed from 1960 to 1980. These components are known to have been designed for lower loads than what is currently specified (Queensland Department of Transport and Main Roads 2015b), but there are many components in this age range which have not developed transverse cracking. If viable, construction and installation practices for concrete pipes in district 412 should be investigated to determine if there are any underlying issues. Inspection records should also be checked for consistency with the inspection manual.

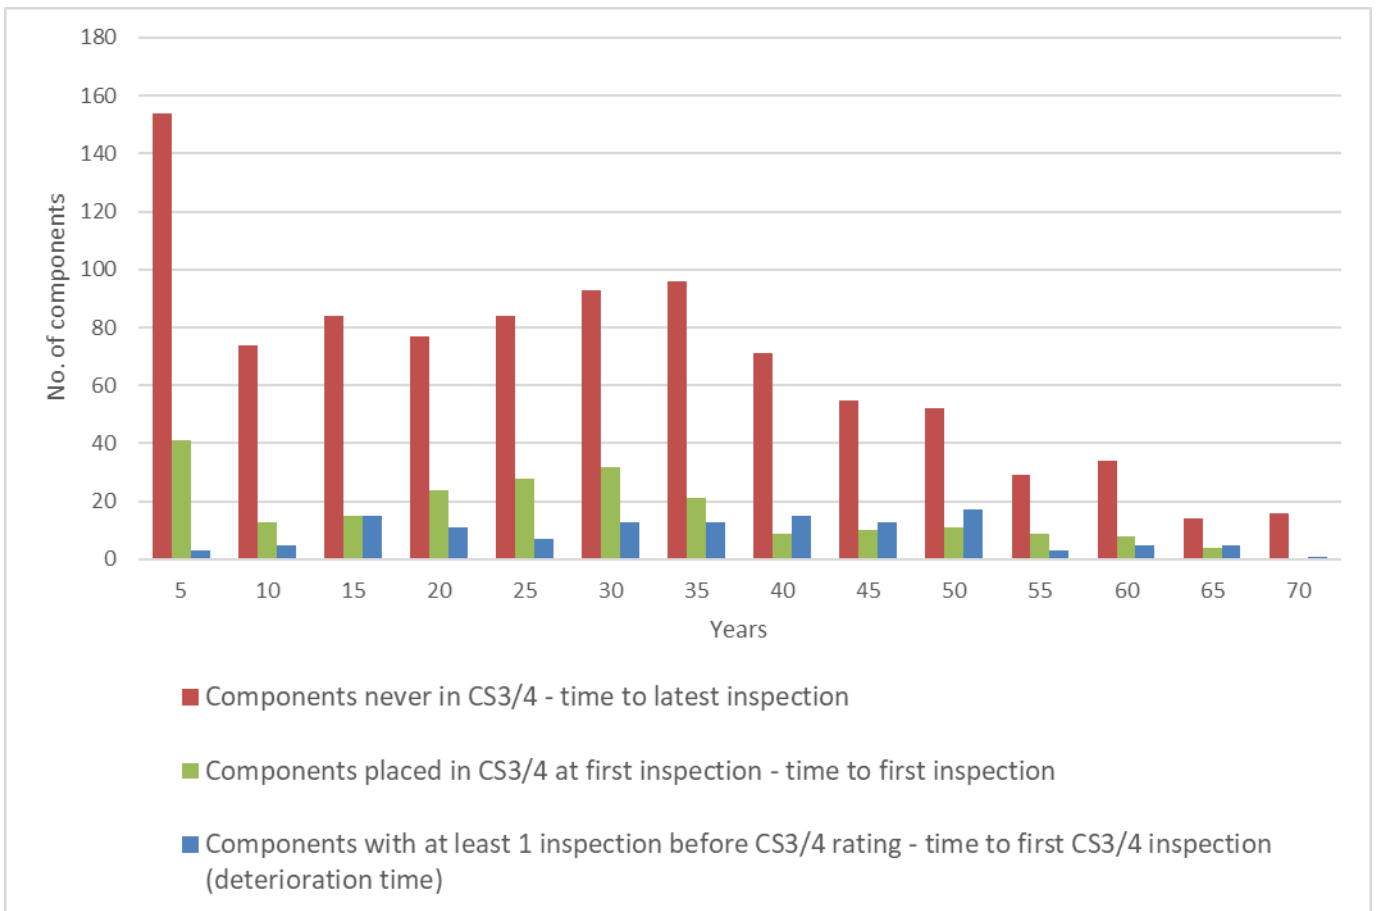
Figure 4.1: Comparison of component deterioration times to continuing lifespan of non-deteriorated components

- There are 41 components which deteriorated to a CS3/4 condition in 5 years or less after construction (Figure 4.1). This is an unexpected result, as pipes designed for a 100-year service life should not deteriorate in such a short period of time. Thirteen of the most recently deteriorated of these components are located in district 407, were installed after 2010 and have joint-separation issues. This may be due to either construction/design practices, or inspection practices. Both of these possibilities should be investigated, and the root cause should be rectified if possible. In order to determine if defects are caused by construction, handover inspections are essential and need to be recorded in BIS. Ensuring this information is captured is an important recommendation from this study.

It must be recognised that the deterioration times for components shown in Figure 4.1, Figure 4.2 and Figure 4.3 have not been formulated using the entire population of components. There are three times as many components which have not entered CS3/4 during their lifetime (933 components) compared to those that have (351 components) (Figure 4.1).

Figure 4.1 shows that for any given time interval, there are significantly more components which have not deteriorated (remaining in CS1/2) than have deteriorated. This discrepancy between the numbers of deteriorated and non-deteriorated components becomes lesser for time intervals greater than 50 years, indicating that older components are generally more likely to have entered CS3/4. It must be noted however that the time intervals greater than 50 years generally contain less components than the shorter time intervals, which contributes to the reduction in discrepancy between the numbers of deteriorated and non-deteriorated components. Taking into account the components which have not deteriorated in each time interval, it can be predicted that the true population-wide average deterioration time would be significantly longer than what is shown by analysis of the components which have already deteriorated. It is also a fact that components which have critically deteriorated in the past are likely to have been replaced and are consequently not included in the analysis. It is impossible to predict what impact these components would have on deterioration time estimates without access to records of failed and replaced components.

The initial analysis excluded components which were rated in CS3/4 at the first inspection ('components placed in CS3/4 at first inspection' in Figure 4.1). It is impossible to determine the exact deterioration times of these components, but it is possible that the deterioration times are shorter than that shown by the set analysed and shown by 'components with at least 1 inspection before CS3/4 rating'. In particular, there are 41 components which have deteriorated in 5 years or less since construction (Figure 4.1).

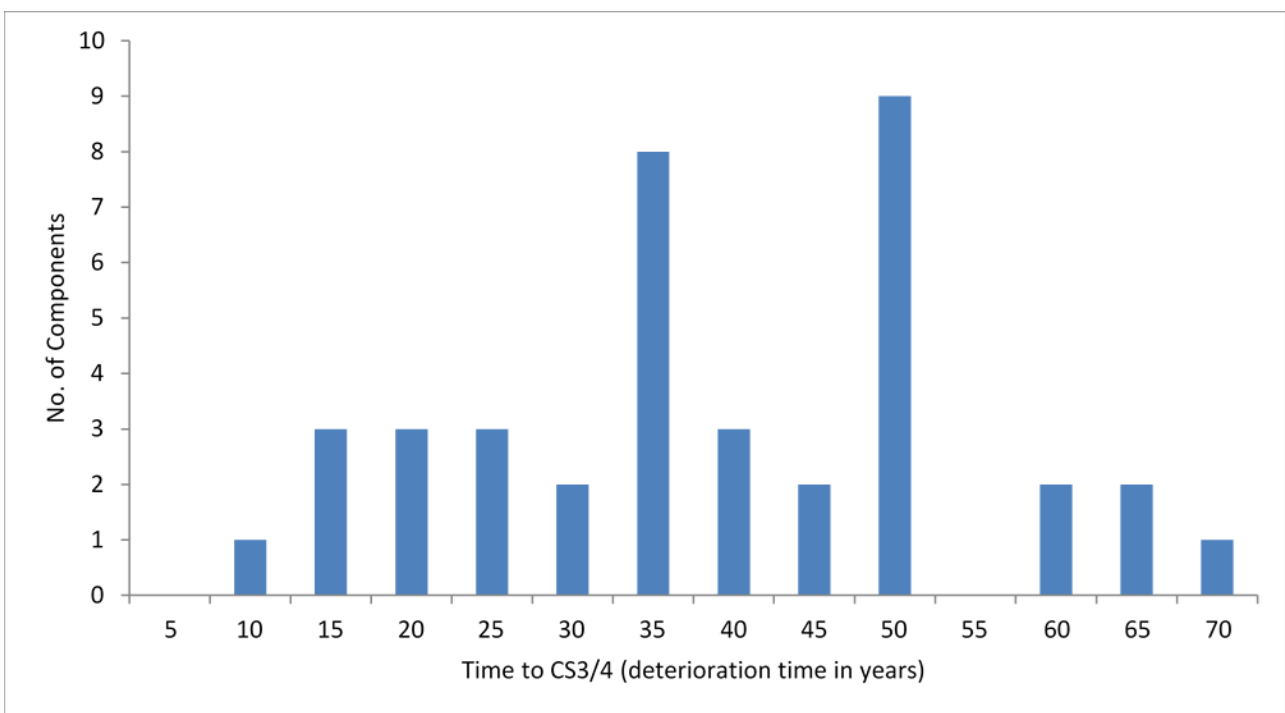
Figure 4.2: Time to CS3/4 for longitudinally cracked components

- There are 39 components which meet the criteria for analysis outlined in the methodology and are identified as longitudinally cracked at the first CS3/4 inspection (Figure 4.2).
- There is a fairly even spread of deterioration times across the longitudinally cracked components analysed, with 1-3 components typically reaching CS3/4 after each increasing 5-year interval of deterioration time (Figure 4.2).

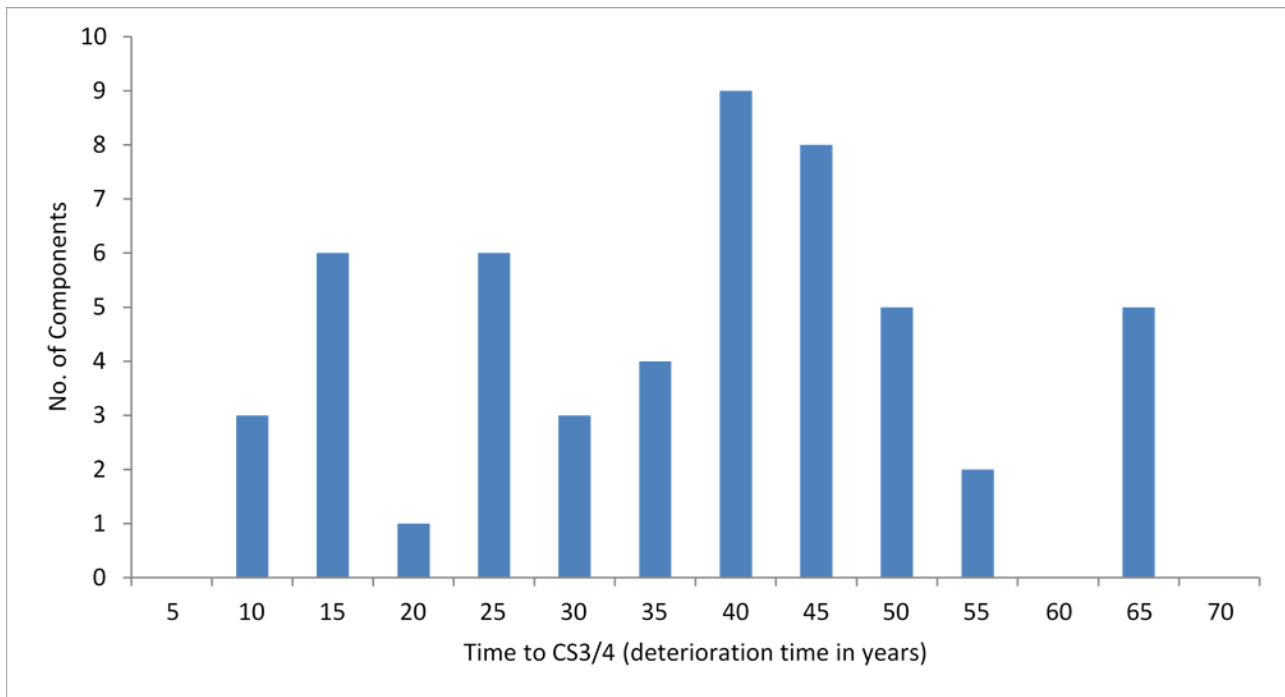
Figure 4.3: Time to CS3/4 for spalled components

- The data for spalled components is more varied compared to the data for longitudinally cracked components and the data for all defects. Three of the five records for the 60–65-year interval are for the same structure (Figure 4.3). A deterioration time of 35–45 years is the most prevalent for spalling defects, with 17 out of 52 components reaching CS3/4 after this amount of time (Figure 4.3).
