FINAL REPORT

Project Title: S3 GUN-Sandgate Road Bridge Load Testing Report (2016/17)

ARRB Project No: PRG16022

Client: Queensland Department of Transport and Main Roads

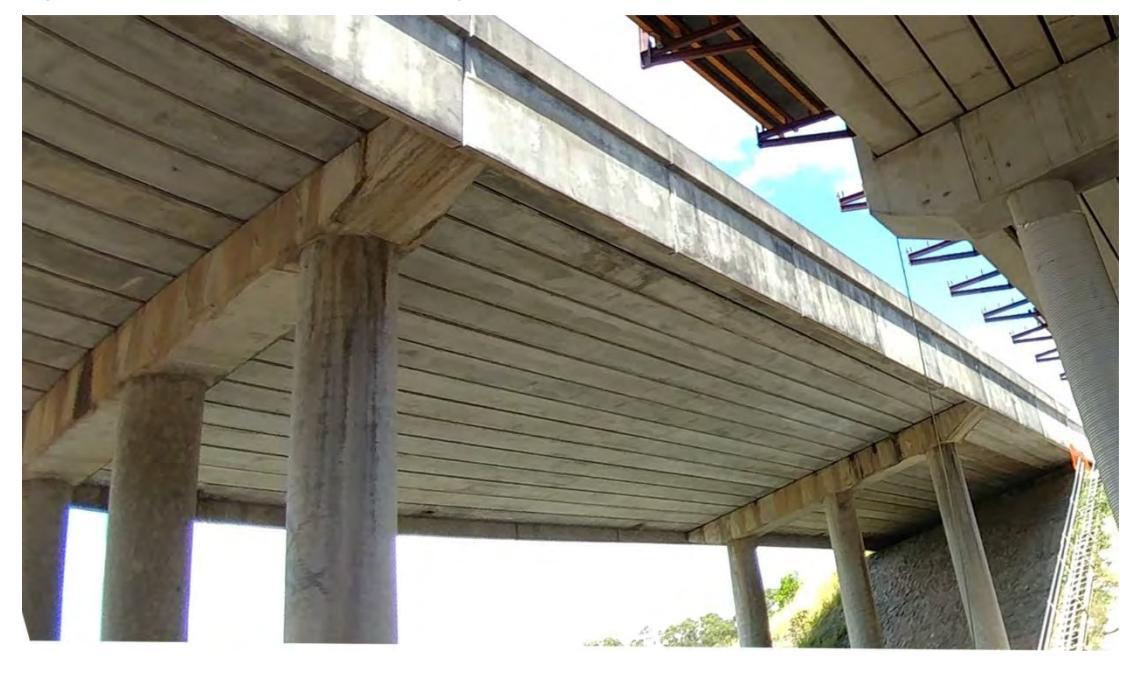
Figure 2.2: View of Span 9 from the bridge soffit (Pier 8 is on the left-hand side)

At the time of the sensor installation, as noted in the Level 2 inspections (R2, R3), 11 out of the 15 DUs in Span 9 exhibited longitudinal cracking to a varying extent. This was likely caused by alkalisilica reaction (ASR), and mostly localised within 2.8 metres from the supports (see Appendix B).

The condition of the structure at the time of testing is summarised in Table 2.2, while the crack layout refers to the R3 map reported in Appendix B. The southernmost unit, DU1, had a 1.5–4.0 mm wide crack across the entire span due to defective drainage. As for R3, most of the

other DUs exhibited minor longitudinal cracking 2.0-2.8 metres from the supports, with a crack width ranging from 0.1-0.9 mm (see Figure 2.4).

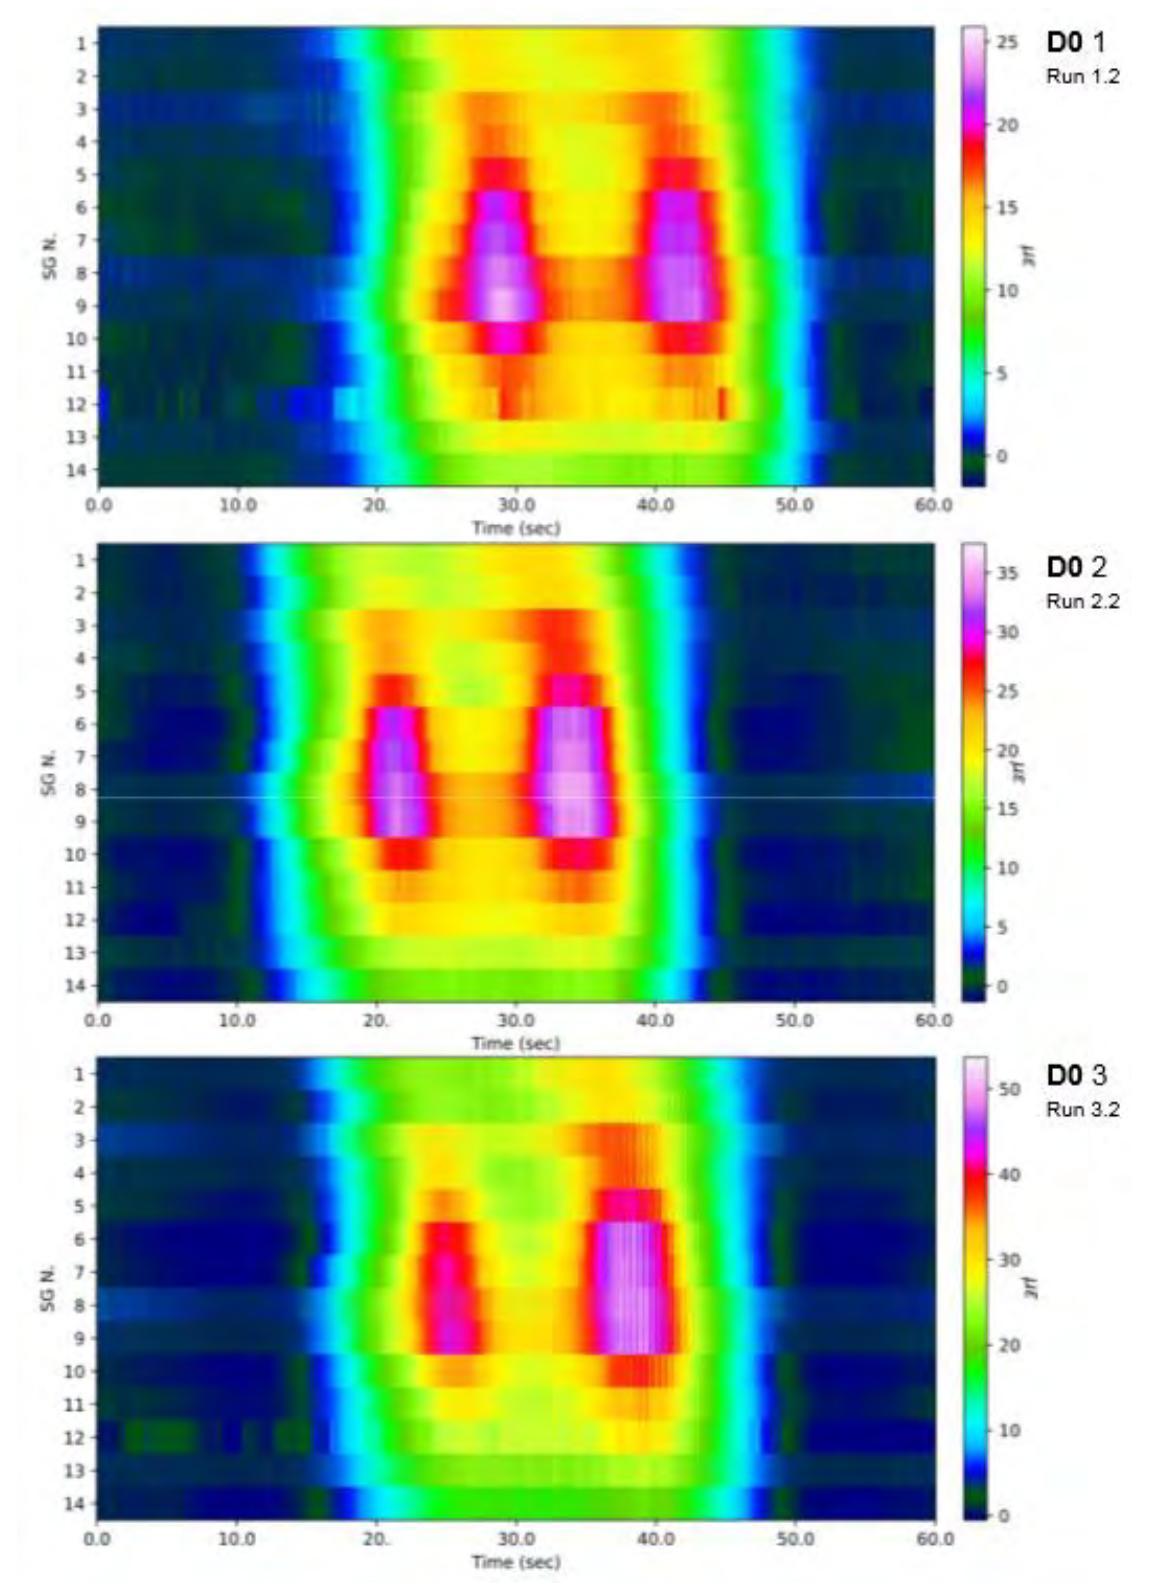
Figure 10.8: Strain intensity maps for load tests, undamaged stages

In the 'undamaged' stage (before severing TSBs) (see stages D01–D03 in Table 6.1), the strain under increased truck loading underwent a linear increase across all DUs, i.e. the strain scaled elastically with the added load. The variation of the strain distribution across the DUs under increasing loads, with the truck travelling along the central path (see Figure 5.2), is shown in Figure 10.8. It can be seen that the distribution pattern did not change when the load changed from 42.5 to 82.5 tonne, while the strain in each DU increased by the same fraction.

Notes: This Figure shows maps of the strain intensity and distribution across Span 9 during the load tests in the undamaged stage (D01, D02 and D03), with the 42.5, 62.5 and 82.5 tonne trucks crossing Span 9 along the central path, respectively. SGB1–7 captured the strain in the northern lane (DU1–7) and SGB8–14 mapped the strain in the southern lane (DU8–14). The truck speed was approximitely 2.5 km/h.

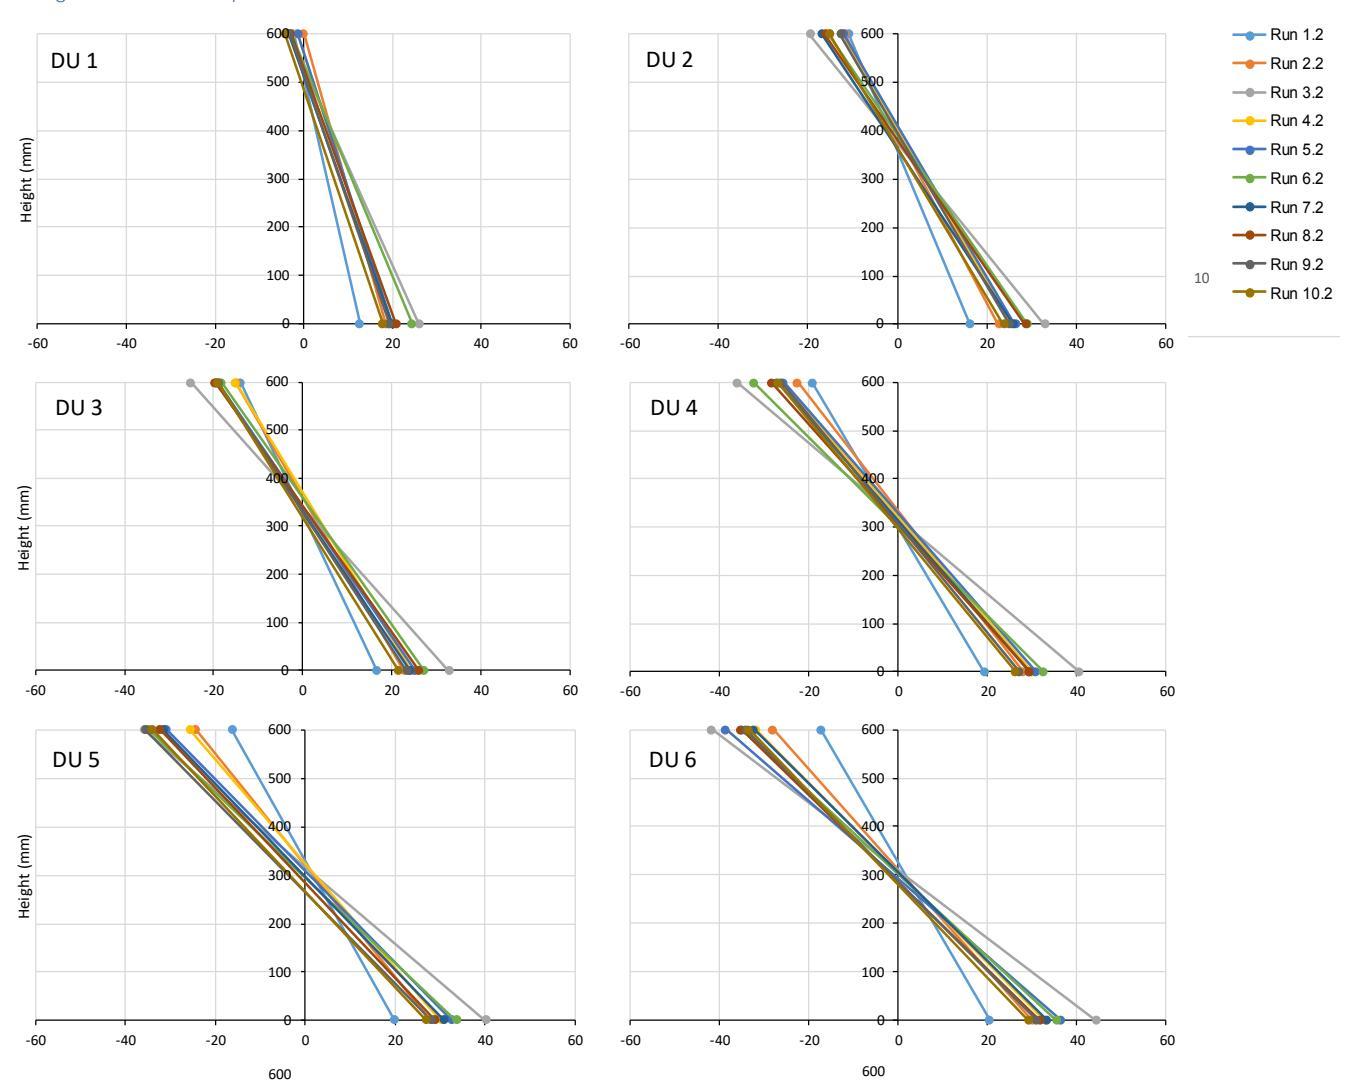
Figure 10.15: NA position, DU1-6

The NA positions derived for DU1–14 under the vehicle along the central path, for the initial condition and each damaged stage, are shown in Figure 10.15 and Figure 10.16. The location of the NA position, before and after TSB severing, is shown in Figure 10.17, where the internal DUs characterised by a more stable NA (DU5–11) are highlighted. It is noted that the SG placed on the top of DU13 (SGT13), after milling of the DWS, appeared to have undergone some damage during installation.

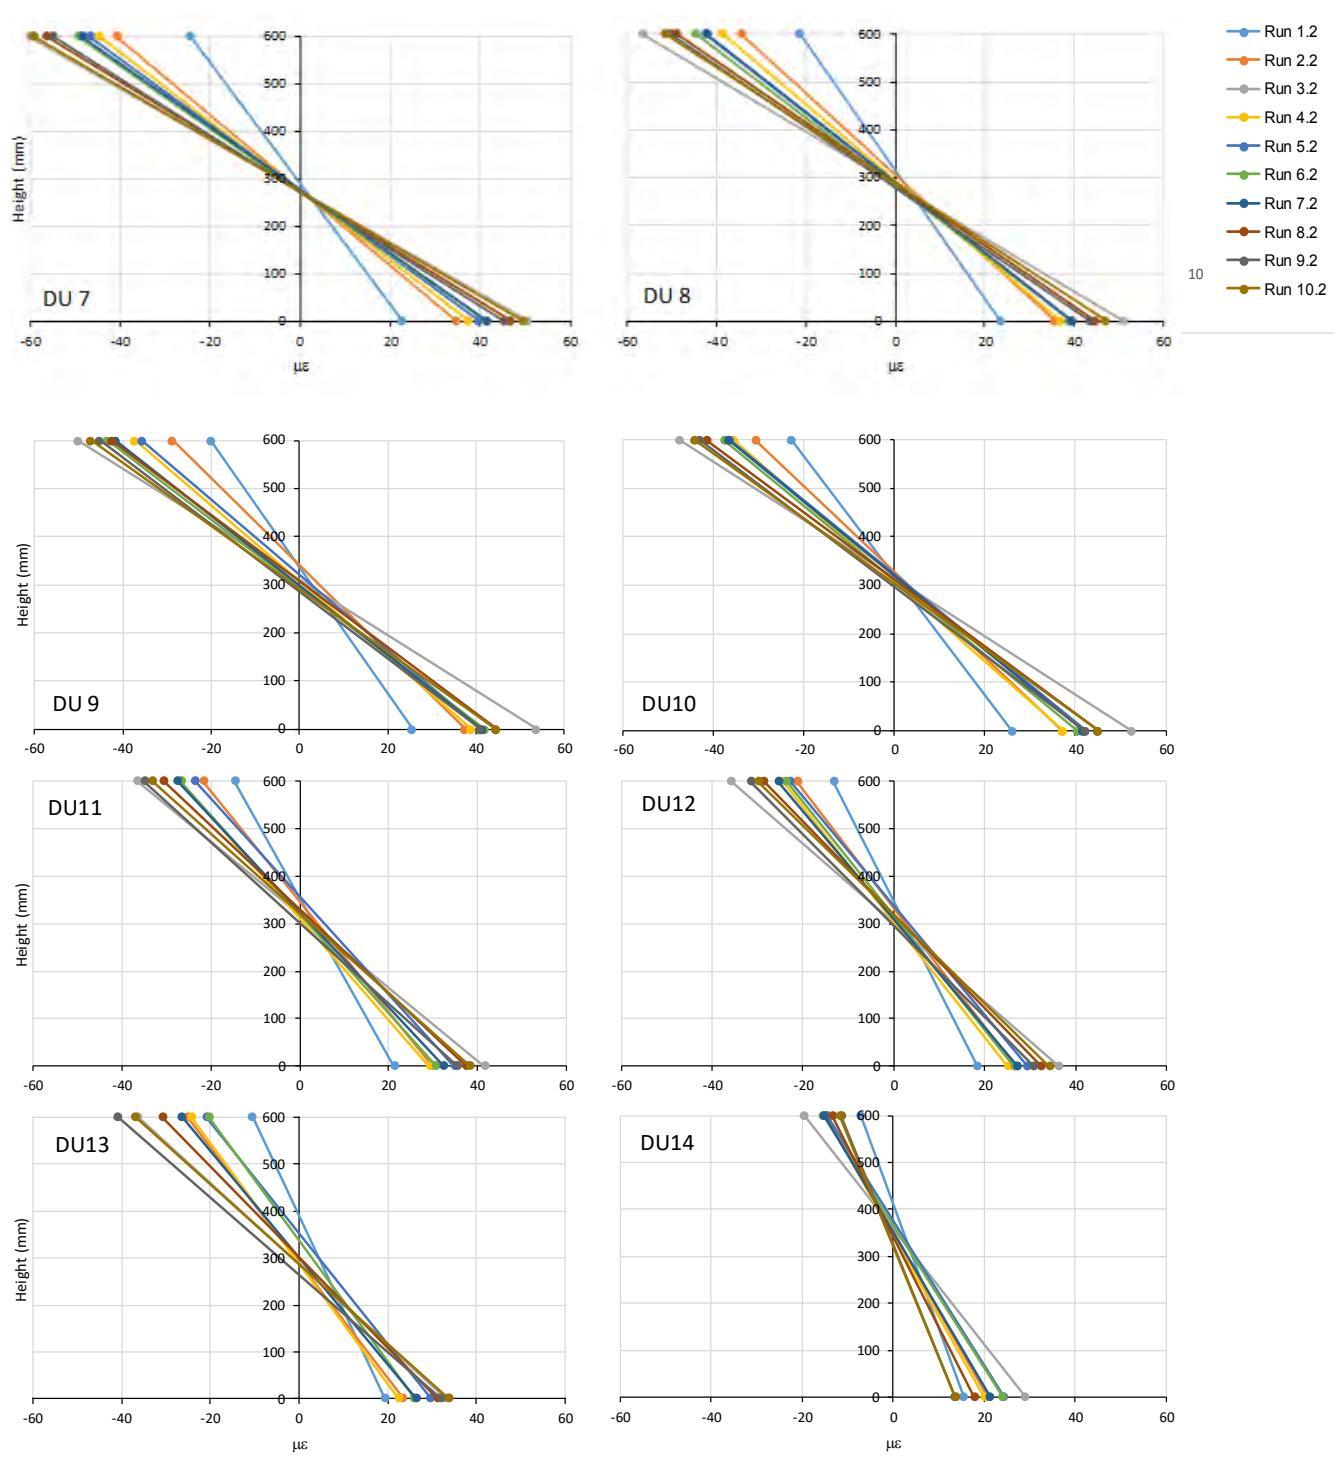
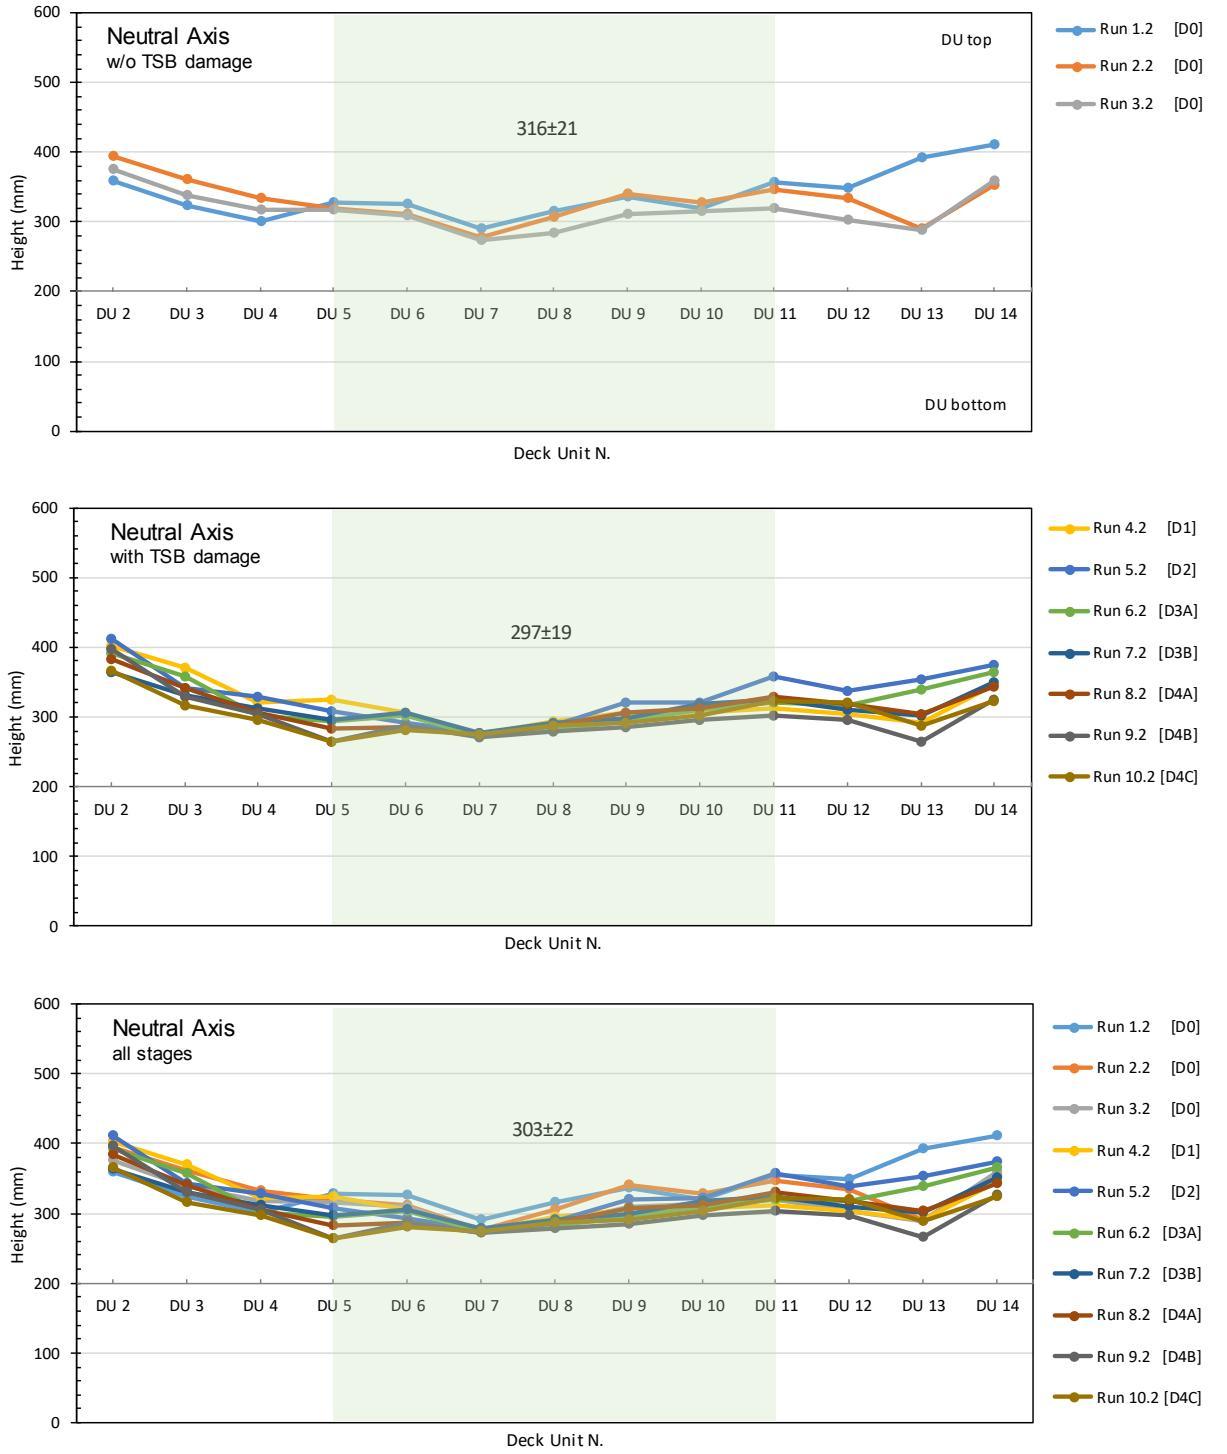
Figure 10.17: NA position for each damaged stage

Notes: This Figure shows the location of the neutral axis (NA) in each beam for each damaged stage, as derived for the load tests with the truck crossing the deck along the central path. The top Figure shows the NA derived for the load tests prior to TSB severing (D01–3), the central Figure shows the NA position after each stage of TSB severing, and the bottom Figure shows the NA position for all tests combined. The light-green shaded area highlights the DUs characterised by a more 'stable' NA, with indication of the average NA value (in mm) for DU5–11.

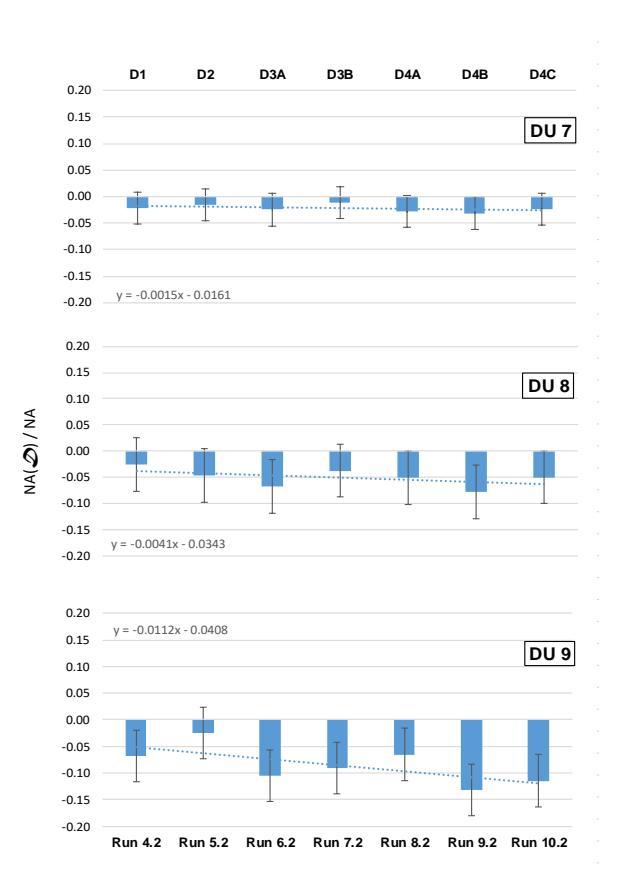
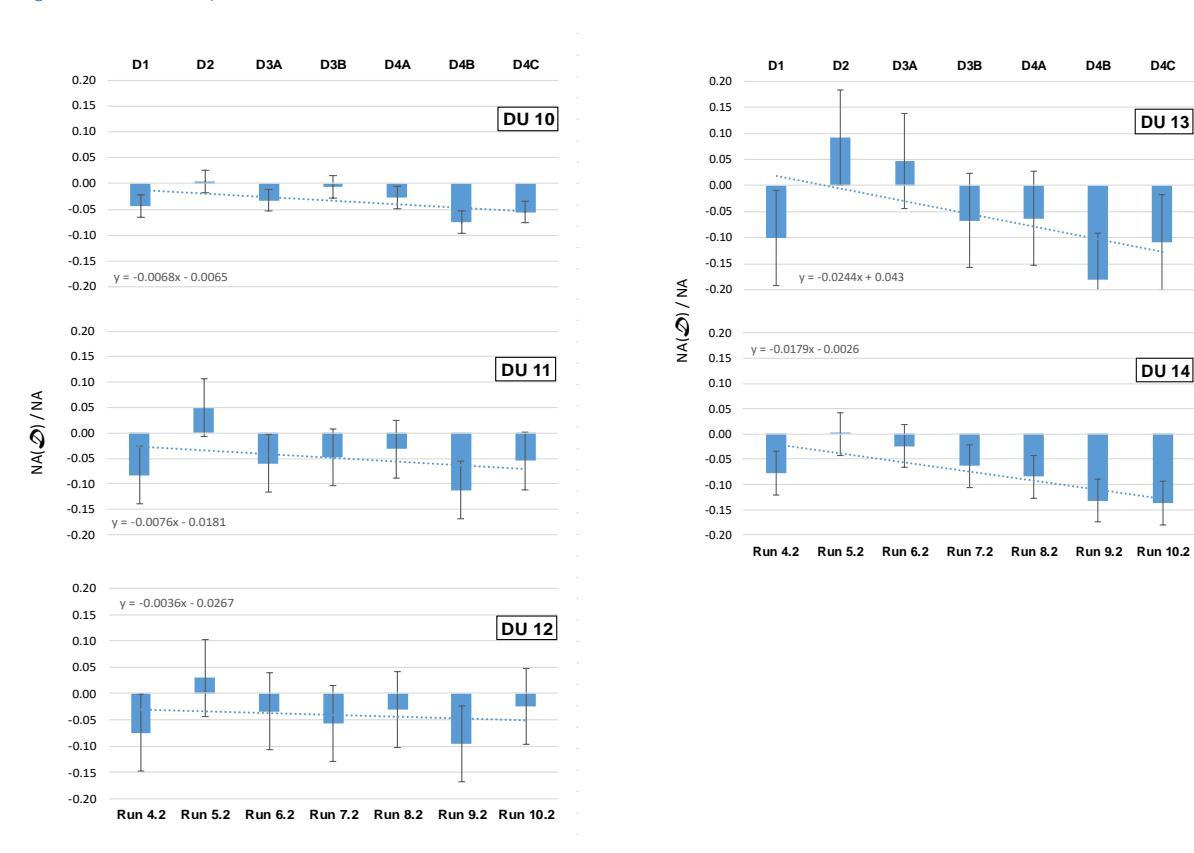
Figure 10.19: NA position variation, DU10–14

Notes: Figure 10.18 and Figure 10.19 show the variation of the neutral axis position across the tests for DU4–14. The neutral axis variation is expressed as the ratio, $NA(\bigcirc) / NA$, where $NA(\bigcirc)$ is the neutral axis position derived after each stage (\bigcirc) of TSB severing, and NA is the neutral axis position derived, for each DU, from the load tests carried out in the undamaged state. All data refer to vehicle runs along the central path with a load of 62.5 tonne. The error bars indicate the standard deviation.

As for Section 10.2.3, the upper limit of RNA of 18% appears to match the LDF increase derived for the deck structure after the last damaged stage (see Figure 10.13).

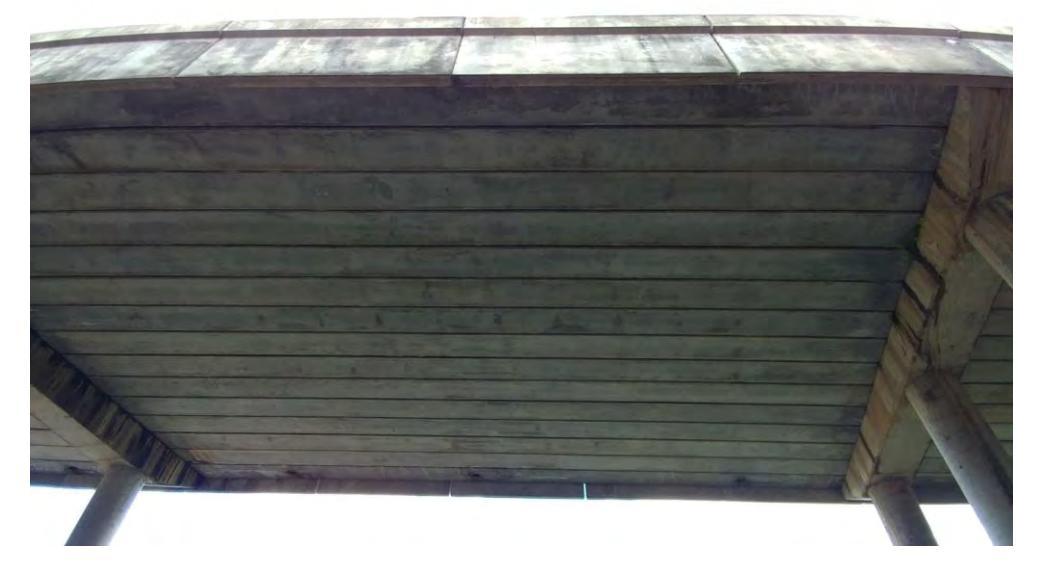
Figure C 4: Close-up view of Span 9

Notes: DU15 is the unit near the top of the photo, partially obscured by the northern parapet. DU1 can be seen near the bottom of the photo, with the drains in mid width.
